**PARKING GARAGE
STRUCTURAL CONDITION SURVEY REPORT-2018**

**HANCOCK AIRPORT PARKING GARAGE
1000 COL. EILEEN COLLINS BLVD
SYRACUSE, NY 13212**

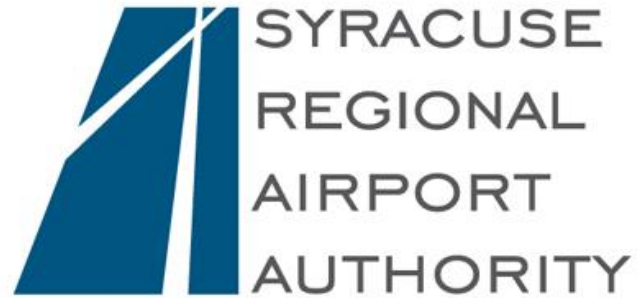
**PARKING GARAGE
STRUCTURAL CONDITION SURVEY REPORT-2018**

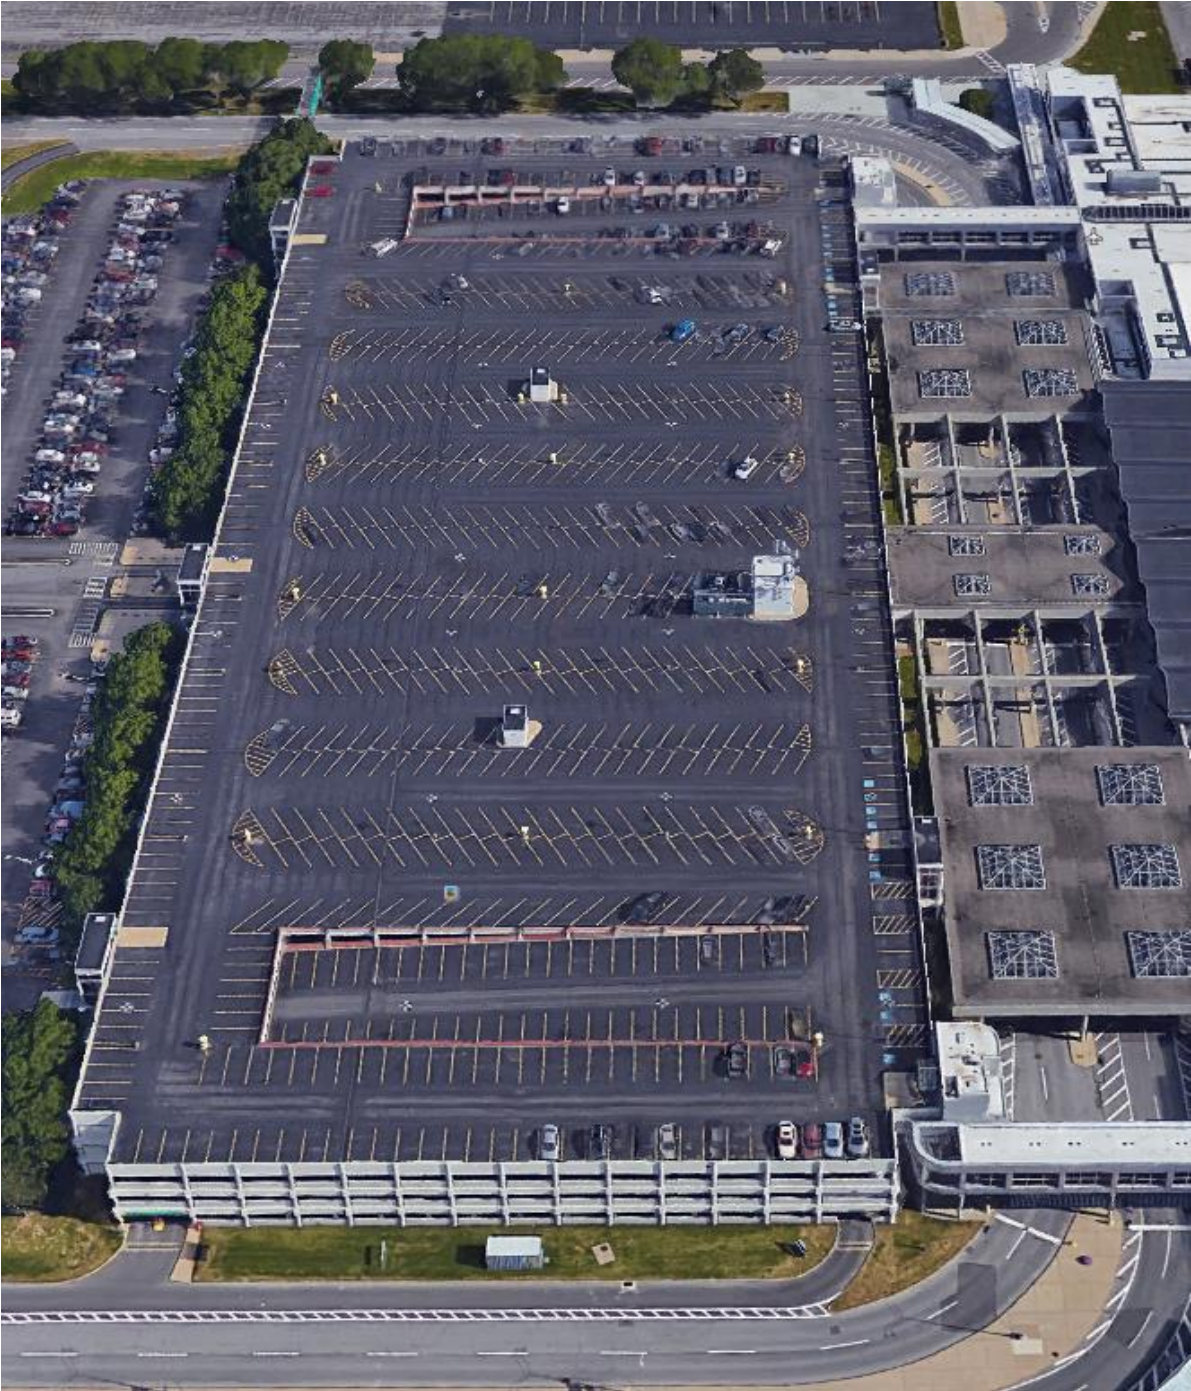
(Photo from Google Earth)

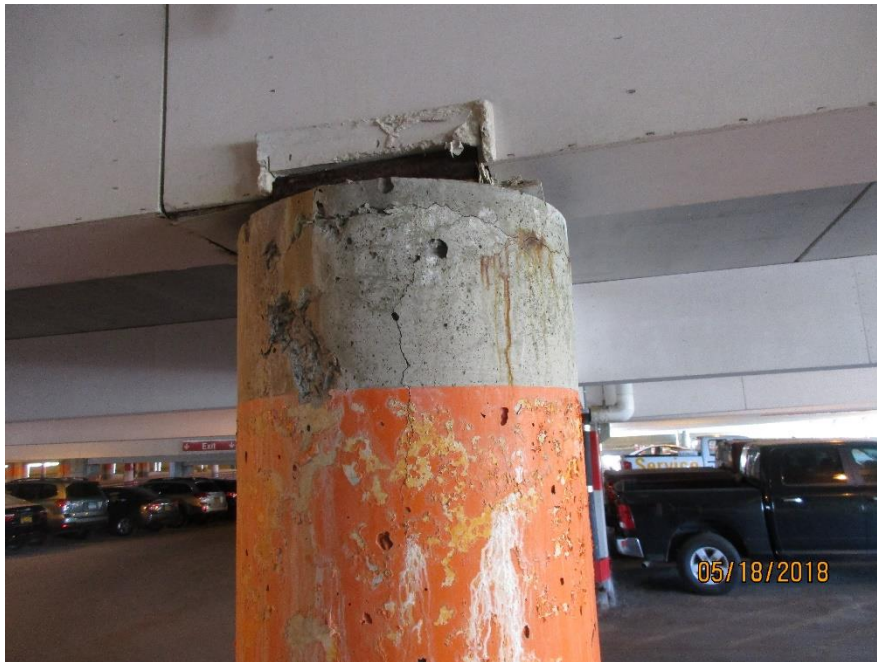
Photo #1: column S3 on Level 3 - hairline cracks at top of column

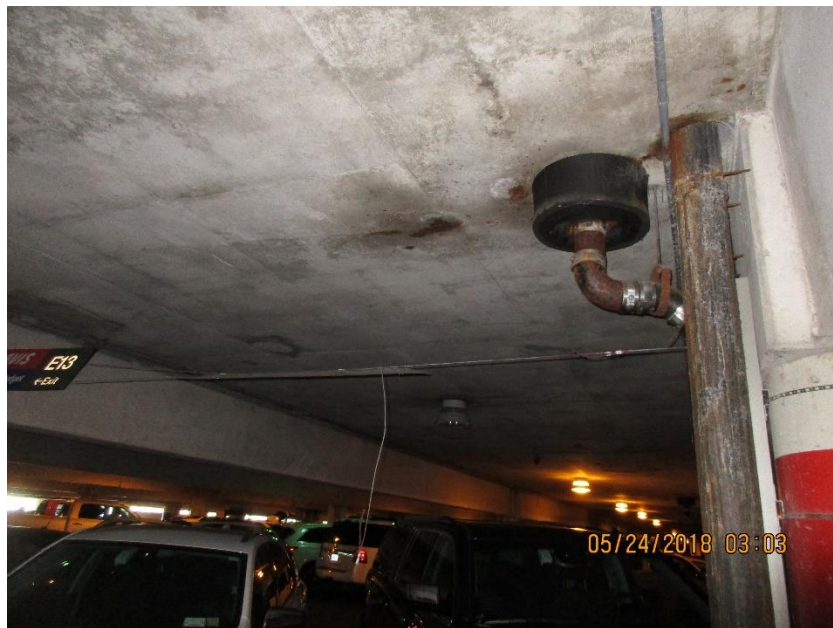
Photo #2: Level 2 Soffit-water stained concrete and corrosion at bottom of concrete deck at the floor drain. Typical condition below second floor. Broken rental car sign cable.

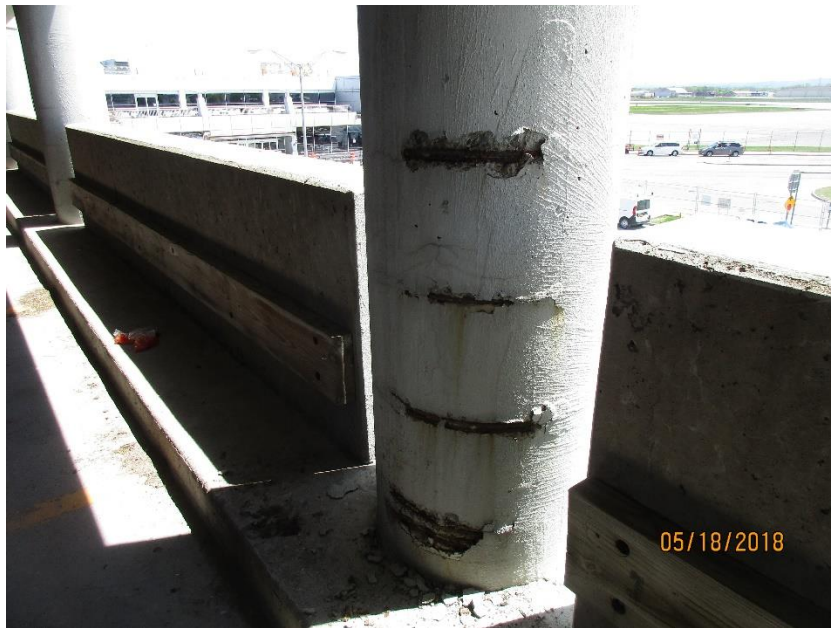
Photo #3: spalling concrete column with corroded ties on south end of Level 3

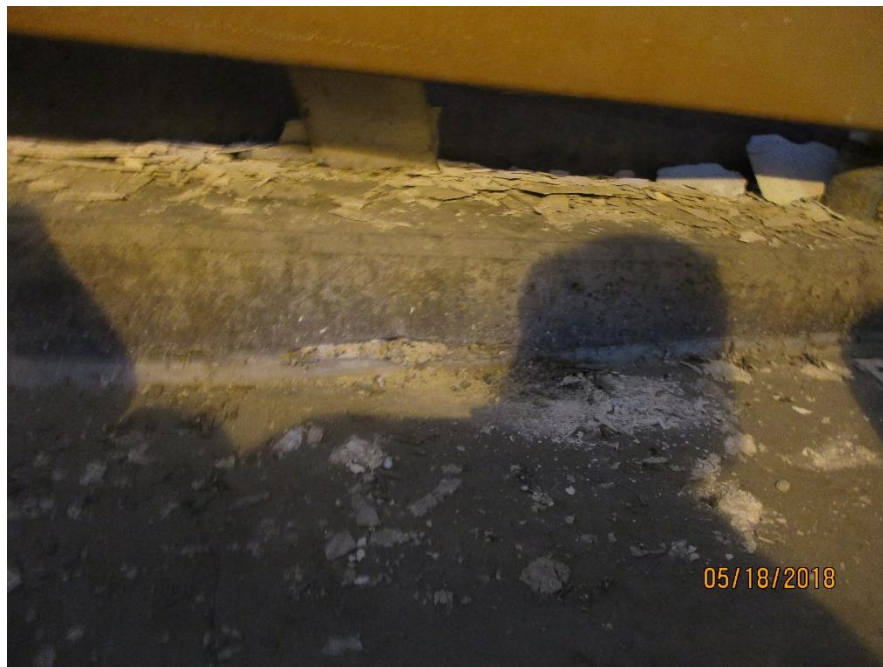
Photo #4: damaged fire proofing board falling on concrete deck near column line Q3 on Level 3

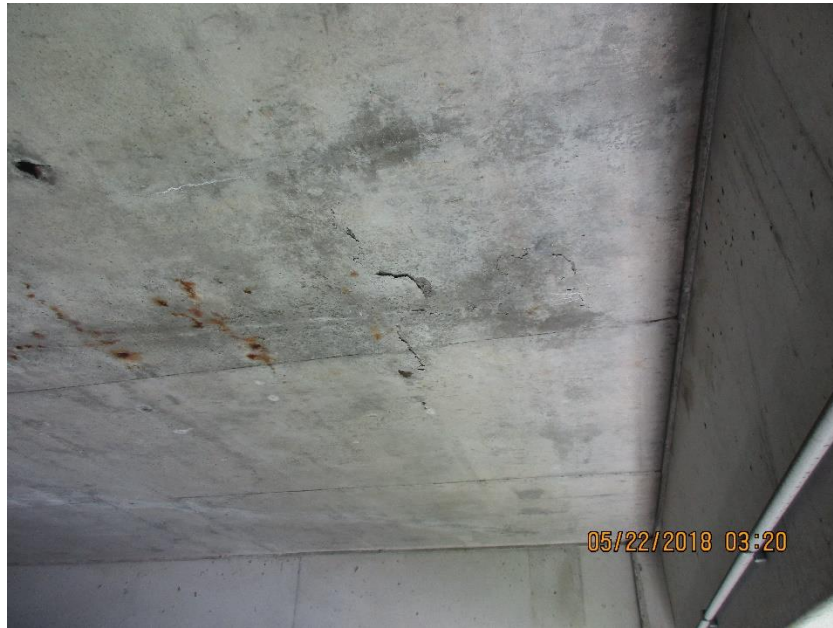
Photo #5: Level 3 soffit near column line E32 - cracked and delaminated soffit

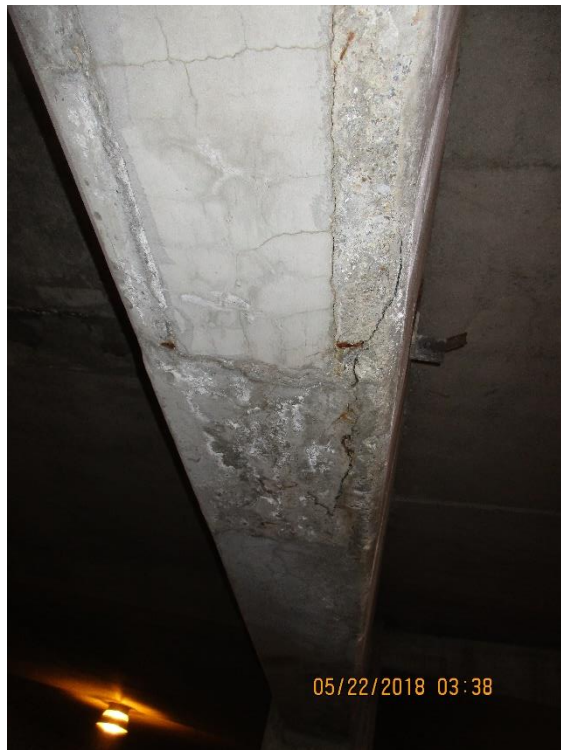
Photo #6: Beam over Level 3 between E28 to E30 – bottom of beam with cracked patches

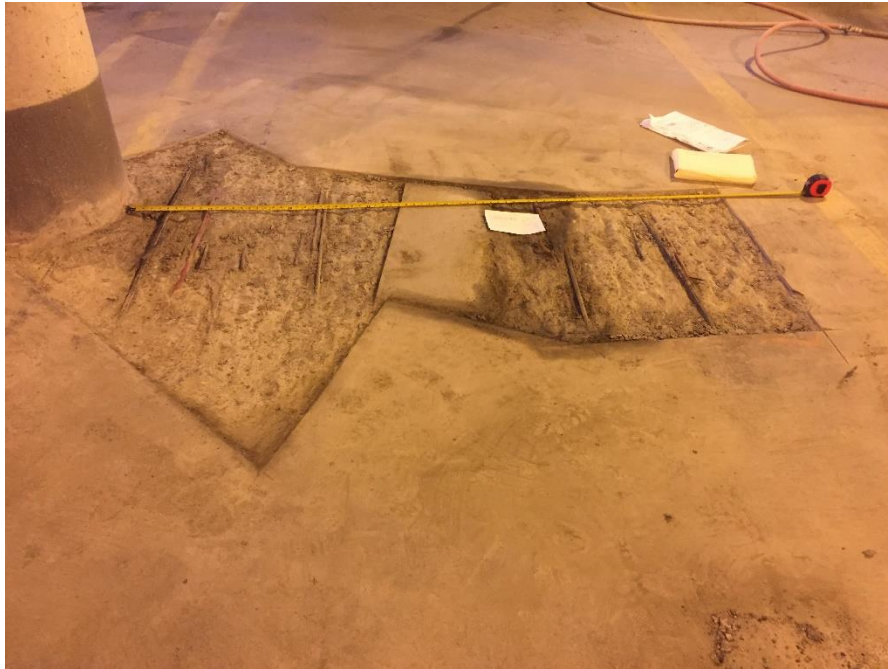
Photo #7: Two broken PTs at column C14 at Level 2.

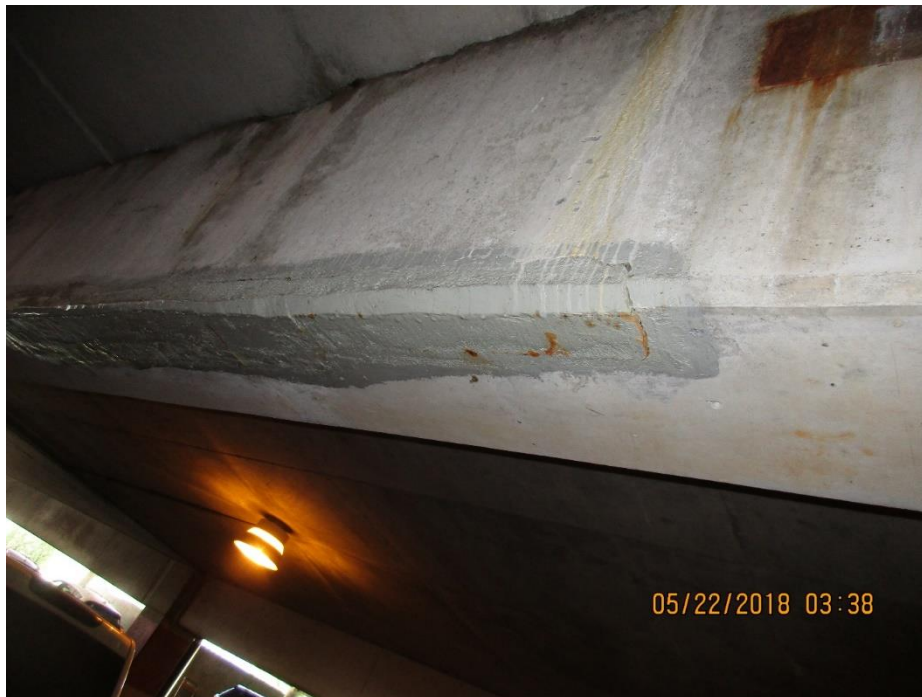
Photo #8: Level 3 Soffit-water leaking along the damaged joint at base of the South Ramp at the roof level. Also, crack along the patched area of girder.

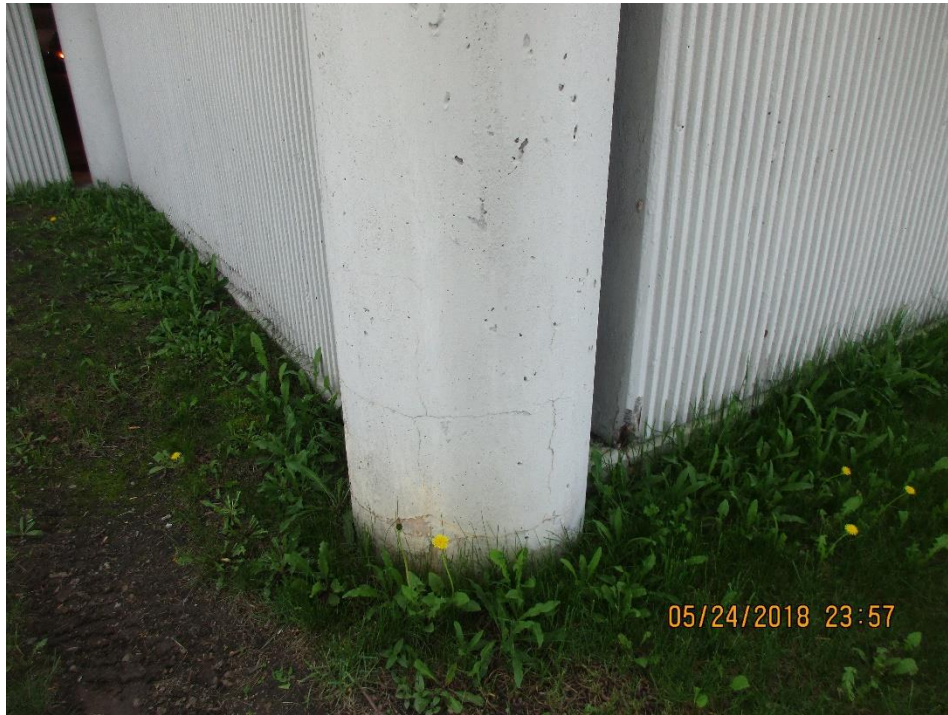
Photo #9: typical concrete column cracking at base.

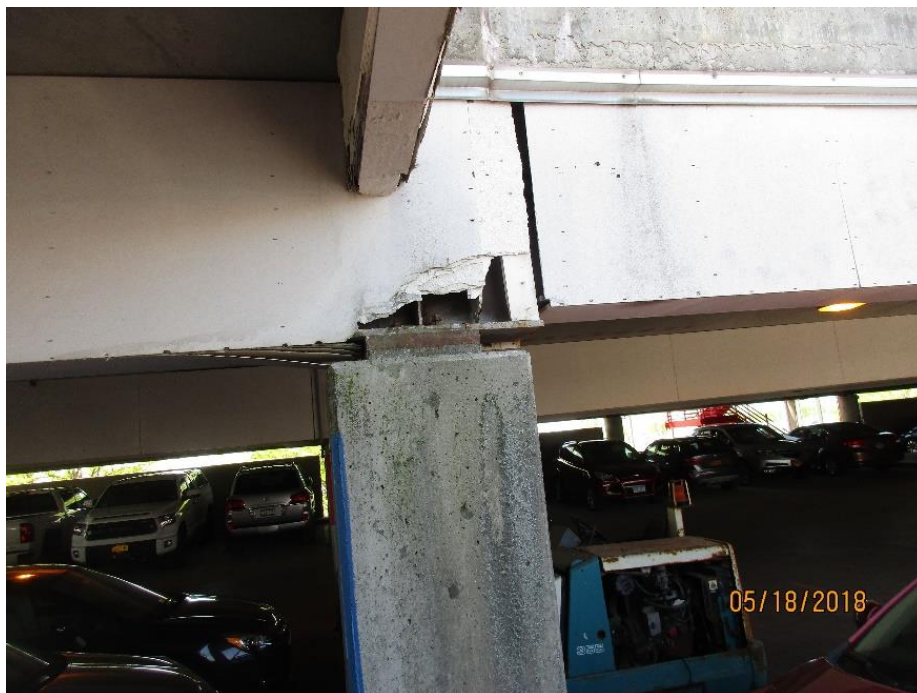
Photo # 10: Level 3- Roof Soffit- water damaged fireproofing board and corrosion of steel beam bearing plate.

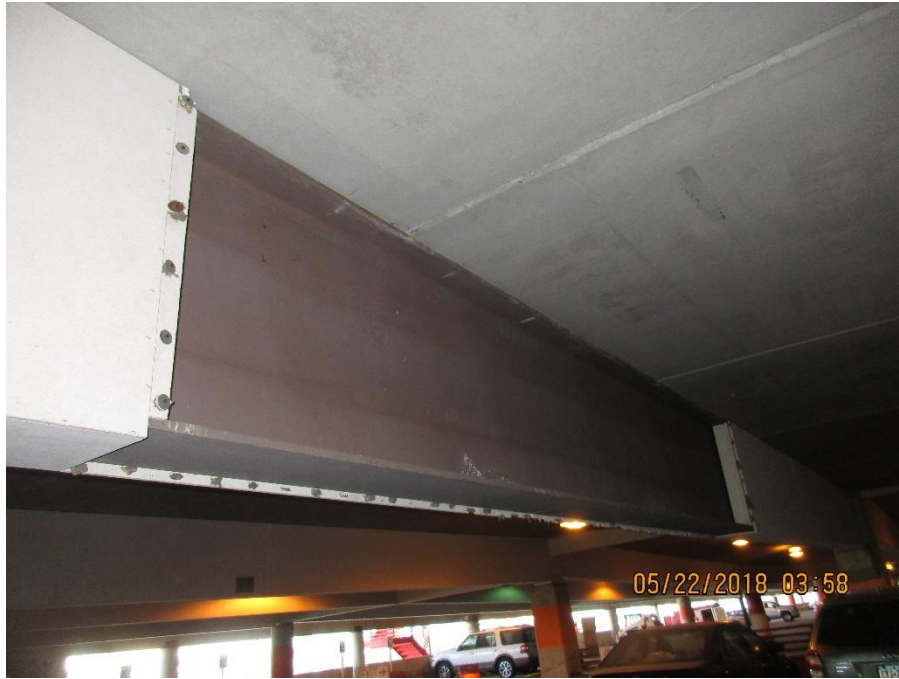
Photo #11: Level 3-Roof Soffit- missing fireproofing board at steel girder.

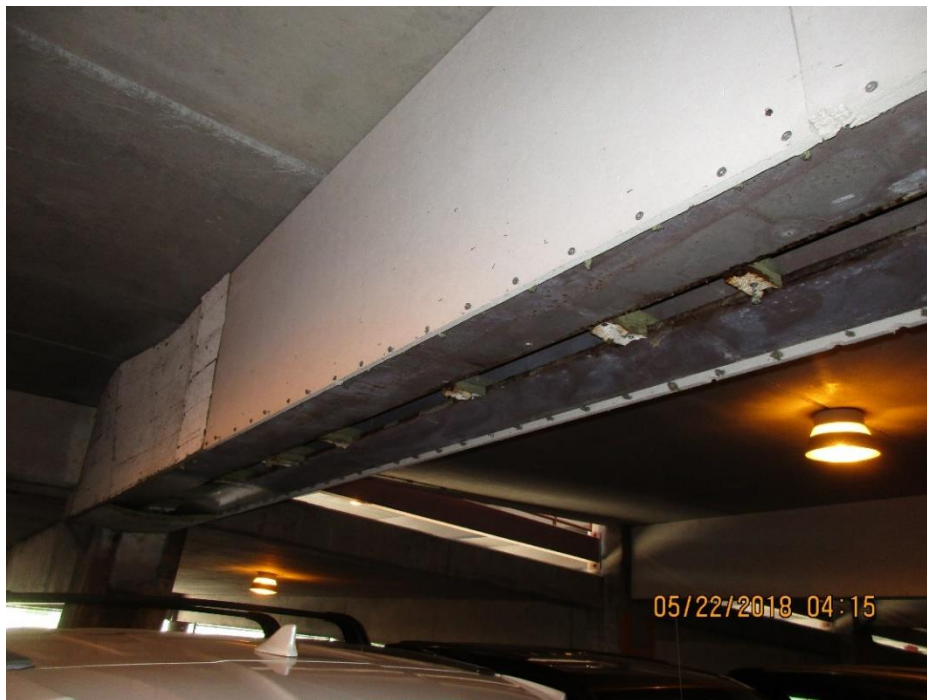
Photo #12: Missing fireproofing board at bottom of steel beam

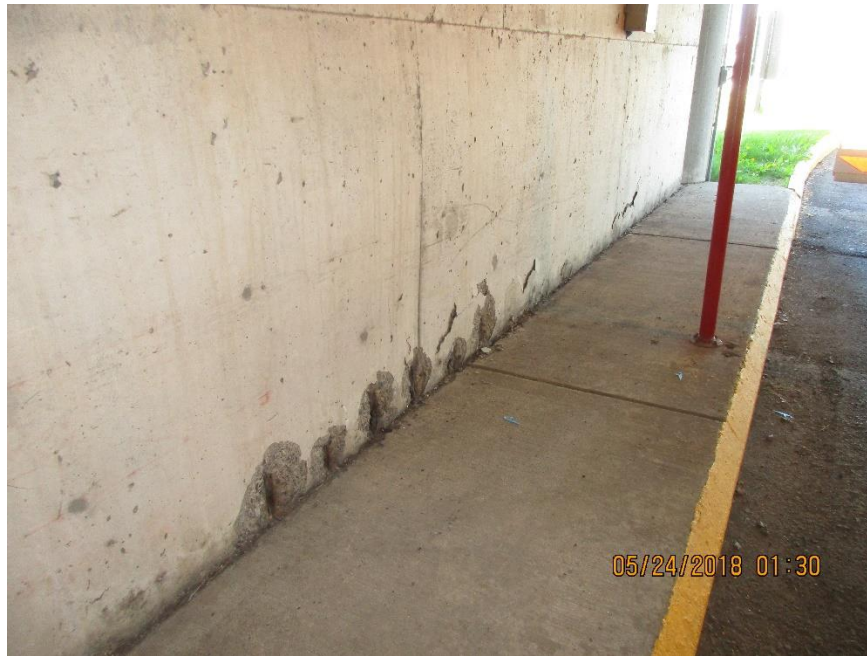
Photo #13: North West garage entrance ground level spalling and corroded reinforcing on wall

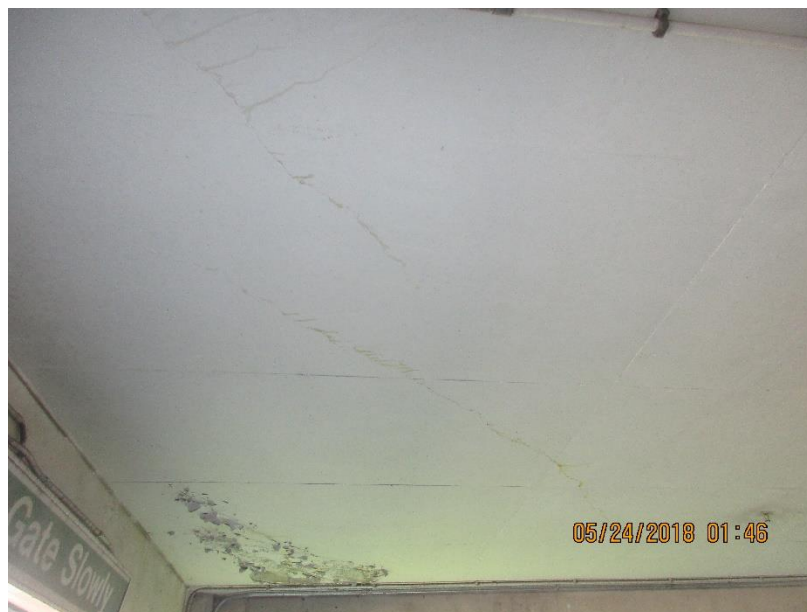
Photo #14: Hairline cracks at Northeast corner Level 2 soffit

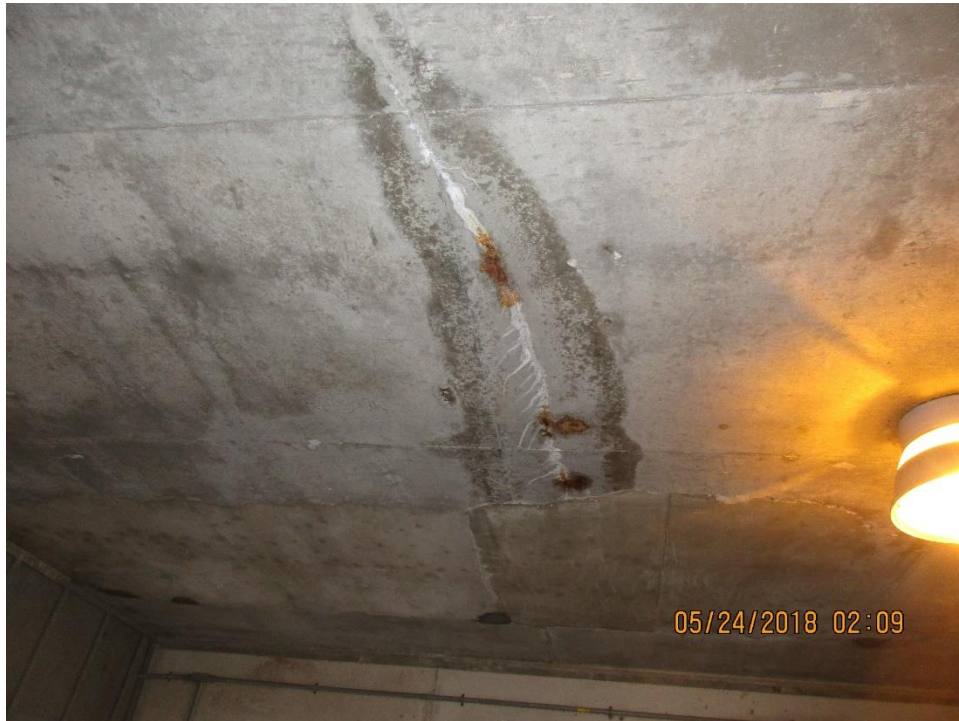
Photo #15: Level 2 soffit near column line Q30 – leaking crack with corrosion

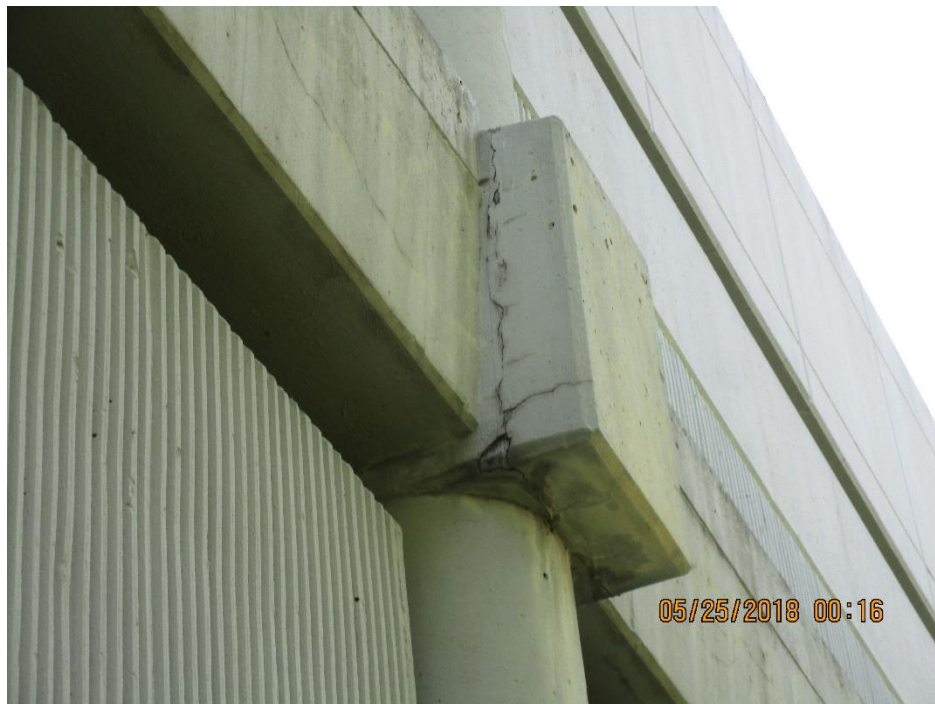
Photo #16: Cracked post tensioning pocket cover

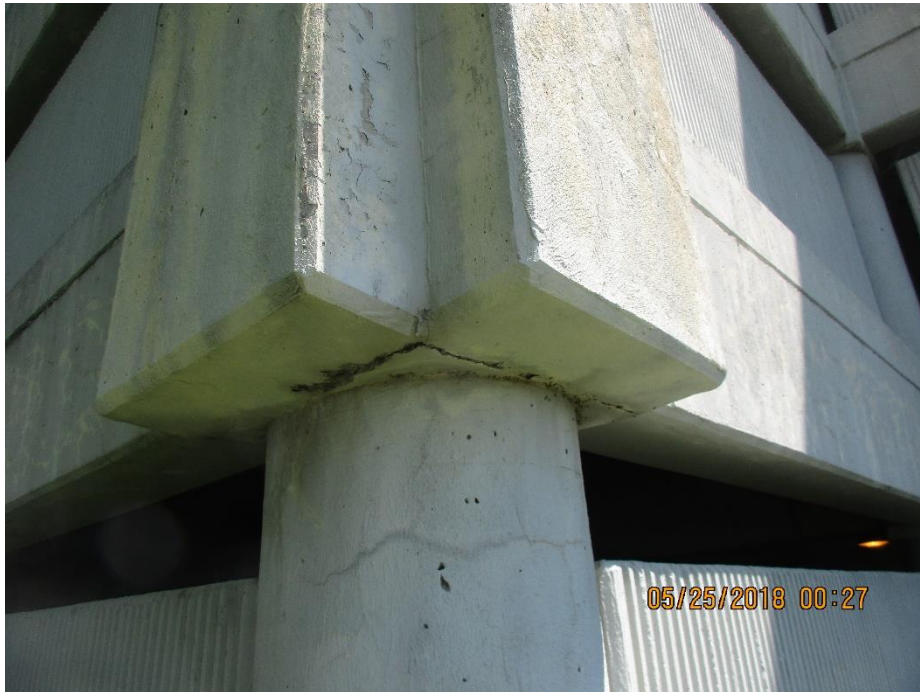
Photo #17: Cracked post tensioning pocket cover

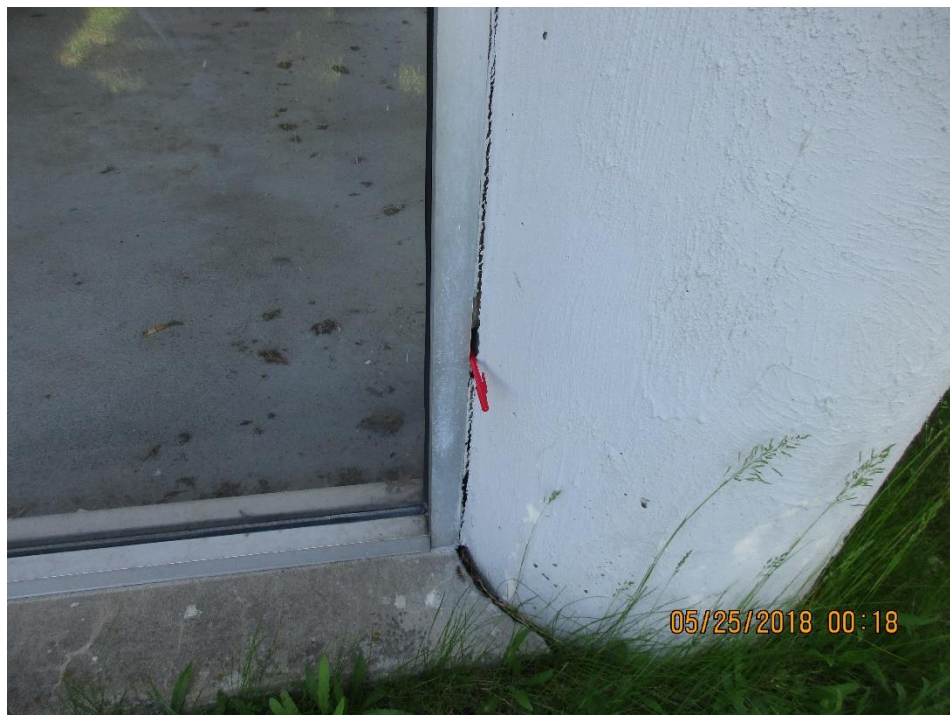
Photo #18: Failed caulk at Level 1 stair tower 3

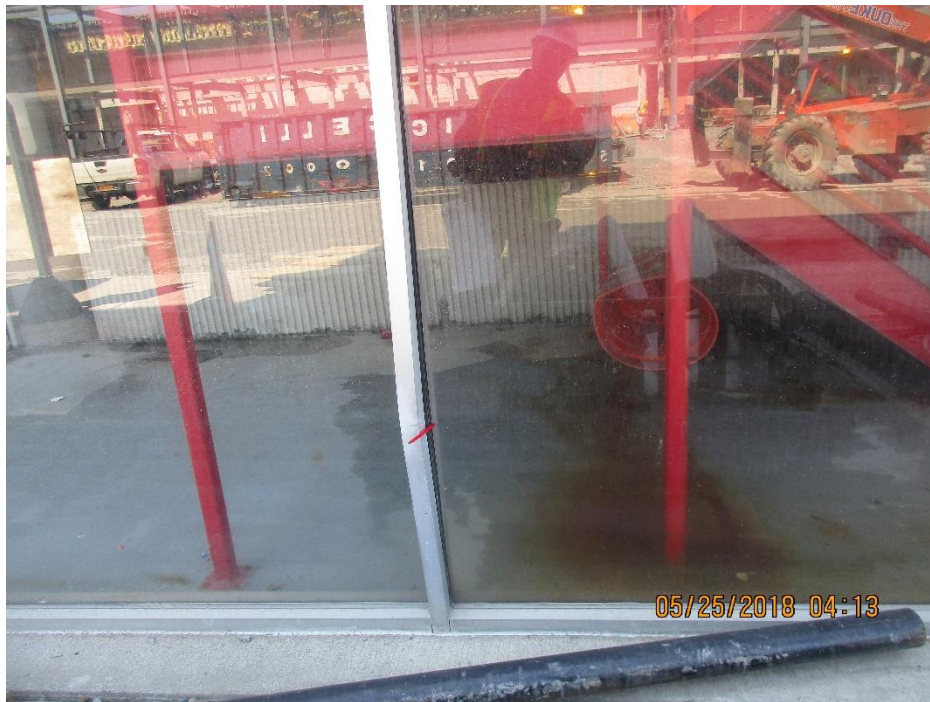
Photo #19: Damaged mullion at stair #1. Edge unsupported at glass panel.

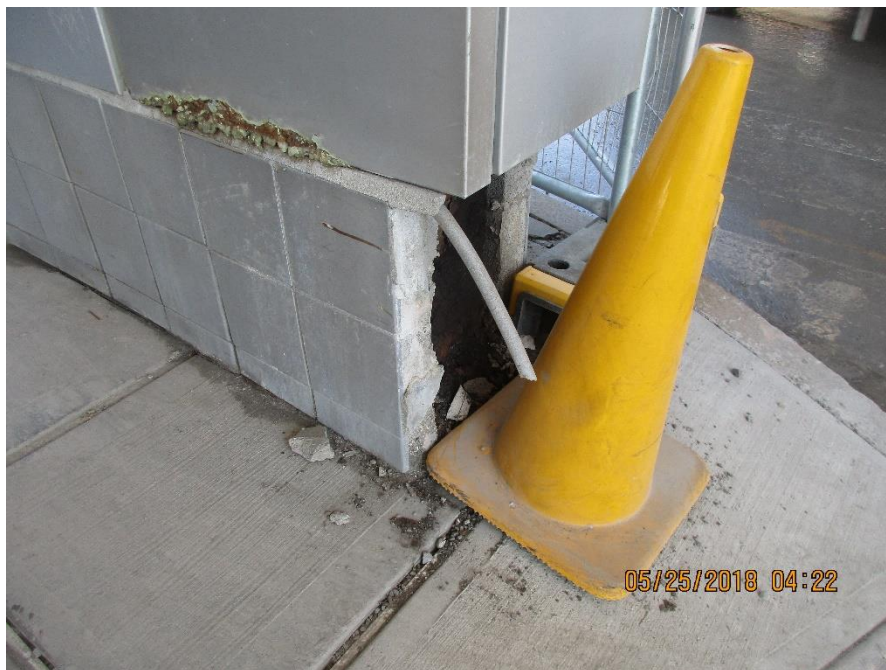
Photo #20: corroded steel column and damage glazed masonry at pedestrian bridge. We believe the glazed masonry was repaired.

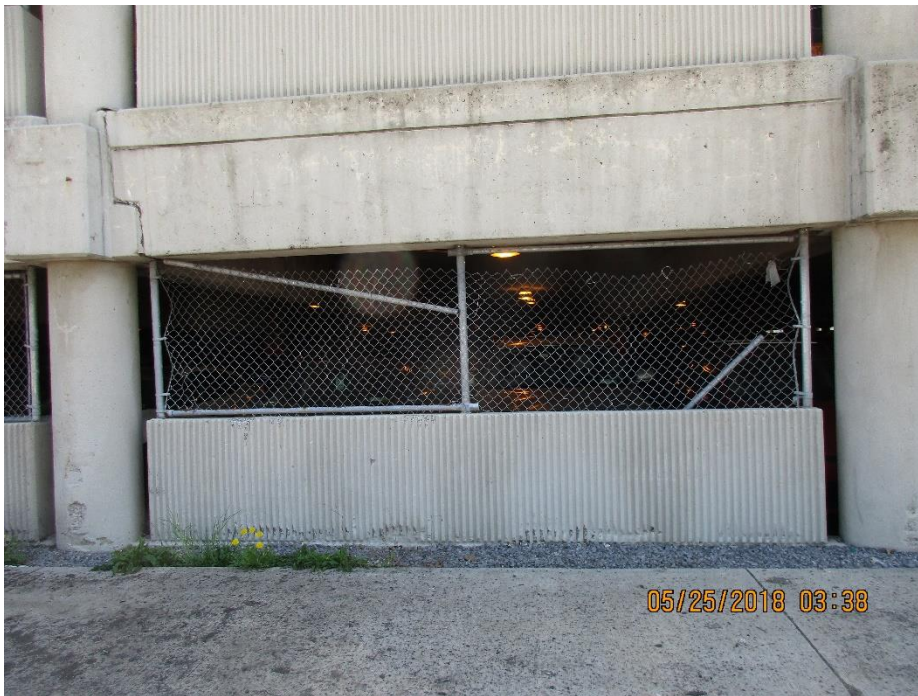
Photo #21: Damaged chain link fence on north side.

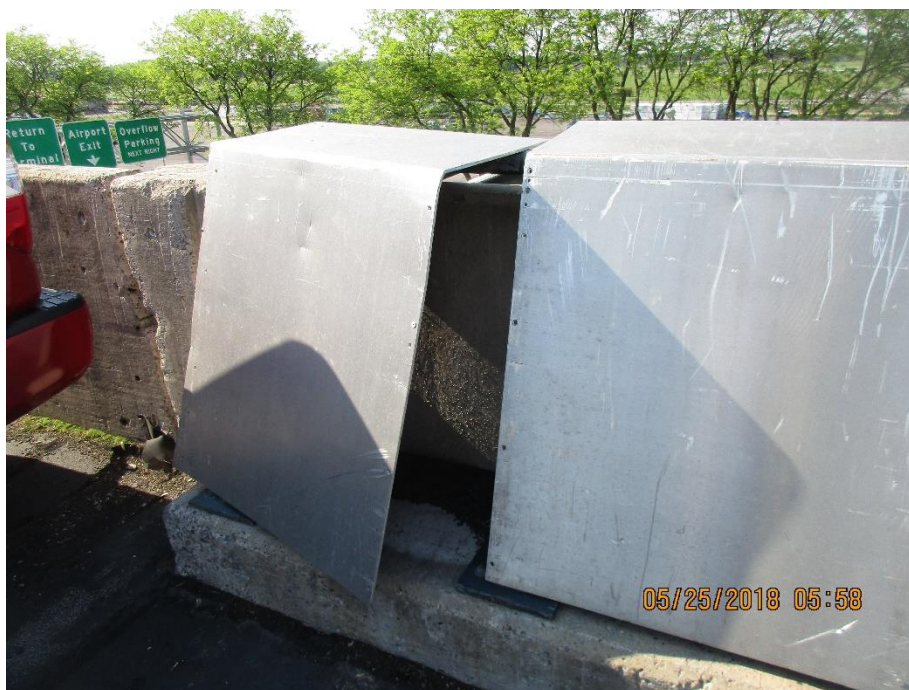
Photo #22: Loose section of snow deflector

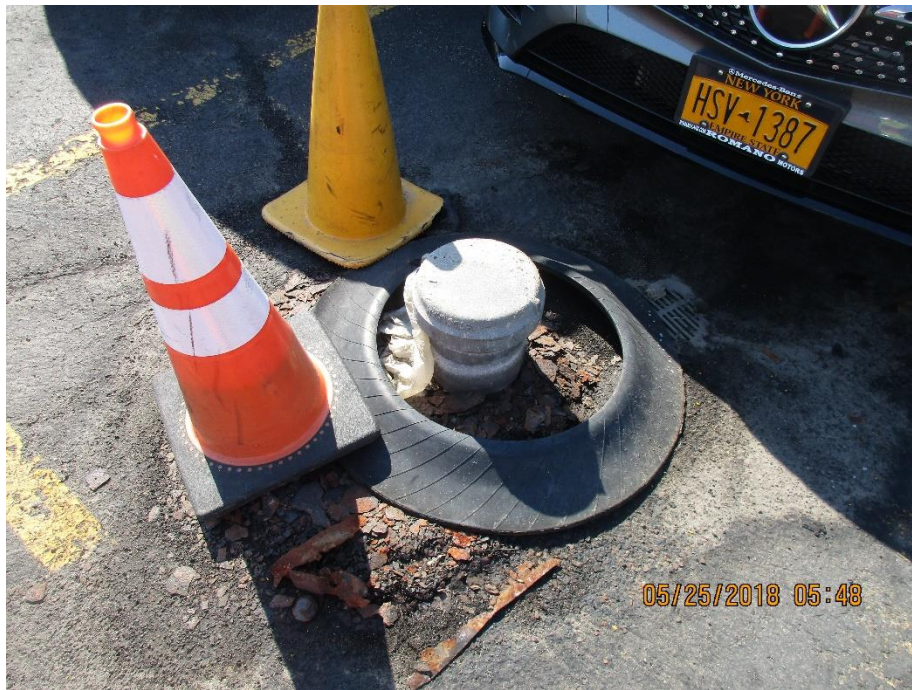
Photo #23: missing steel bollard around utility.

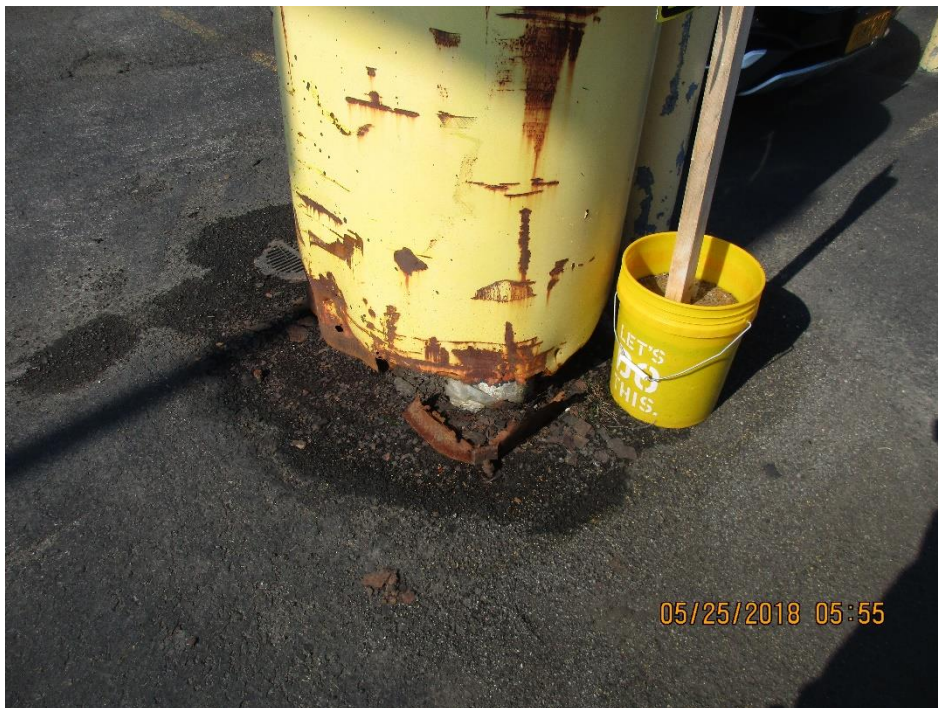
Phot #24: Damaged and displaced steel bollard.

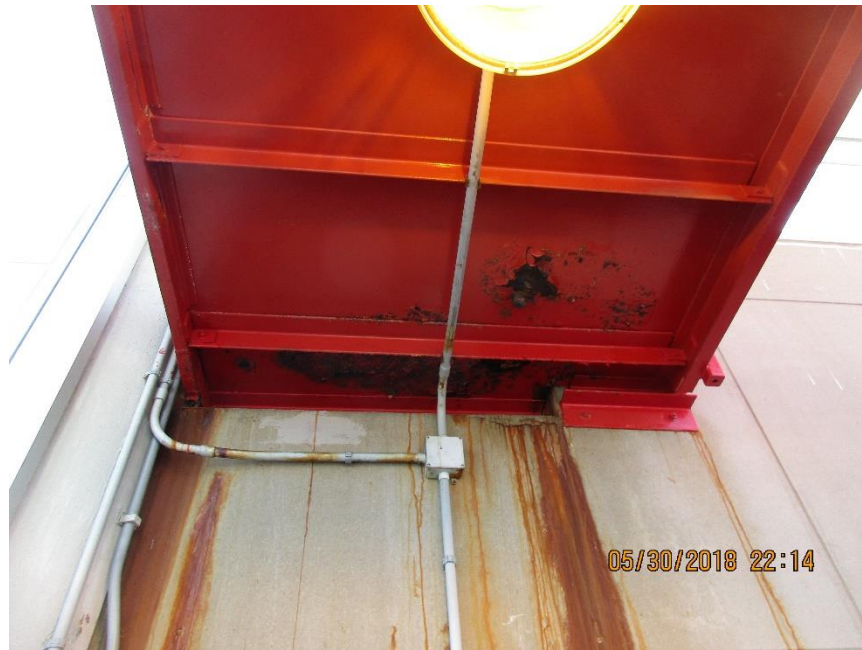
Photo #25: Stair tower 4 – Corrosion of steel pan of landing and water stains running down side of wall

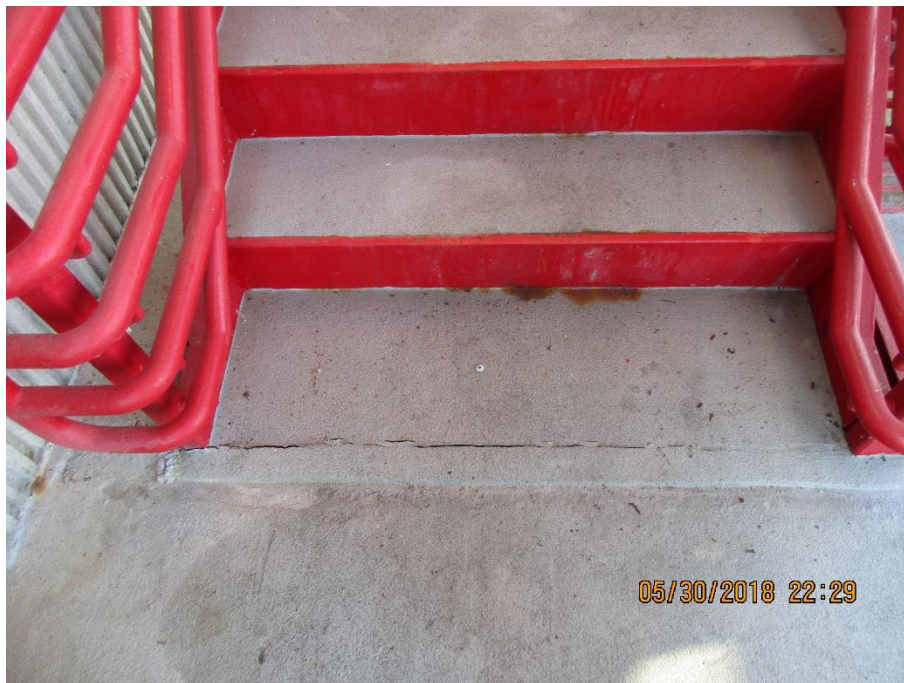
Photo #26: Stair tower 3 – cracked stair pan

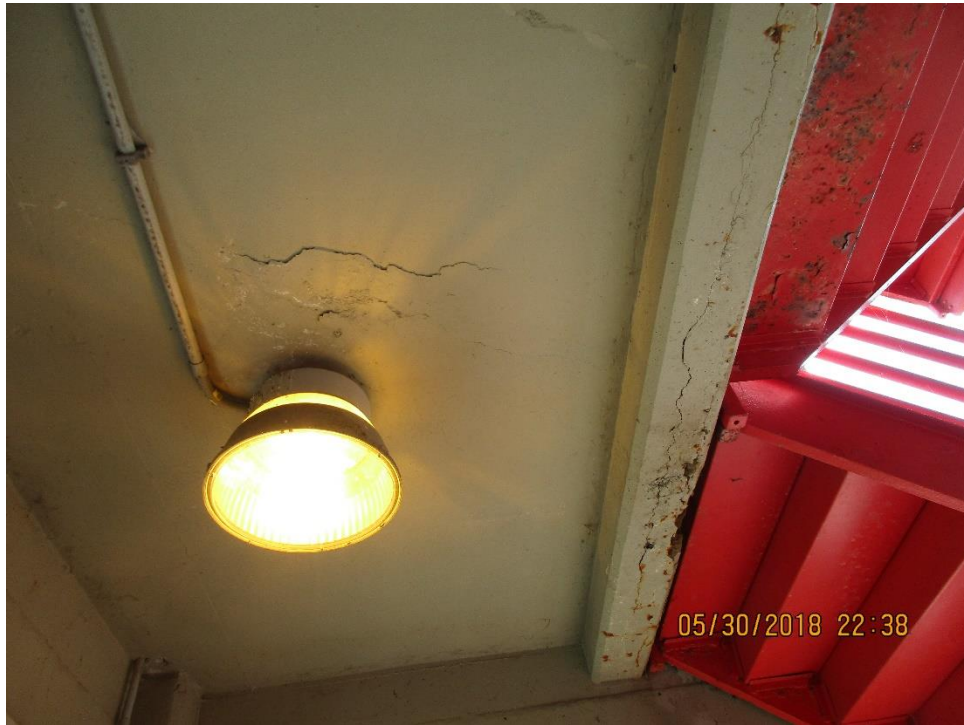
Photo #27: Stair tower #3 – cracked beam and soffit of Level 3 landing

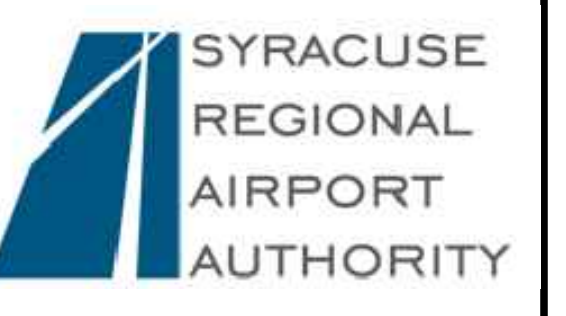
**SYRACUSE HANCOCK INTERNATIONAL AIRPORT
PARKING GARAGE STRUCTURAL CONDITION SURVEY 2018**

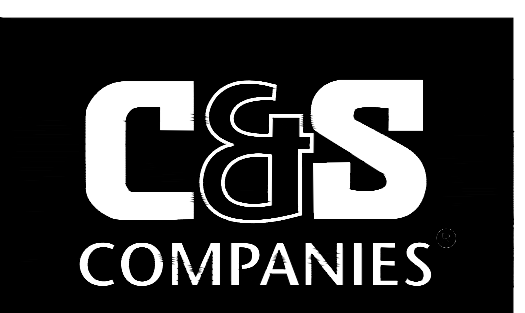
C&S Engineers, Inc.
 499 Col. Eileen Collins Blvd.
 Syracuse, New York 13212
 Phone: 315-455-2000
 Fax: 315-455-9667
 www.cscos.com

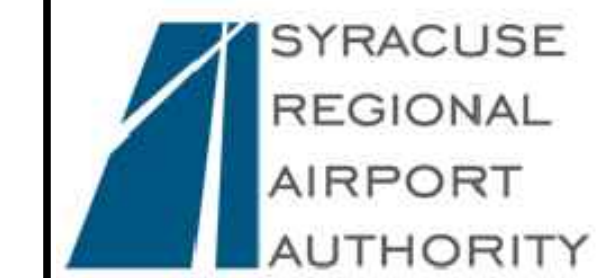
**SYRACUSE HANCOCK INTERNATIONAL AIRPORT
 PARKING GARAGE STRUCTURAL CONDITION SURVEY 2018**

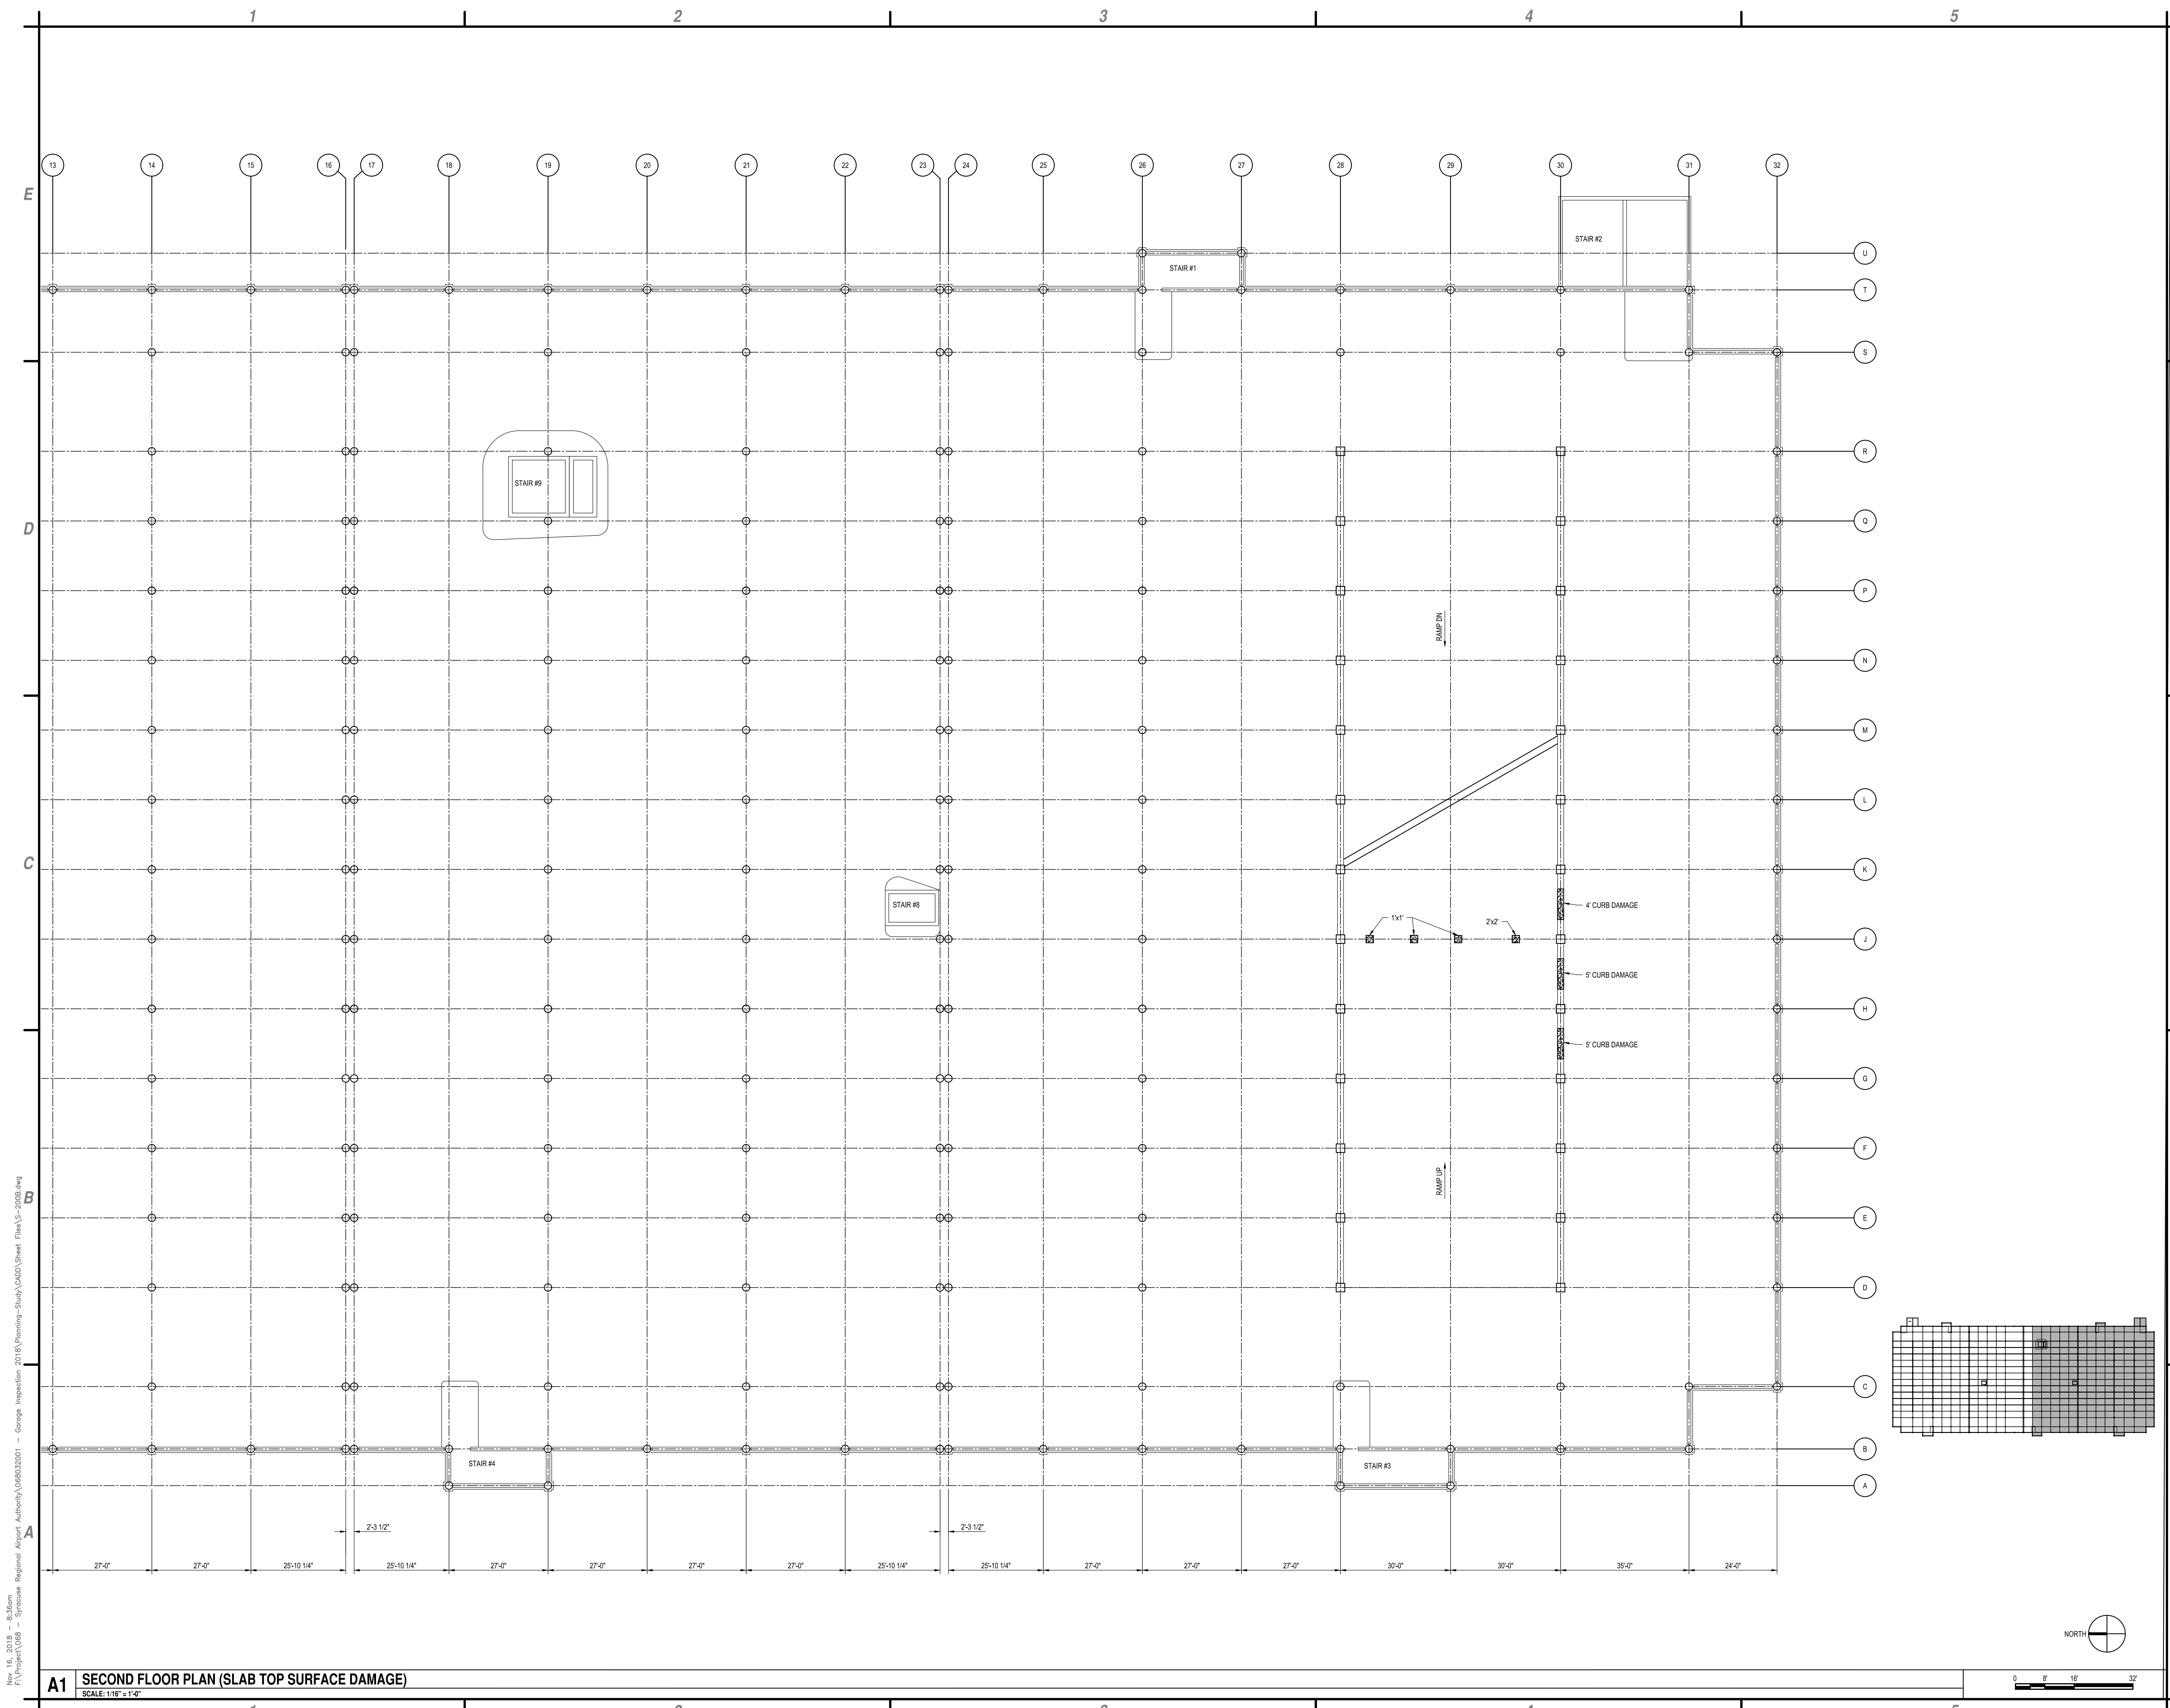
Nov 16, 2018 - 8:36am
 F:\Project\088 - Syracuse Regional Airport Authority\088032001 - Garage Inspection 2018\Planning-Study\CAD\Sheet Files\S-200B.dwg
 Project: 088 - Syracuse Regional Airport Authority\088032001 - Garage Inspection 2018\Planning-Study\CAD\Sheet Files\S-200B.dwg
