**PARKING GARAGE
STRUCTURAL CONDITION SURVEY REPORT-2018**

**HANCOCK AIRPORT PARKING GARAGE
1000 COL. EILEEN COLLINS BLVD
SYRACUSE, NY 13212**

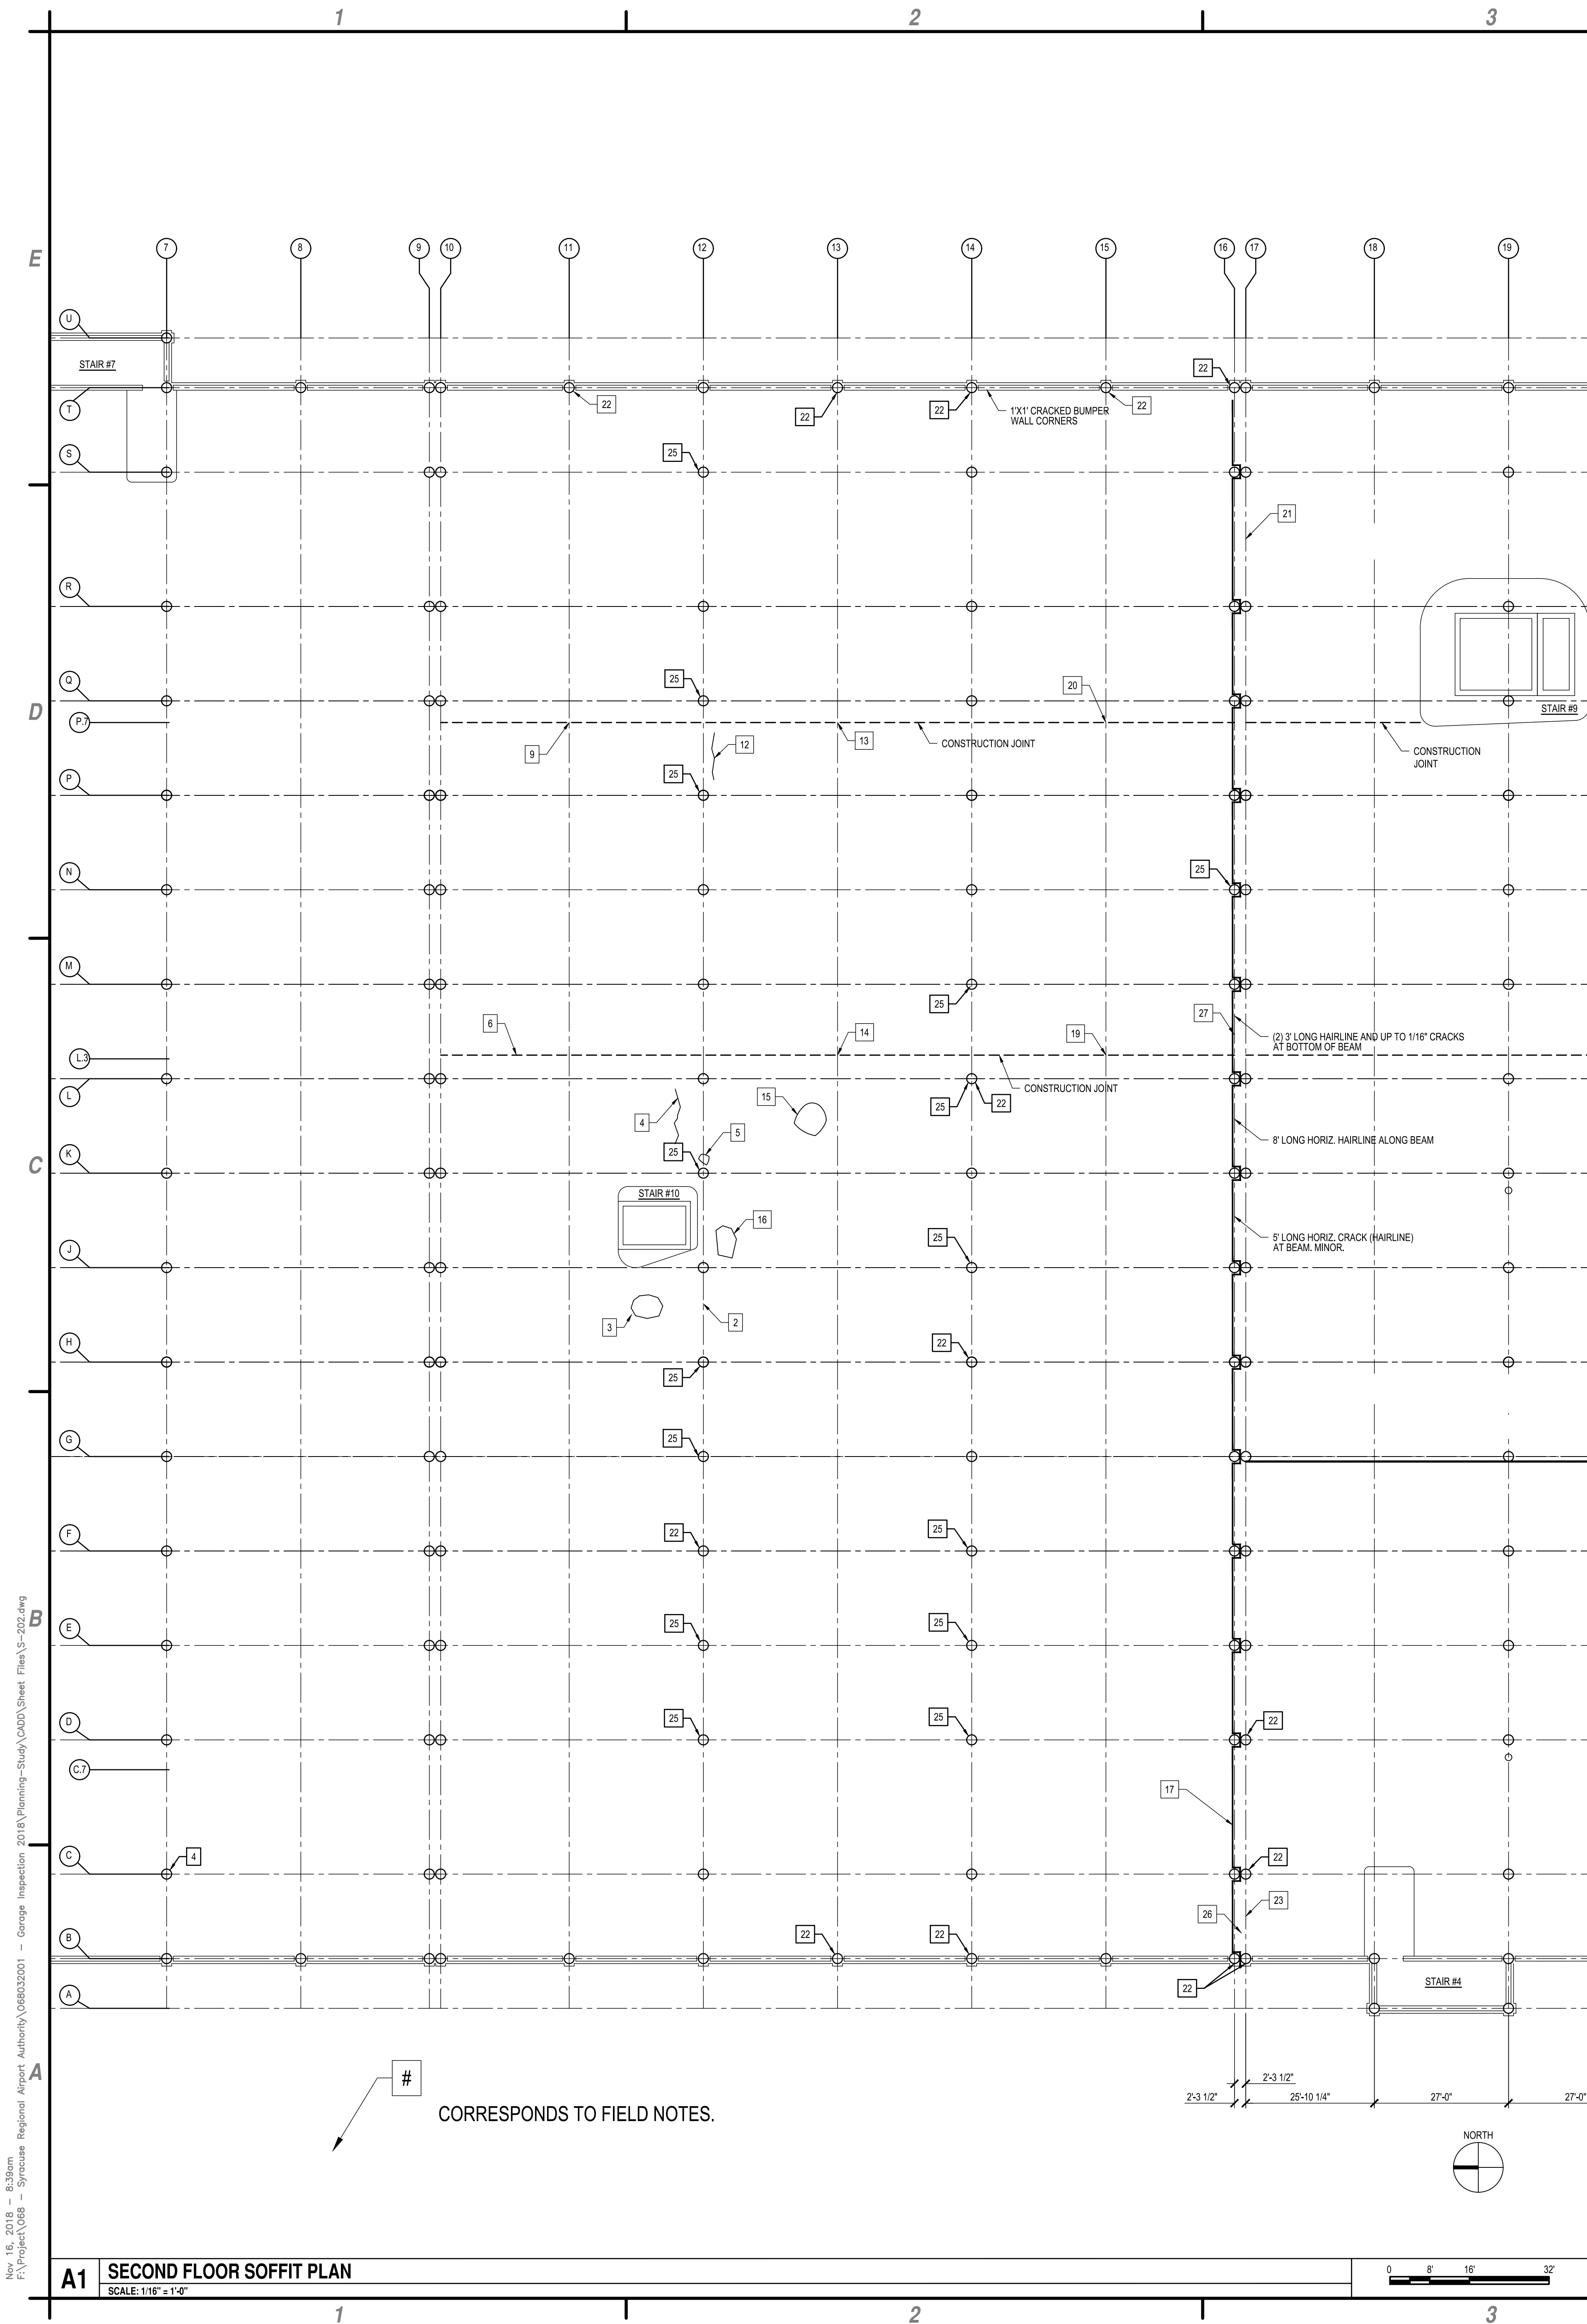
A1 SECOND FLOOR PLAN (SLAB TOP SURFACE DAMAGE)
 SCALE: 1/16" = 1'-0"

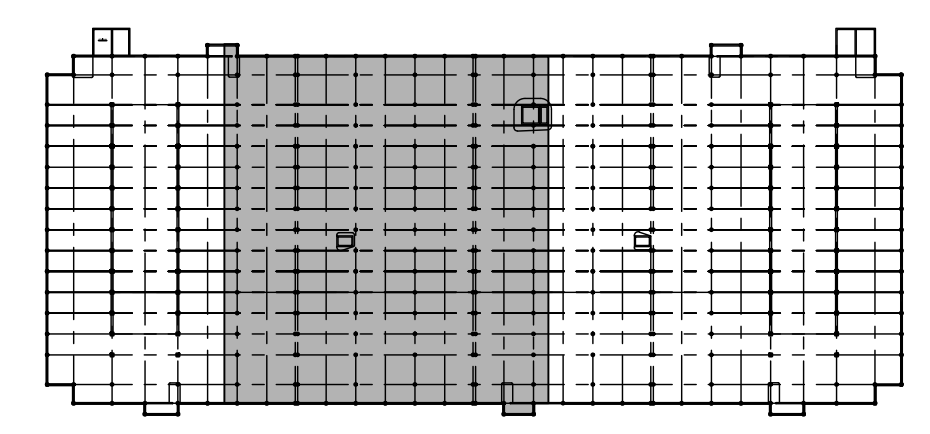
**SYRACUSE HANCOCK INTERNATIONAL AIRPORT
 PARKING GARAGE STRUCTURAL CONDITION SURVEY 2018**

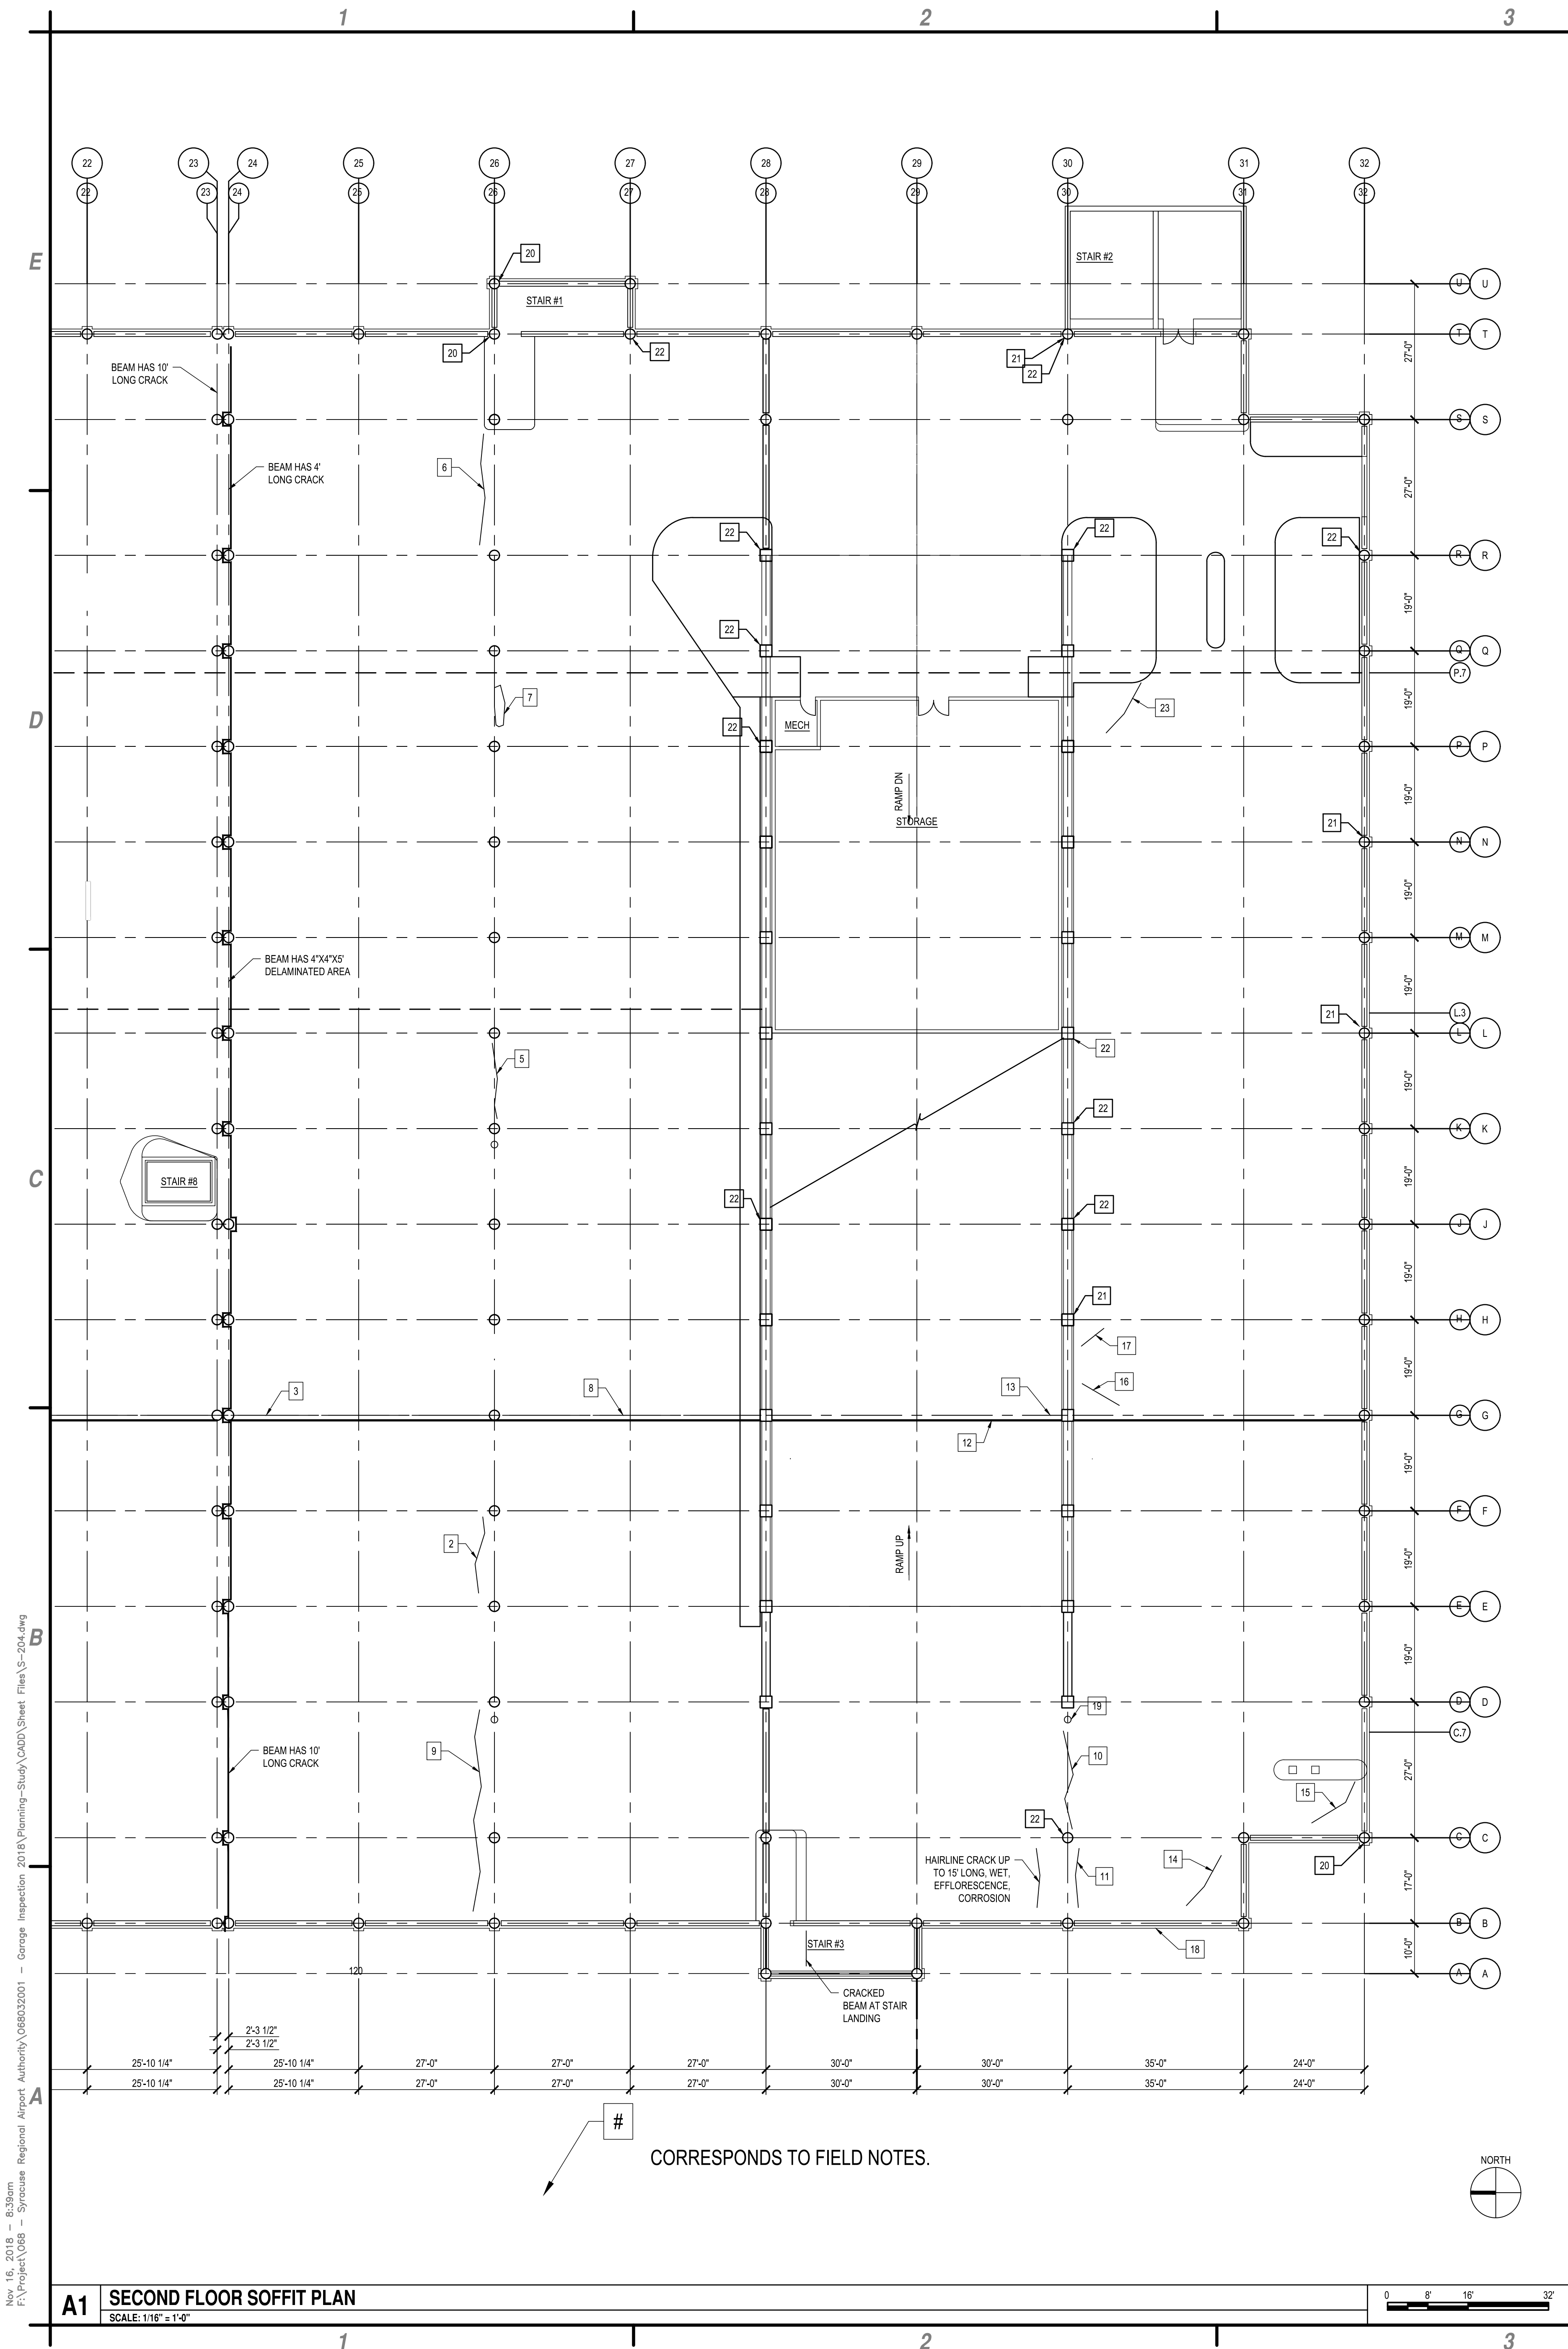
A1 SECOND FLOOR SOFFIT PLAN
SCALE: 1/16" = 1'-0"

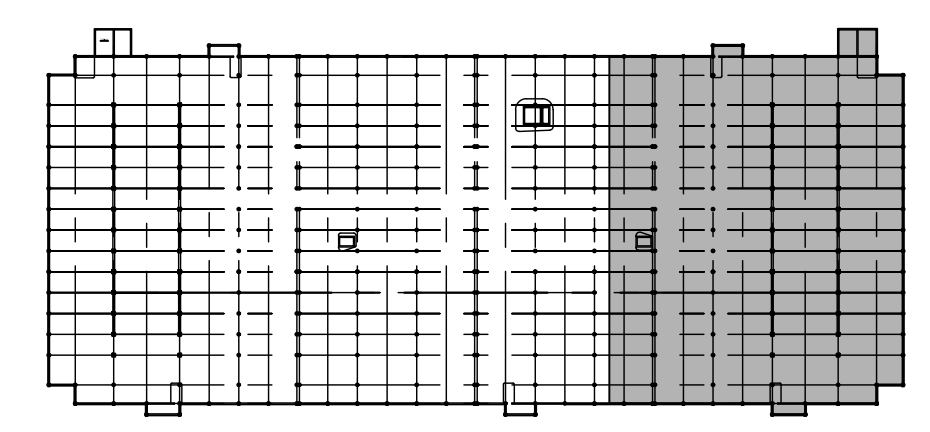
**SYRACUSE HANCOCK INTERNATIONAL AIRPORT
PARKING GARAGE STRUCTURAL CONDITION SURVEY 2018**

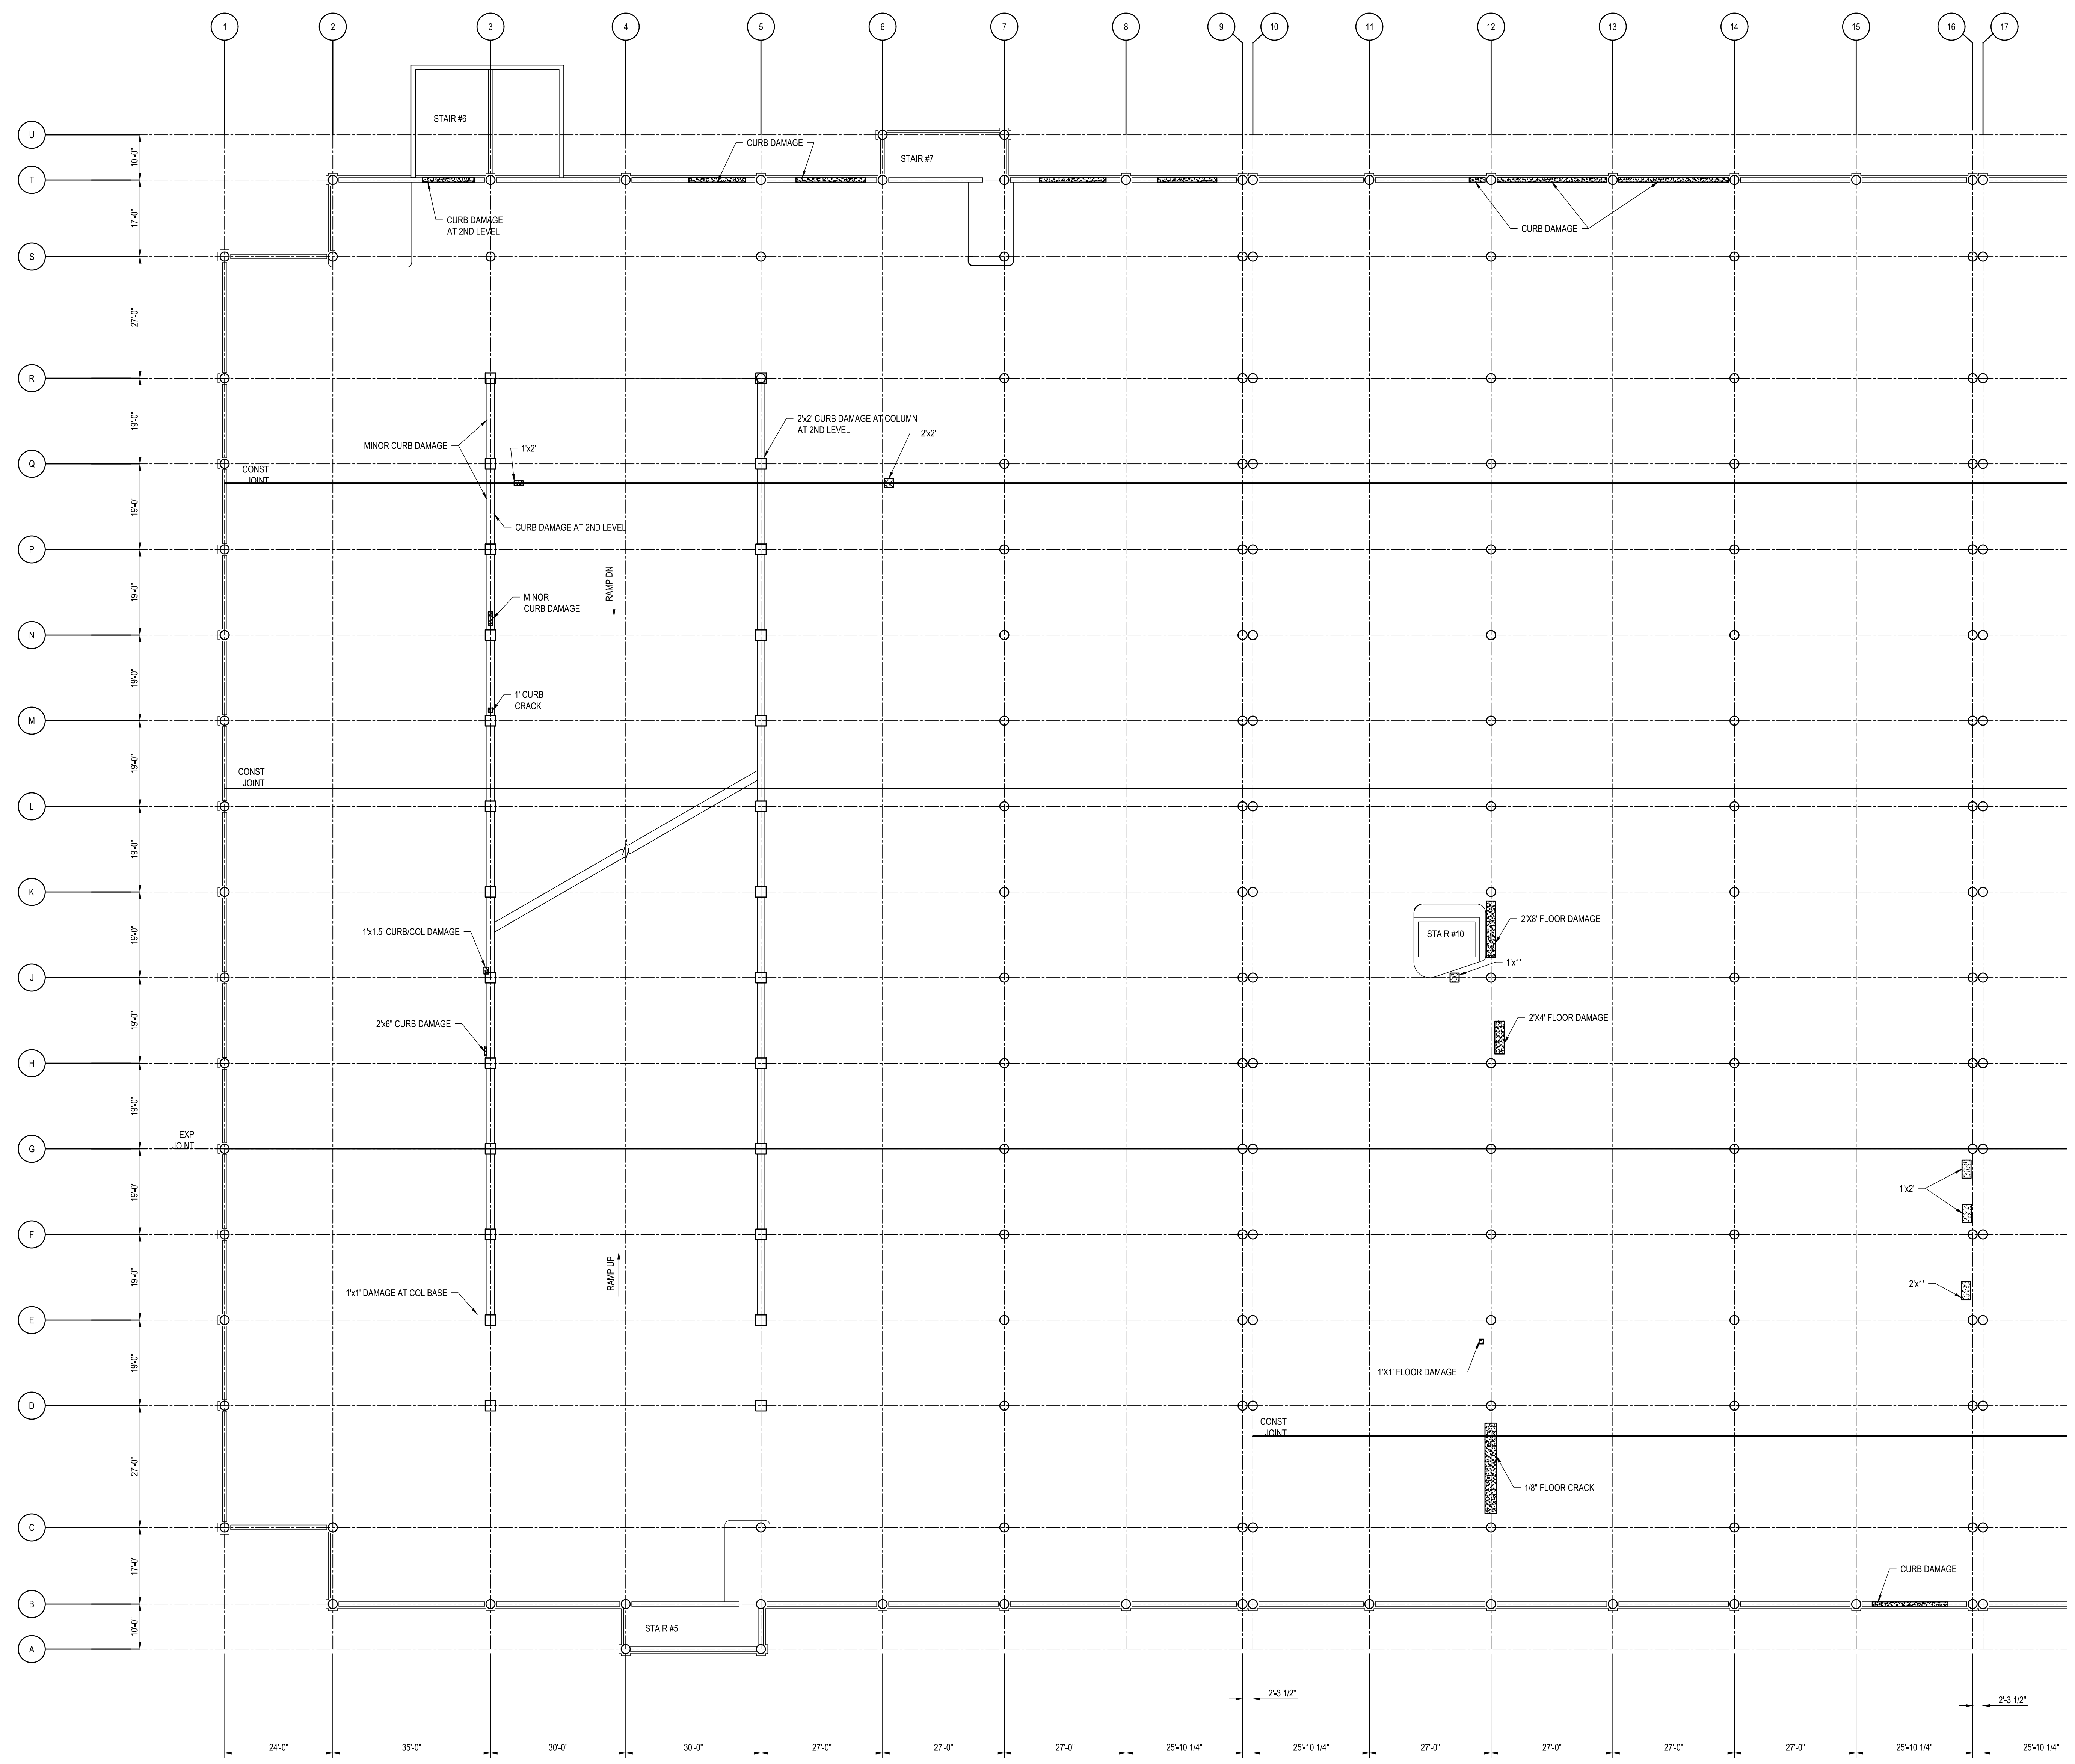
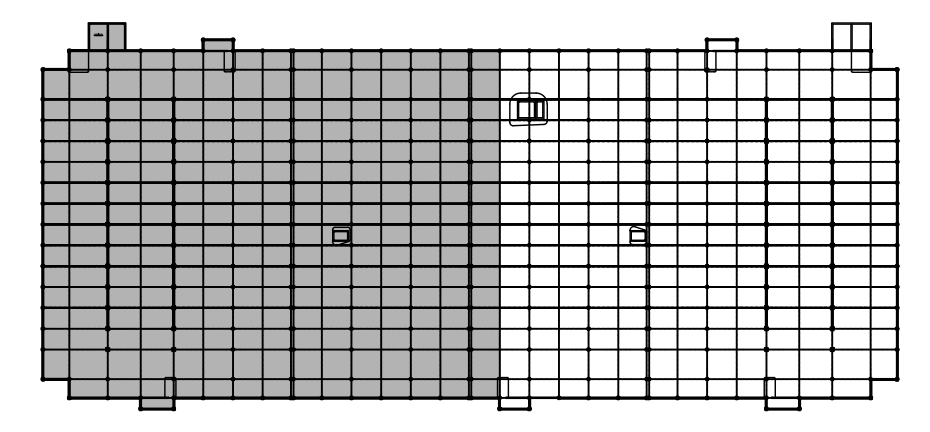
Nov 16, 2018 - 8:38am Regional Airport Authority\088032001 - Garage Inspection 2018\Planning-Study\CAD\Sheet Files\S-300A.dwg
F:\Project\088 - Syracuse Regional Airport Authority\088032001 - Garage Inspection 2018\Planning-Study\CAD\Sheet Files\S-300A.dwg

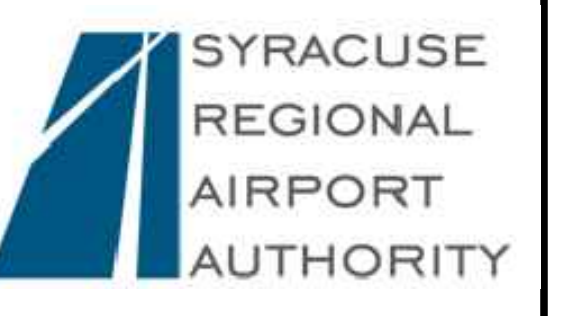
**SYRACUSE HANCOCK INTERNATIONAL AIRPORT
PARKING GARAGE STRUCTURAL CONDITION SURVEY 2018**

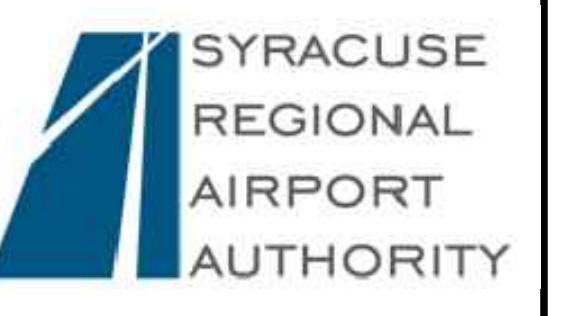
**SYRACUSE HANCOCK INTERNATIONAL AIRPORT
 PARKING GARAGE STRUCTURAL CONDITION SURVEY 2018**

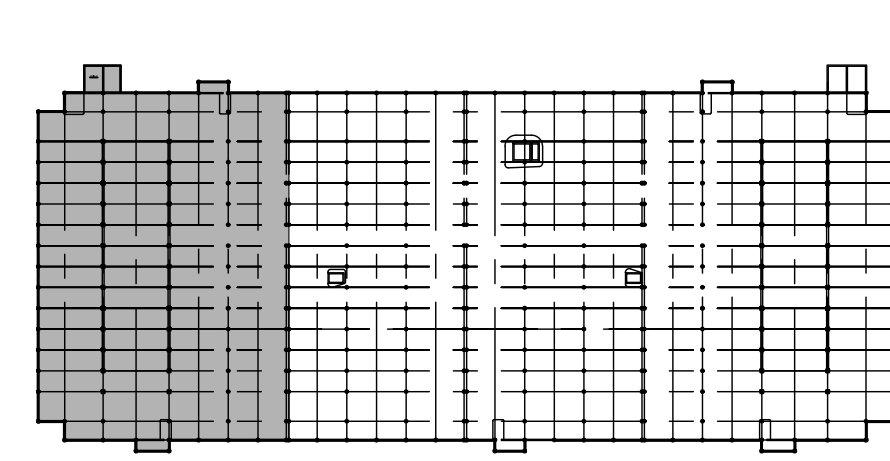
**SYRACUSE HANCOCK INTERNATIONAL AIRPORT
 PARKING GARAGE STRUCTURAL CONDITION SURVEY 2018**

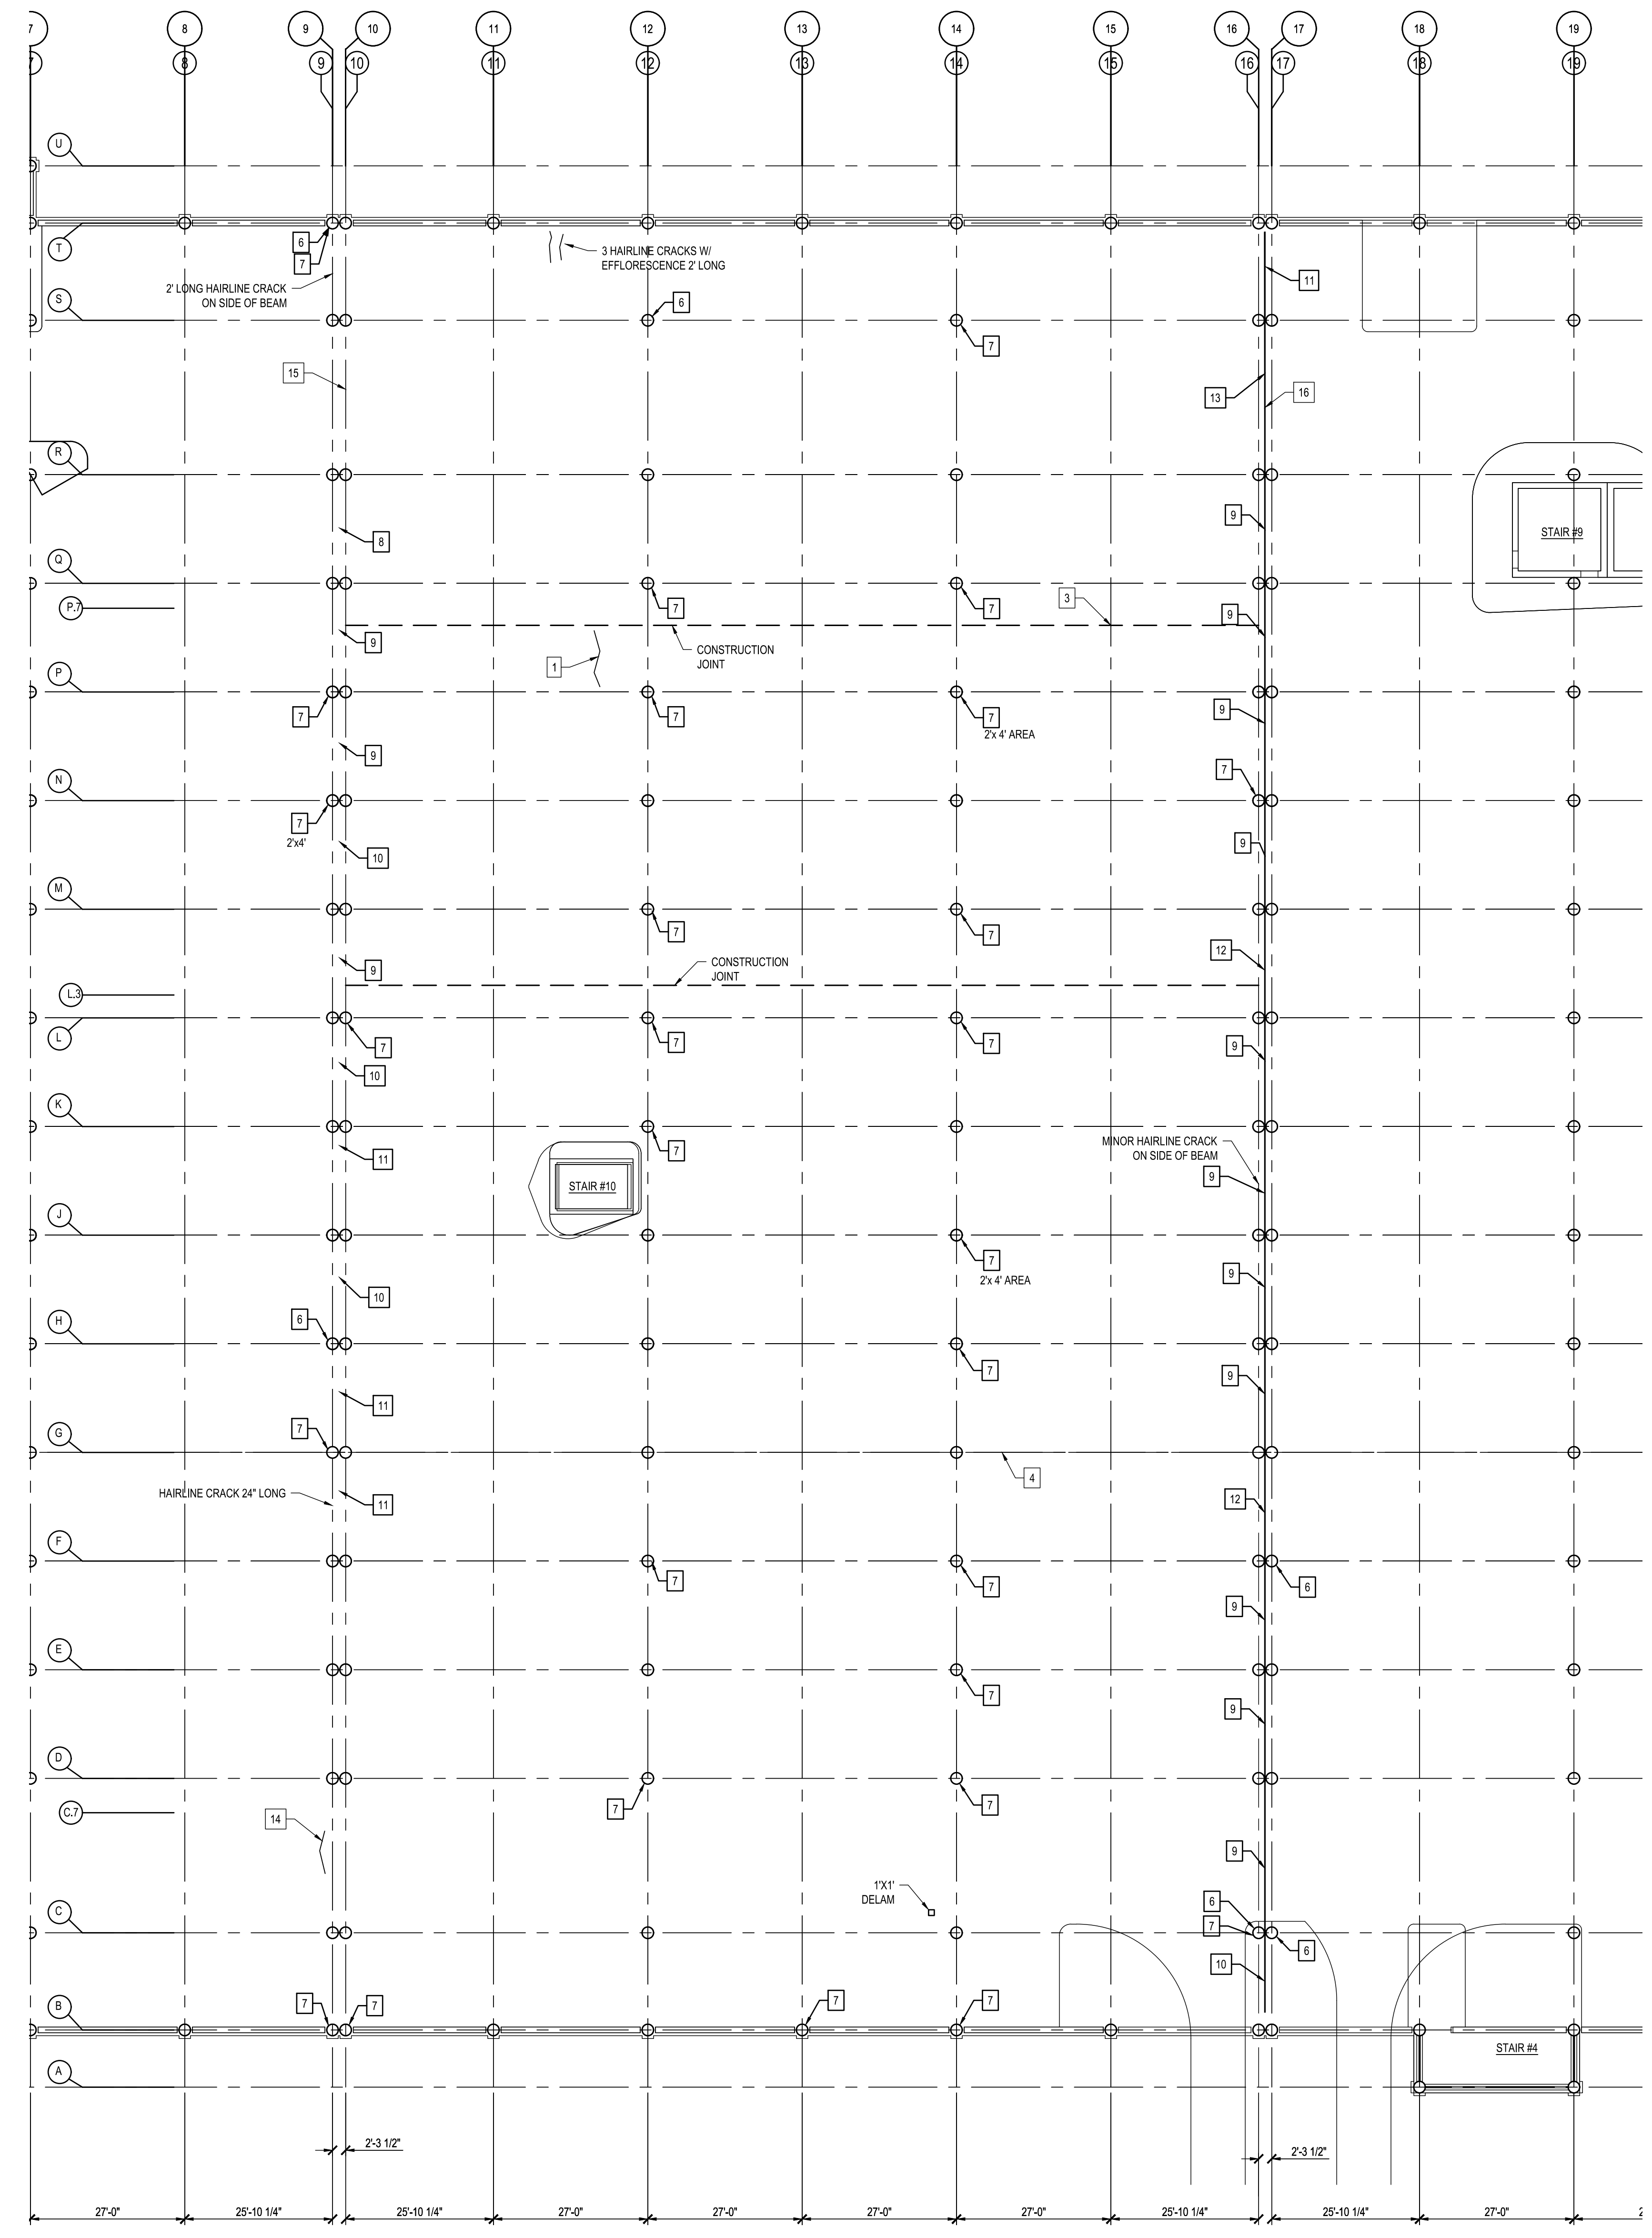
CORRESPONDS TO FIELD NOTES.

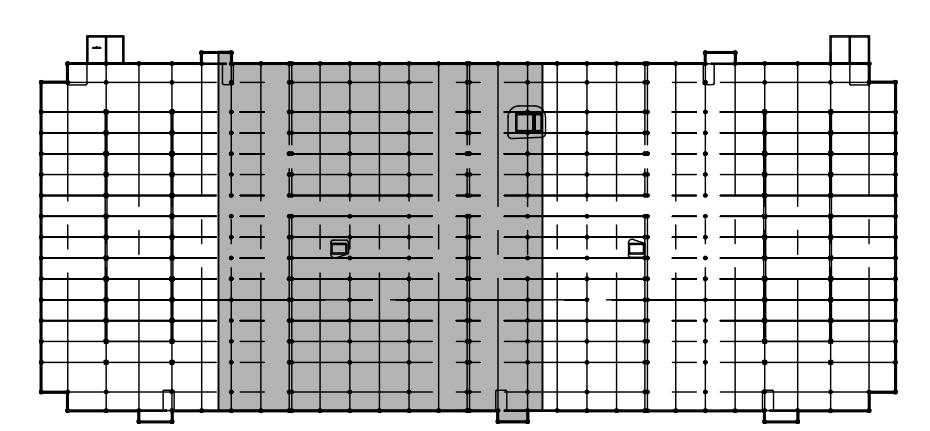
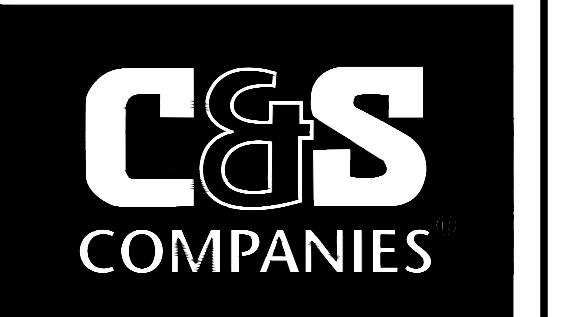
C&S Engineers, Inc.
499 Col. Eileen Collins Blvd.
Syracuse, New York 13212
Phone: 315-455-2000
Fax: 315-455-9667
www.cscos.com

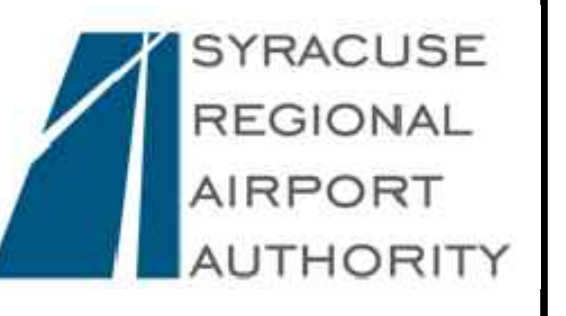
SYRACUSE HANCOCK INTERNATIONAL AIRPORT
PARKING GARAGE STRUCTURAL CONDITION SURVEY 2018

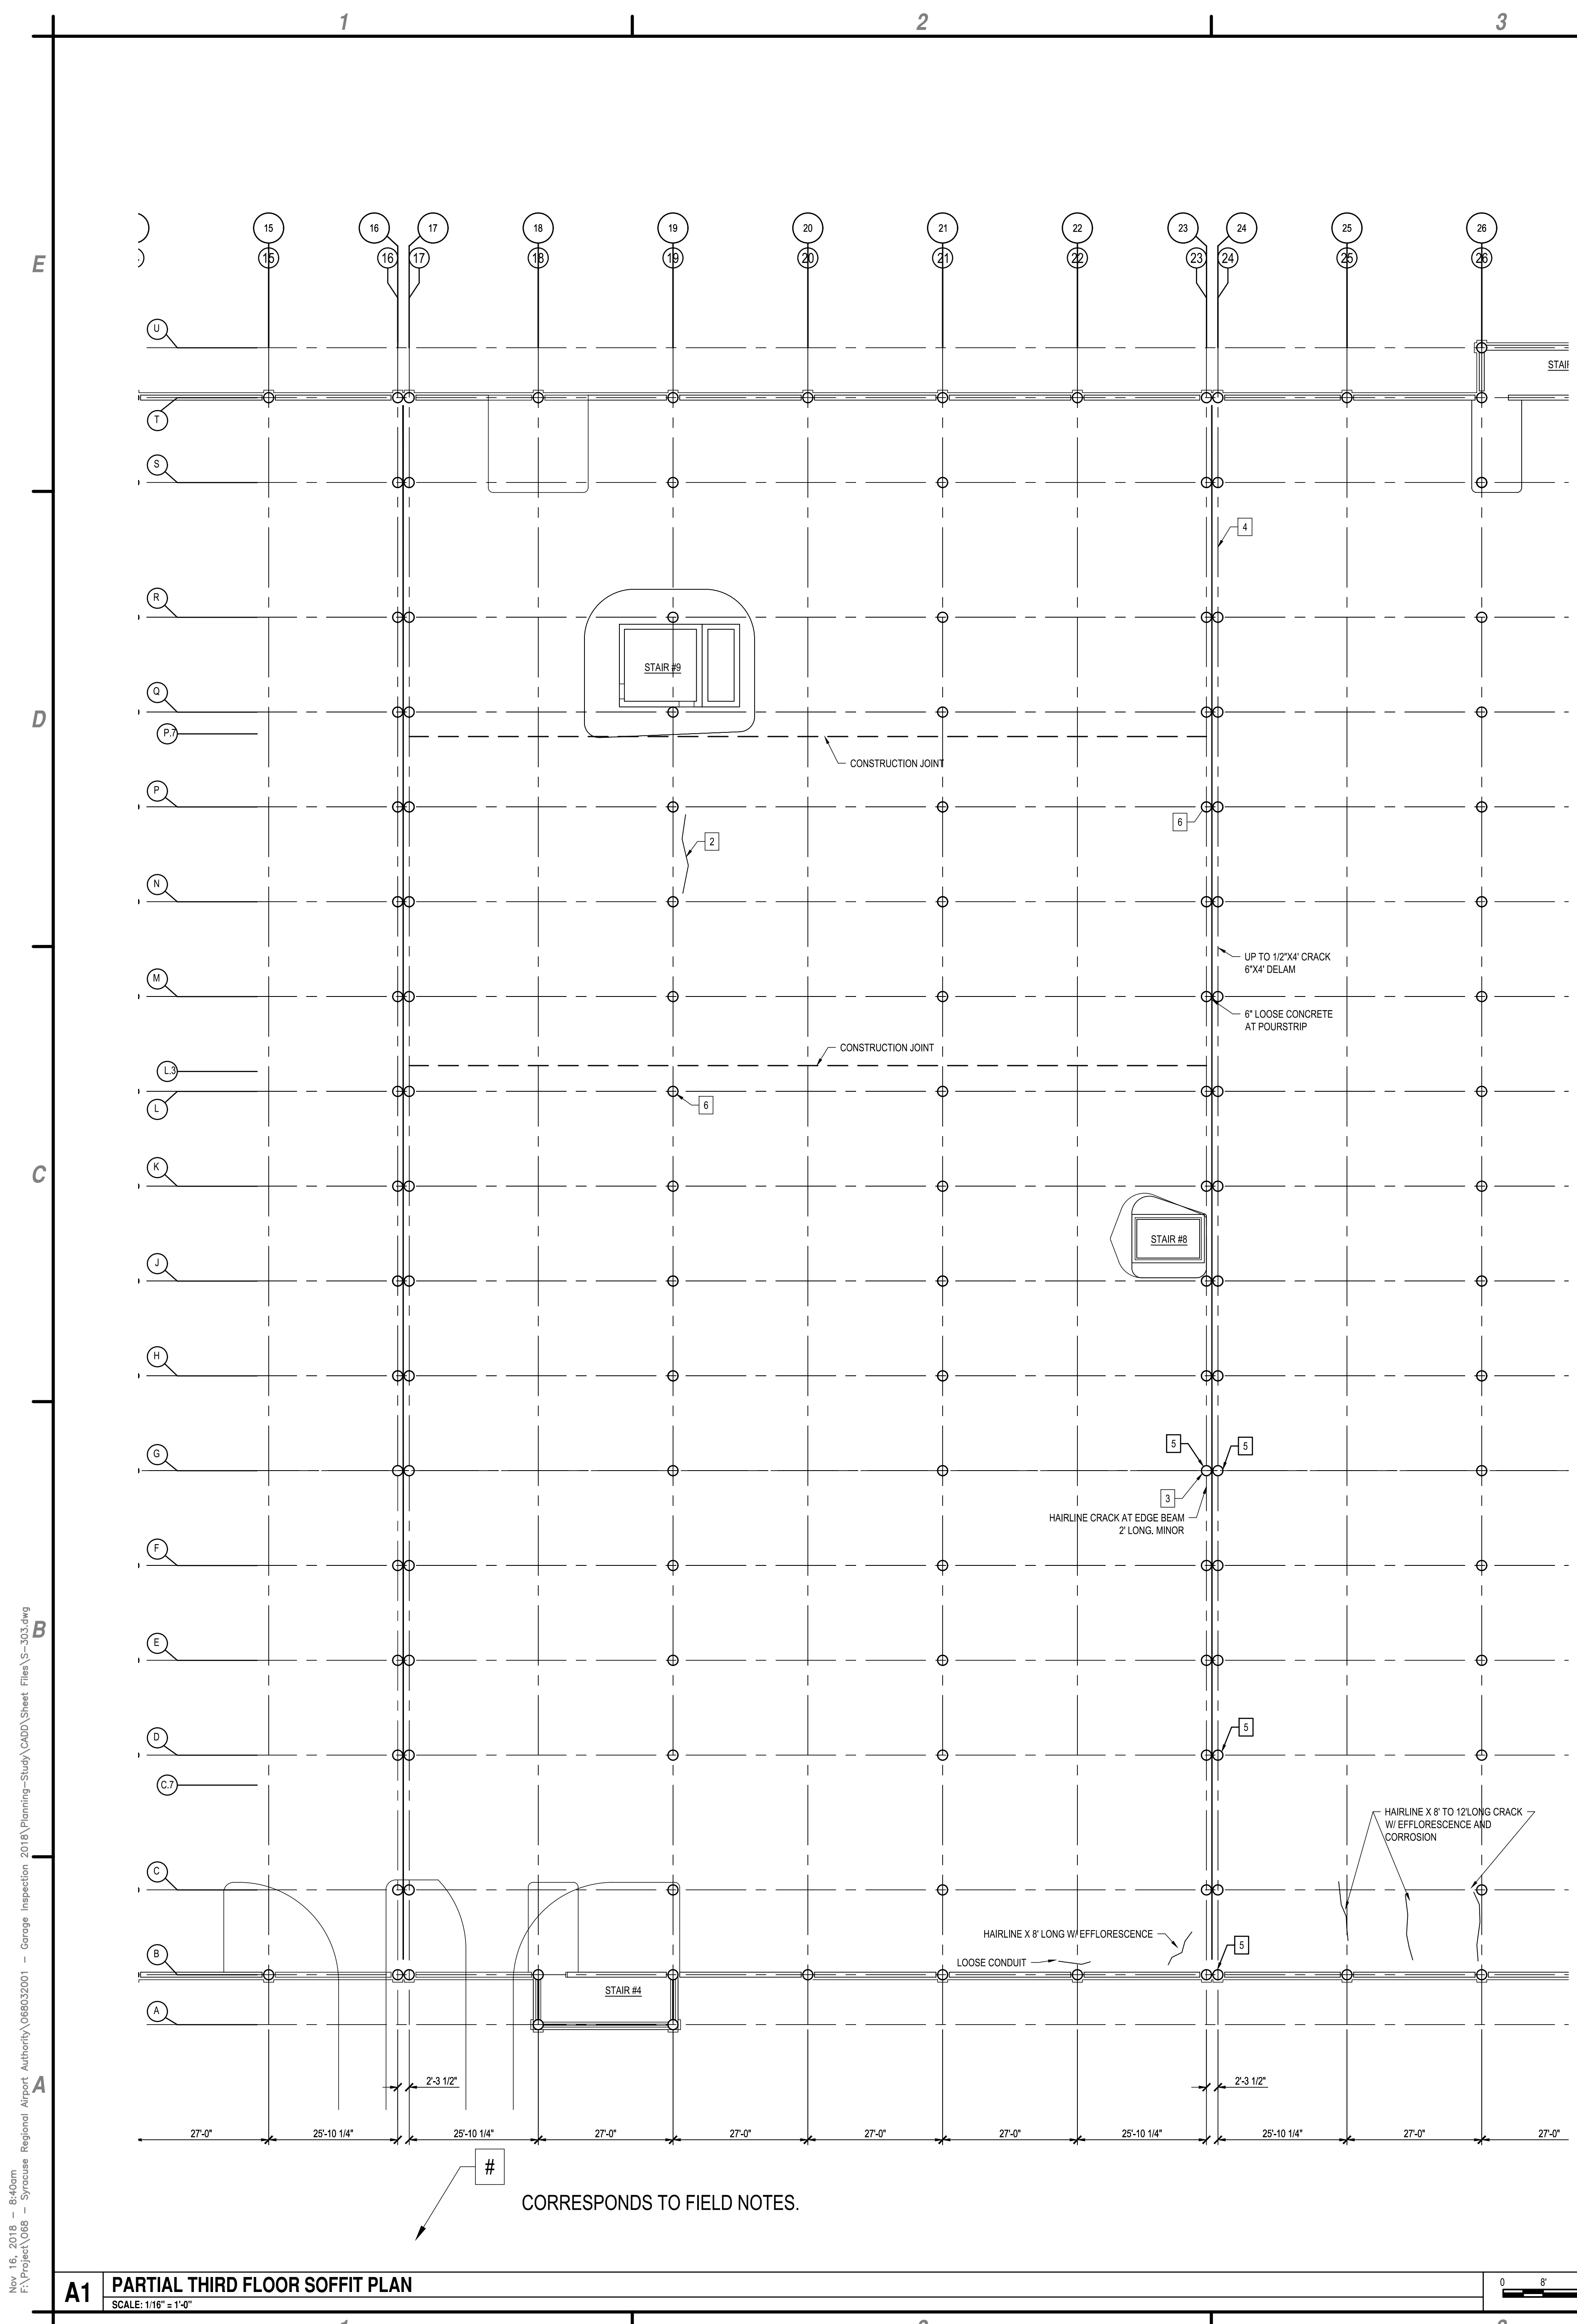
FIELD NOTES	
NOTE	DESCRIPTION
1	Not used
2	Hairline x 16' long crack with waterstains and efflorescence.
3*	Up to 1/8" cracked corbel.
4*	Up to 1/8" x 10' long crack at bottom of beam below pour strip slab.
5	Random hairline cracks on column.
6*	Spall less than 1'x2' on column.

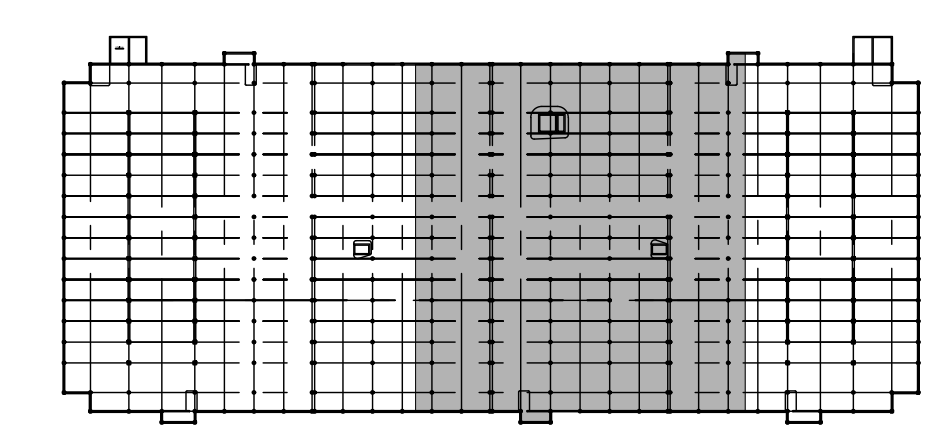
C&S COMPANIES
 C&S Engineers, Inc.
 499 Col. Eileen Collins Blvd.
 Syracuse, New York 13212
 Phone: 315-455-2000
 Fax: 315-455-9667
 www.cscos.com
