**PARKING GARAGE
STRUCTURAL CONDITION SURVEY REPORT-2018**

**HANCOCK AIRPORT PARKING GARAGE
1000 COL. EILEEN COLLINS BLVD
SYRACUSE, NY 13212**

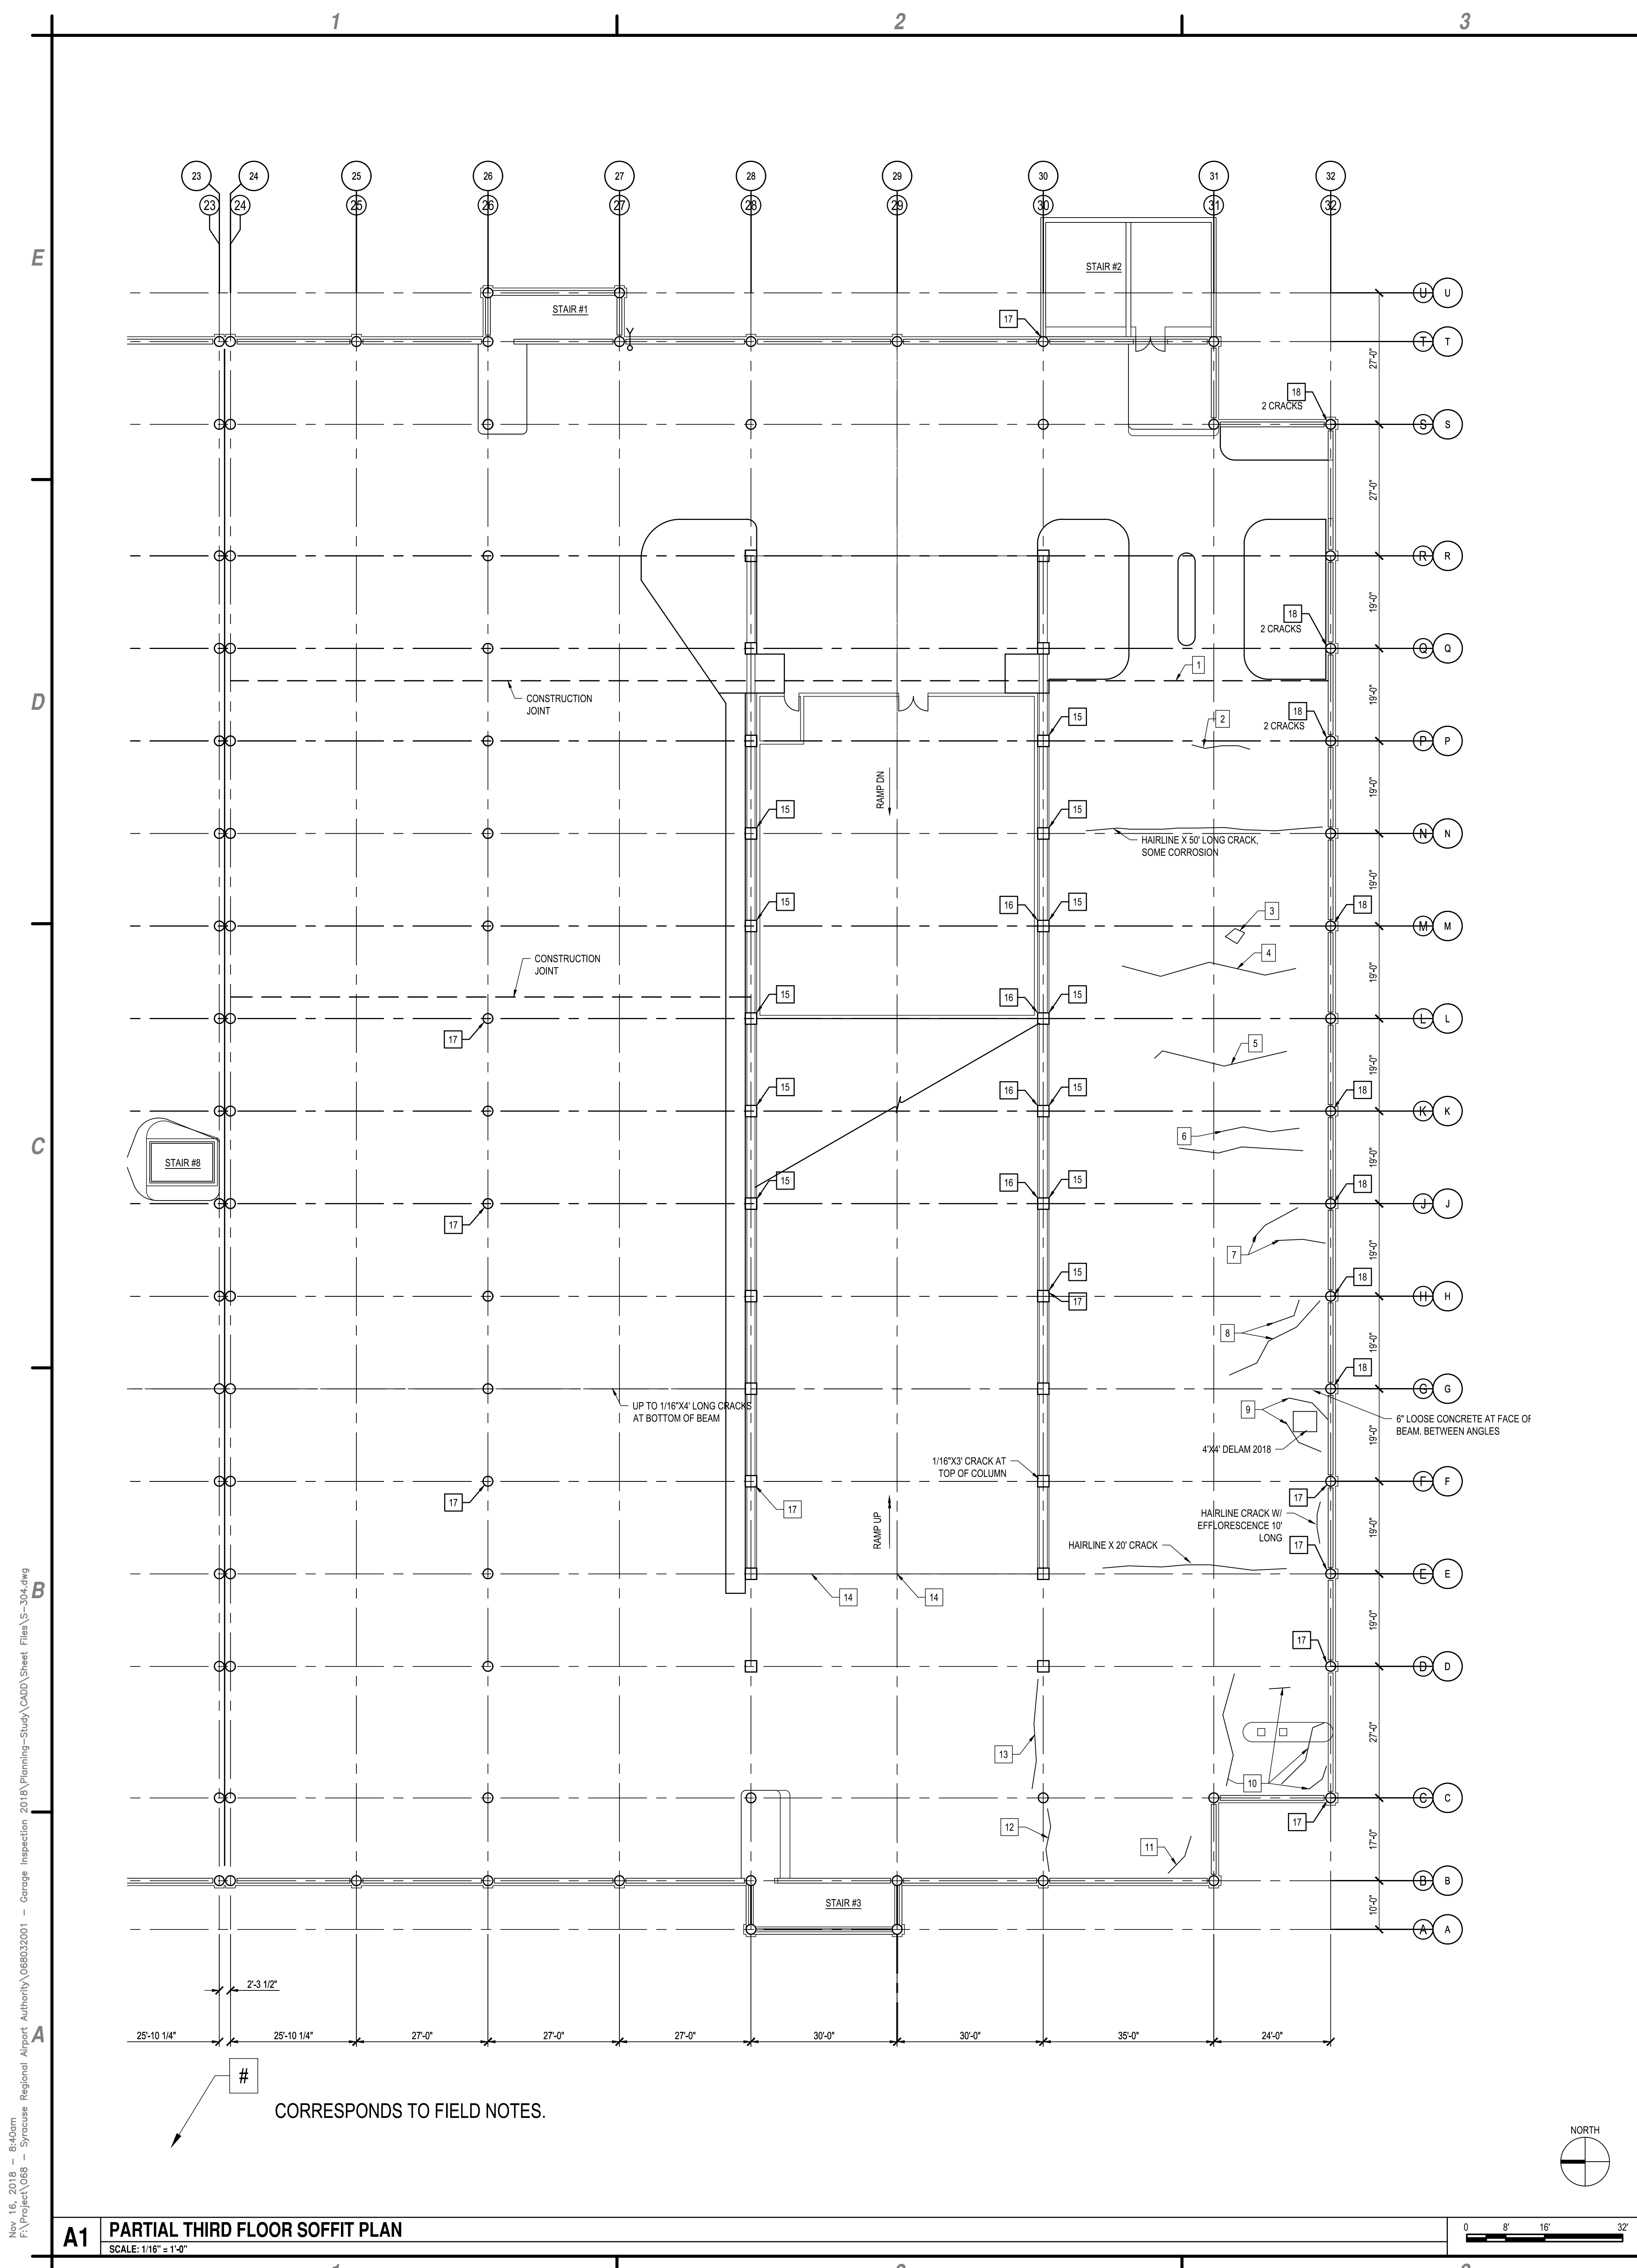
A5 FIELD NOTES
 SCALE: NOT TO SCALE

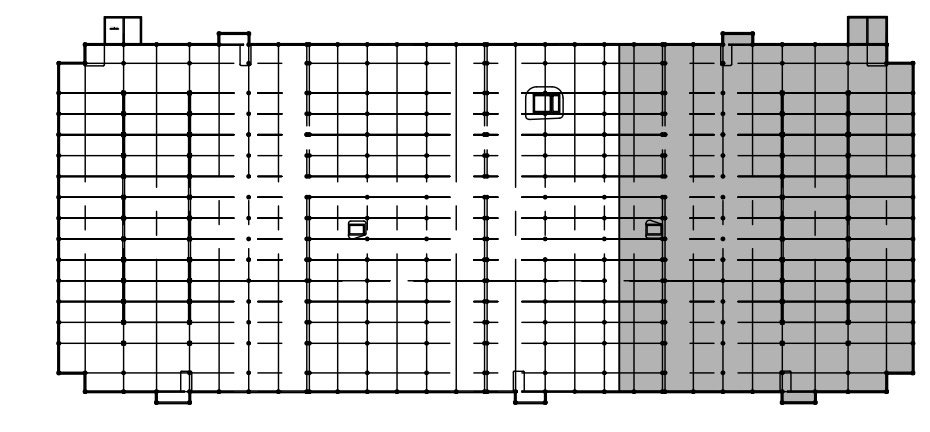
**SYRACUSE HANCOCK INTERNATIONAL AIRPORT
 PARKING GARAGE STRUCTURAL CONDITION SURVEY 2018**

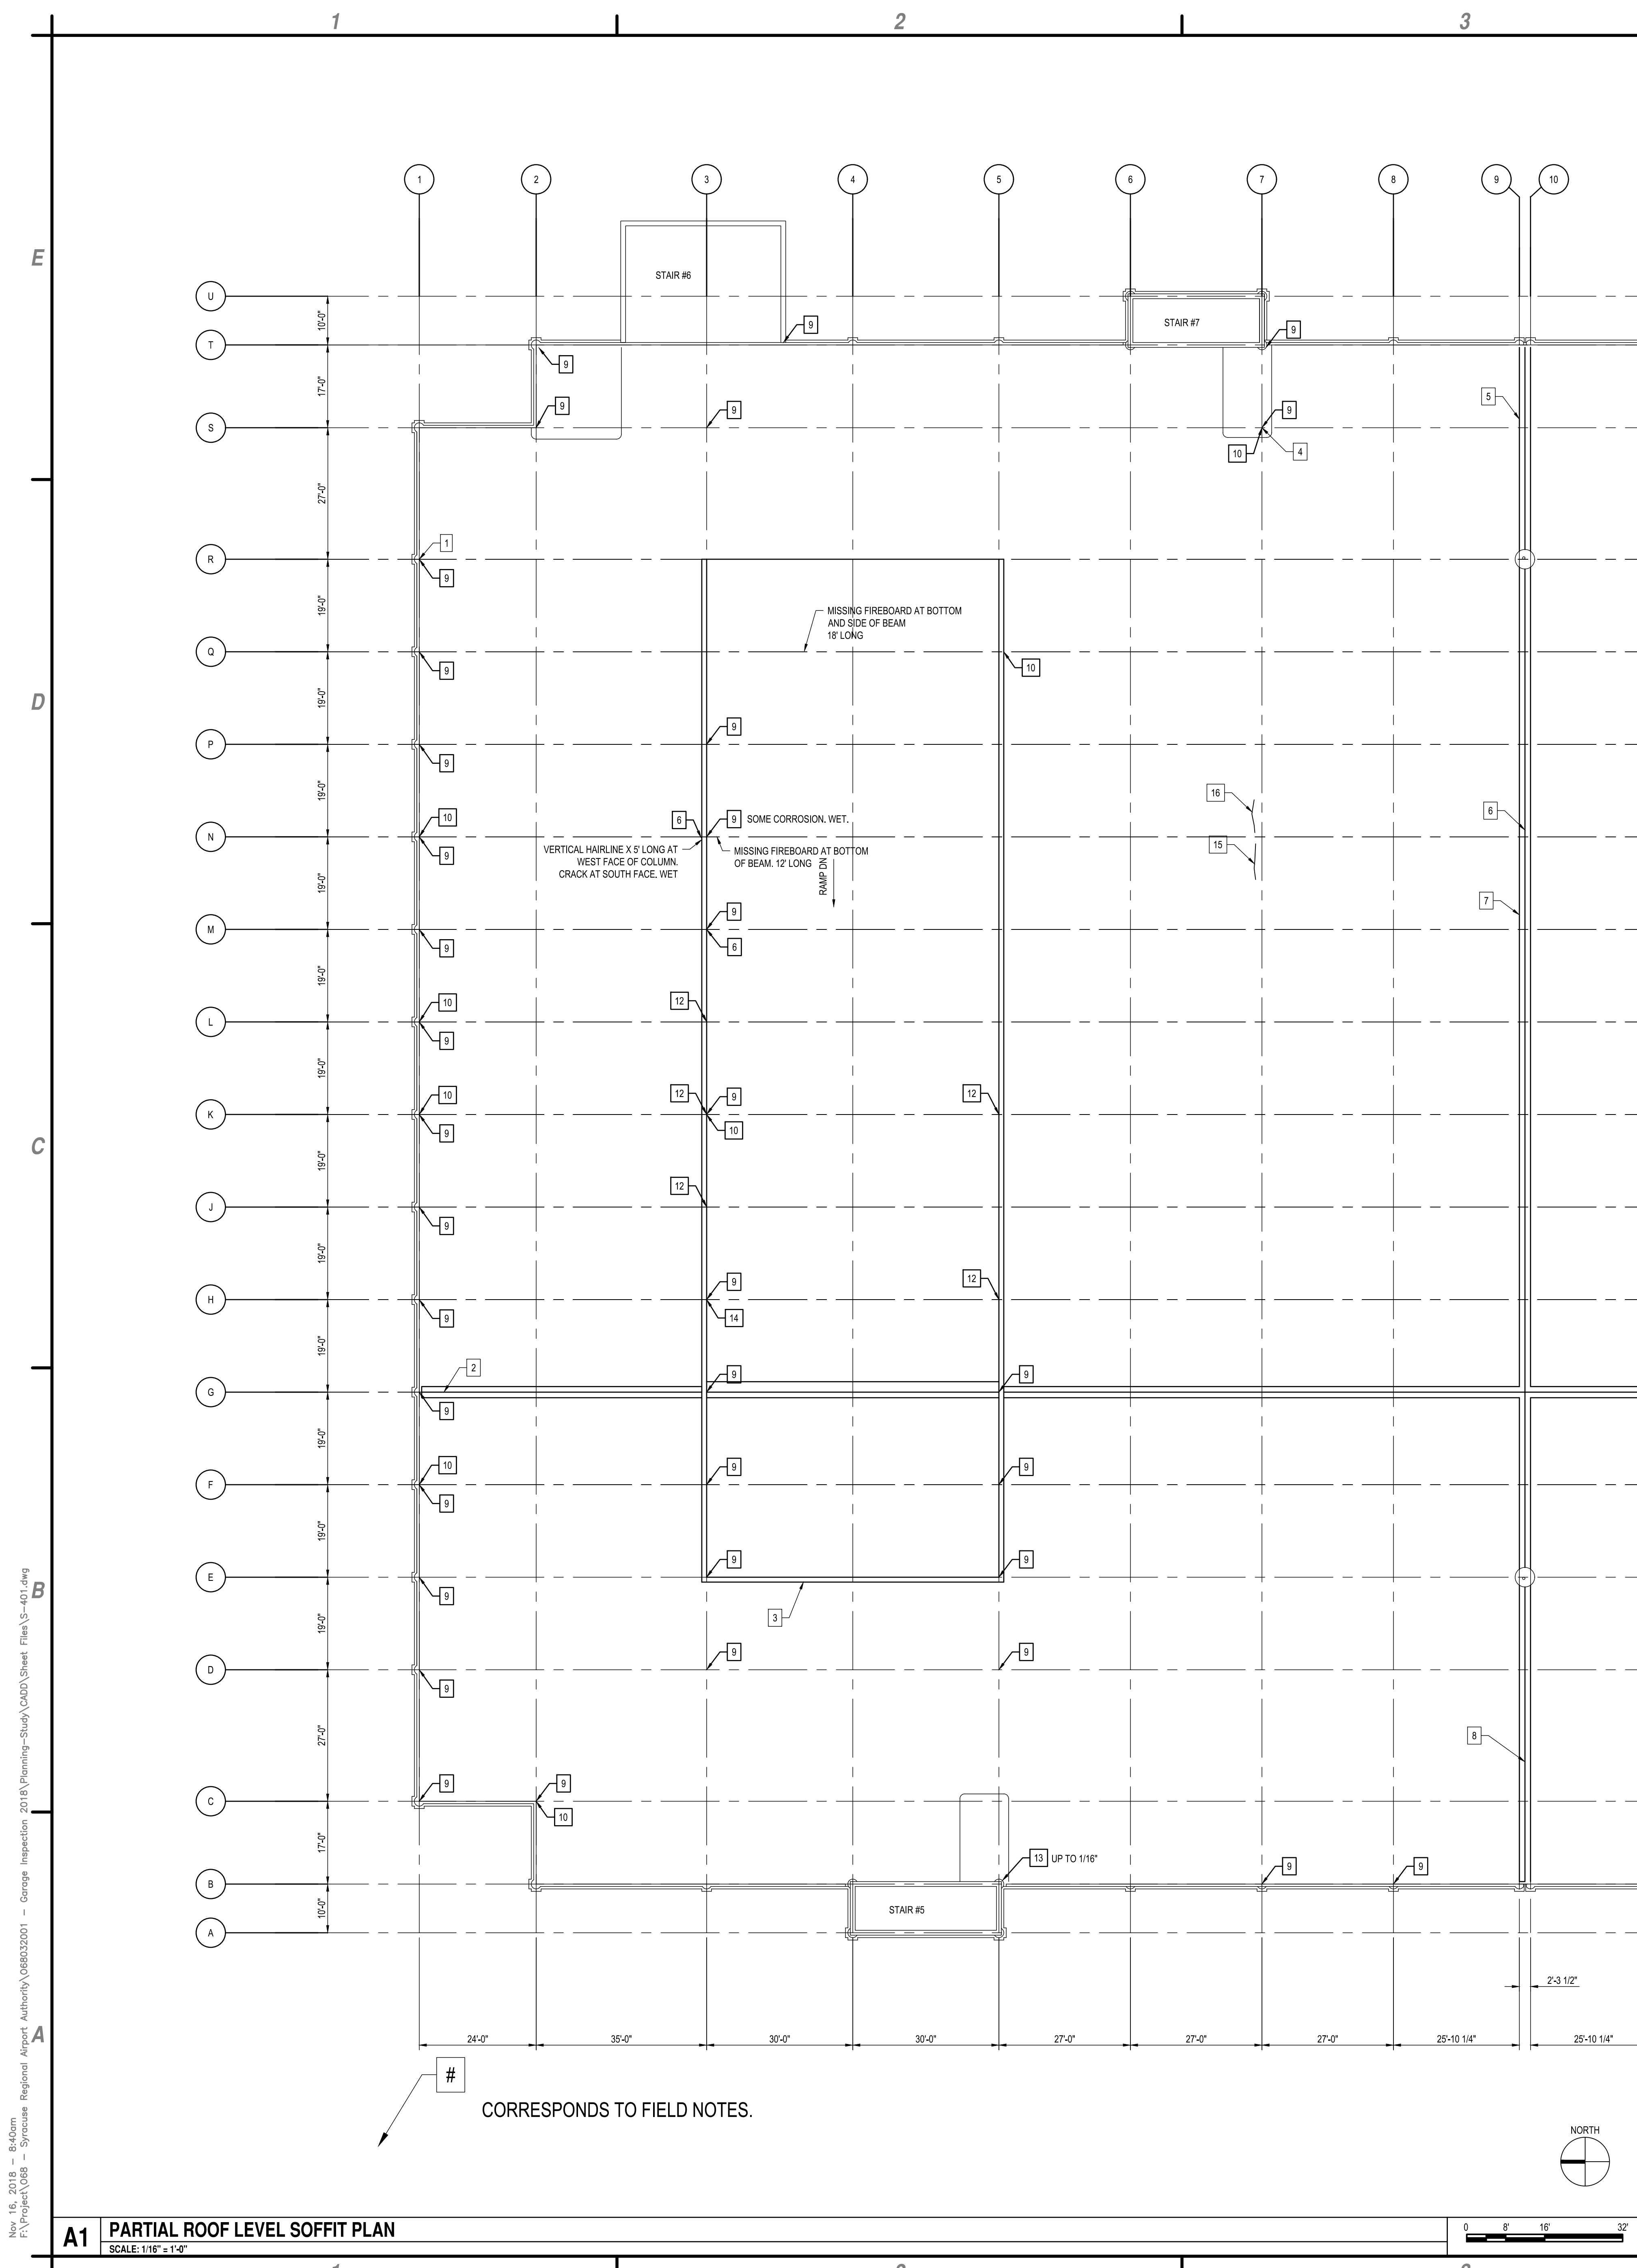
FIELD NOTES	
NOTE	DESCRIPTION
1*	Loose fire board at column.
2	Missing 40' long section of fire board at beam/expansion joint.
3	Missing 30' long section of fire board.
4	Water leak with corroded conduit.
5	Missing fire board at 2' long section of steel beams.
6	6" x 6" area of loose fire board.
7*	Missing fire board entire length of beam. Loose at bottom. Remove and reinstall.
8*	Leaking expansion joint. Repair.
9	Hairline cracks mainly at column ties.
10	Minor delaminations on column, less than 6" dia.
11	Not used
12	Cracked PT pocket along the perimeter.
13	Up to 1/16" x 3' long cracks on column with corrosion.
14	1/32" x 2' long (2) cracks on column.
15	2' and 3' long cracks in pre-cast concrete with efflorescence.
16	6' long crack in pre-cast concrete with efflorescence.

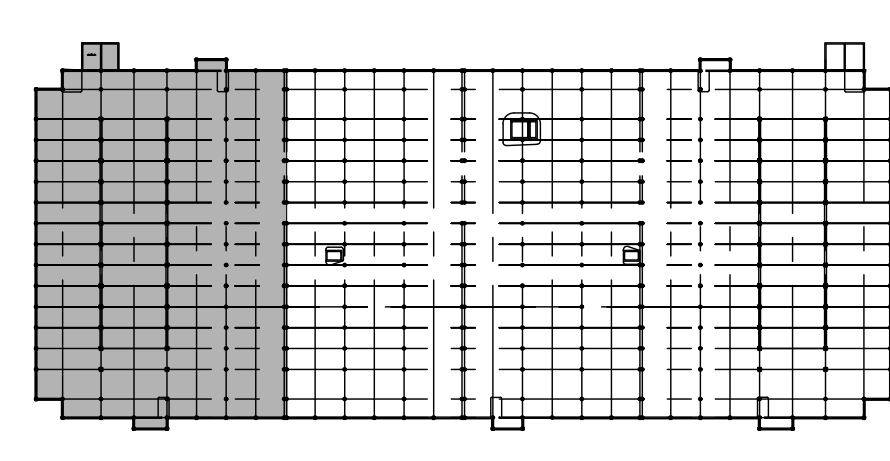
**SYRACUSE HANCOCK INTERNATIONAL AIRPORT
 PARKING GARAGE STRUCTURAL CONDITION SURVEY 2018**

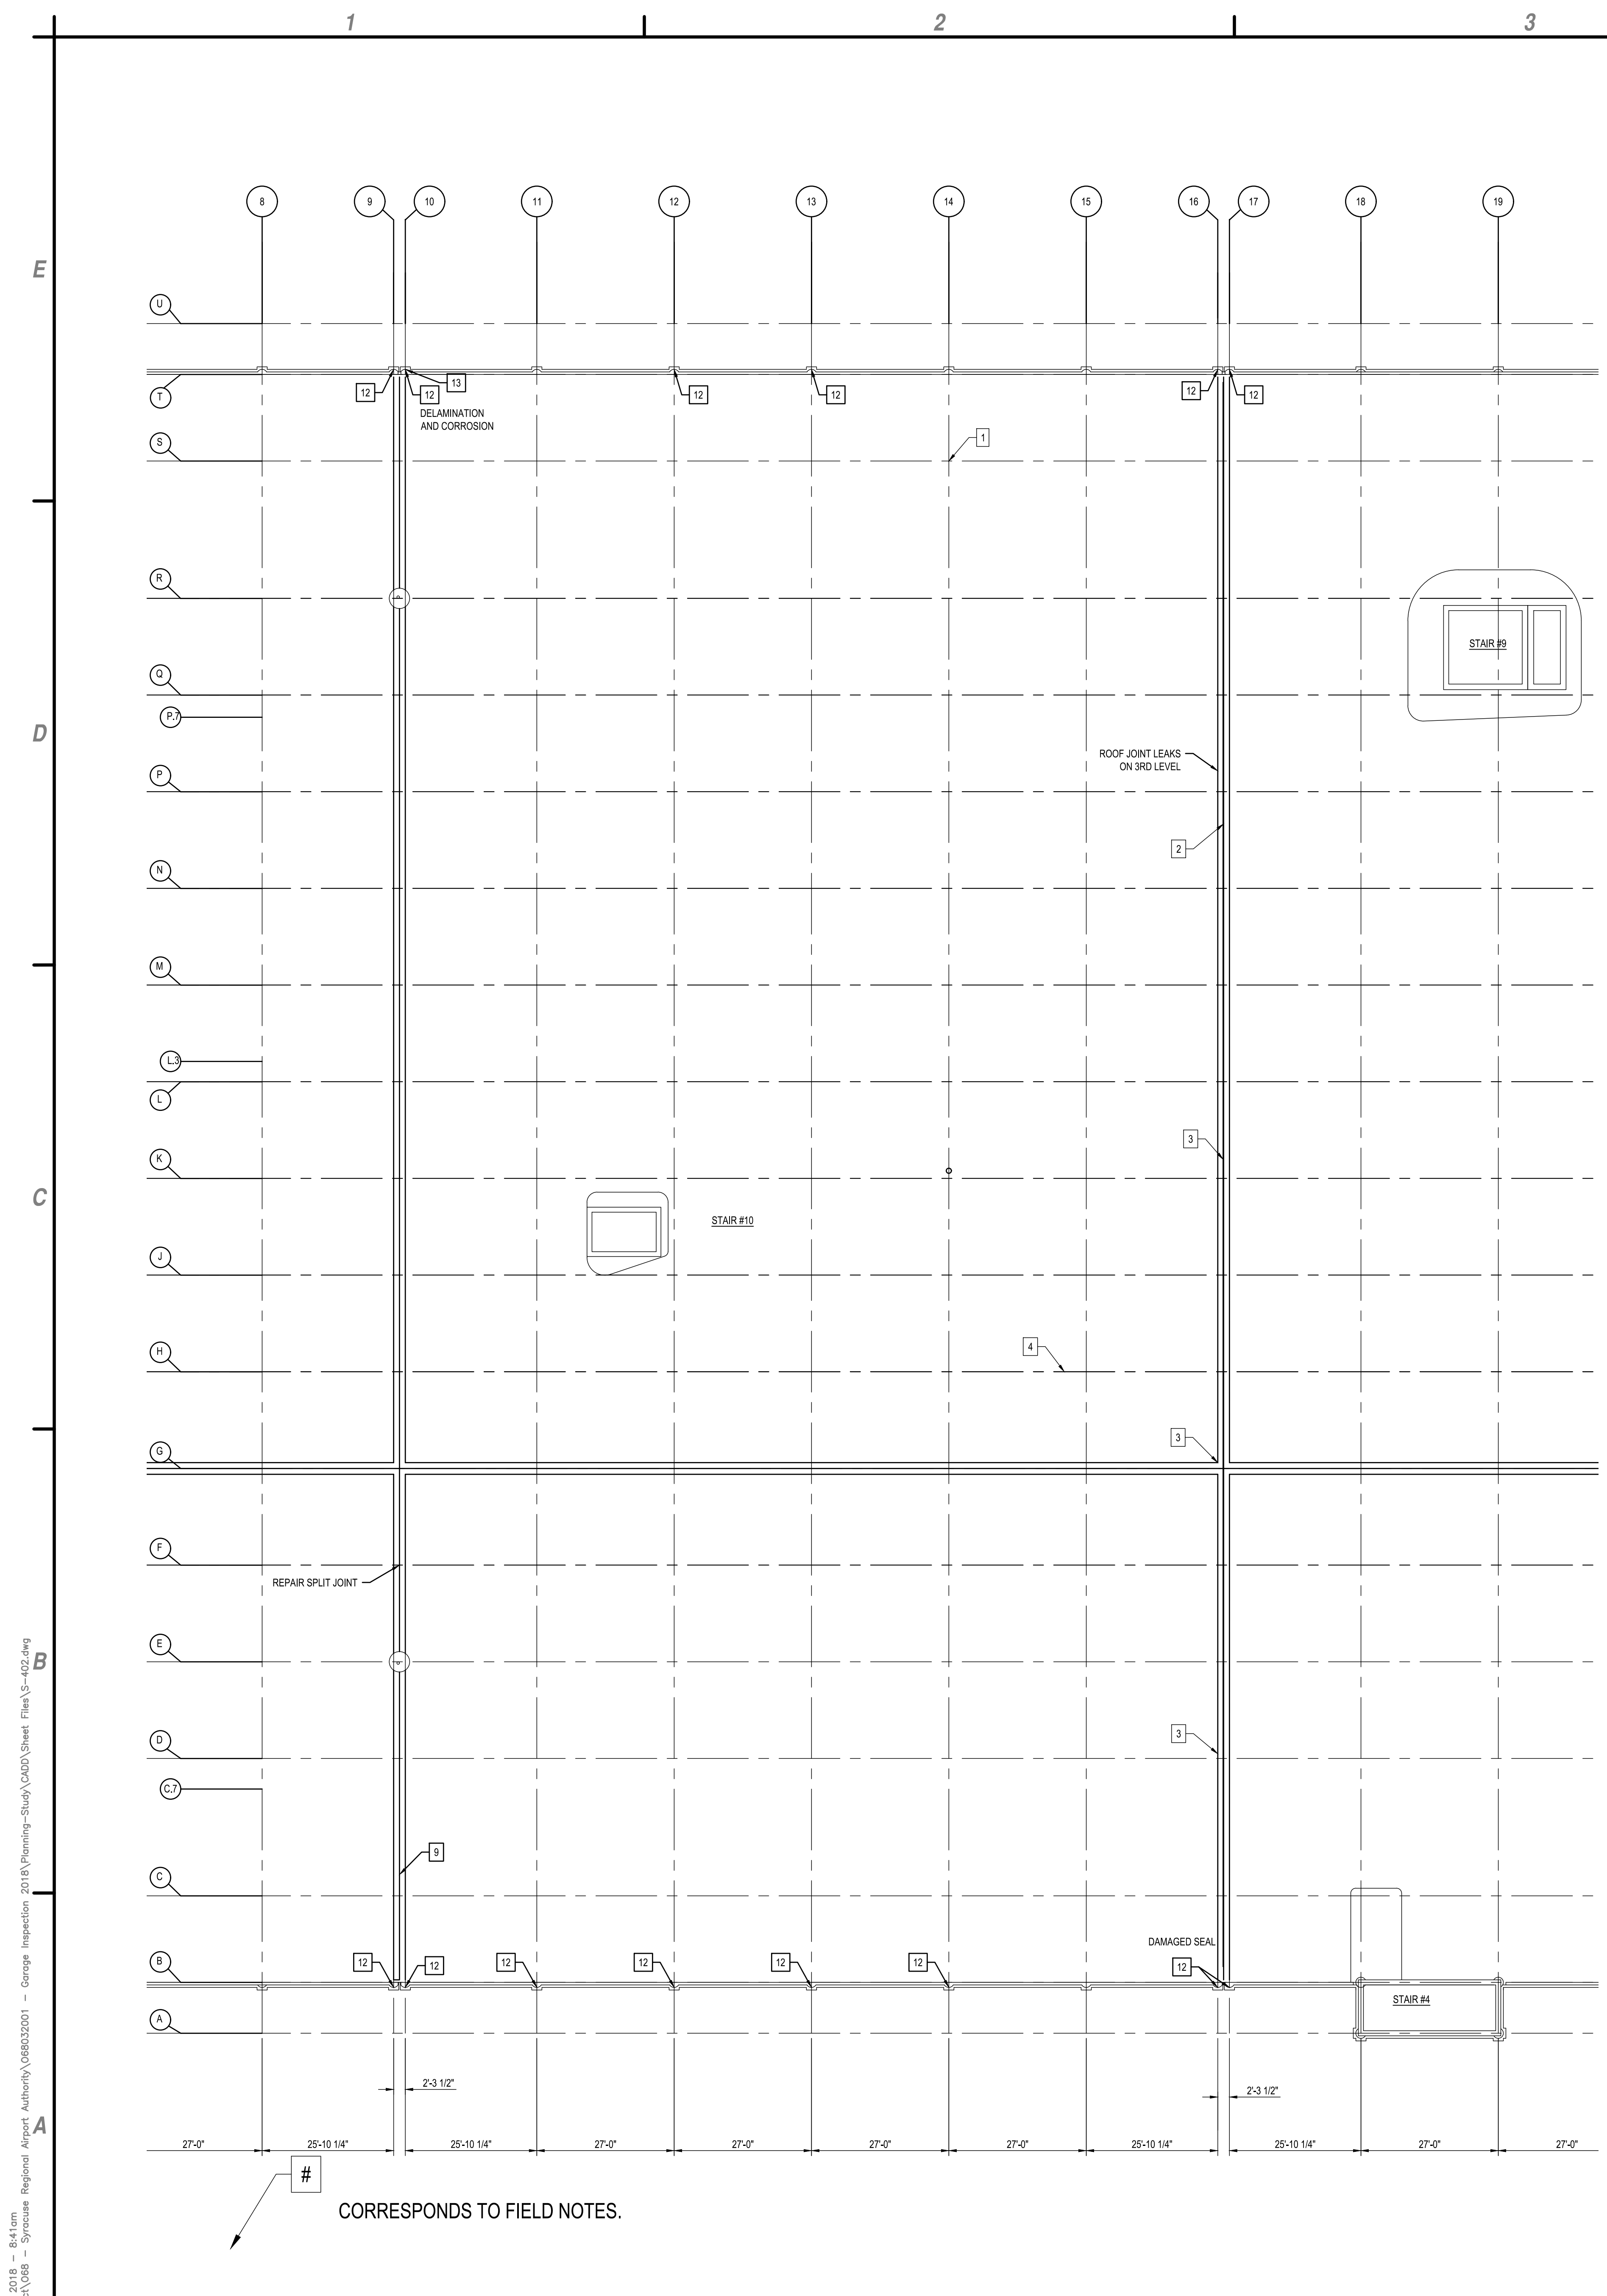
FIELD NOTES	
NOTE	DESCRIPTION
1	1' x 1' area of damaged fire board at top of column/beam base plate.
2	Loose fire board along beam anchor to beam.
3	6" x 12" area of loose fire board.
4	Missing 8' long fire board at bottom of beam.
5*	Not used
6*	Not used
7*	Not used
8*	Not used
9*	Reseal edge of expansion joint. Water leaks from roof level joint on 3rd level.
10*	Not used
11*	Not used
12	Random hairline cracks at column.
13*	Spall less than 1'x2' at column.

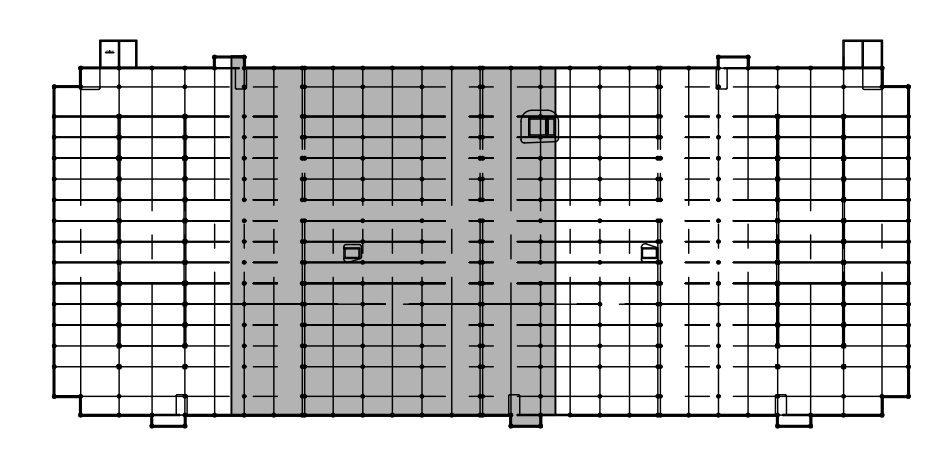
C&S COMPANIES
 C&S Engineers, Inc.
 499 Col. Eileen Collins Blvd.
 Syracuse, New York 13212
 Phone: 315-455-2000
 Fax: 315-455-9667
 www.cscos.com

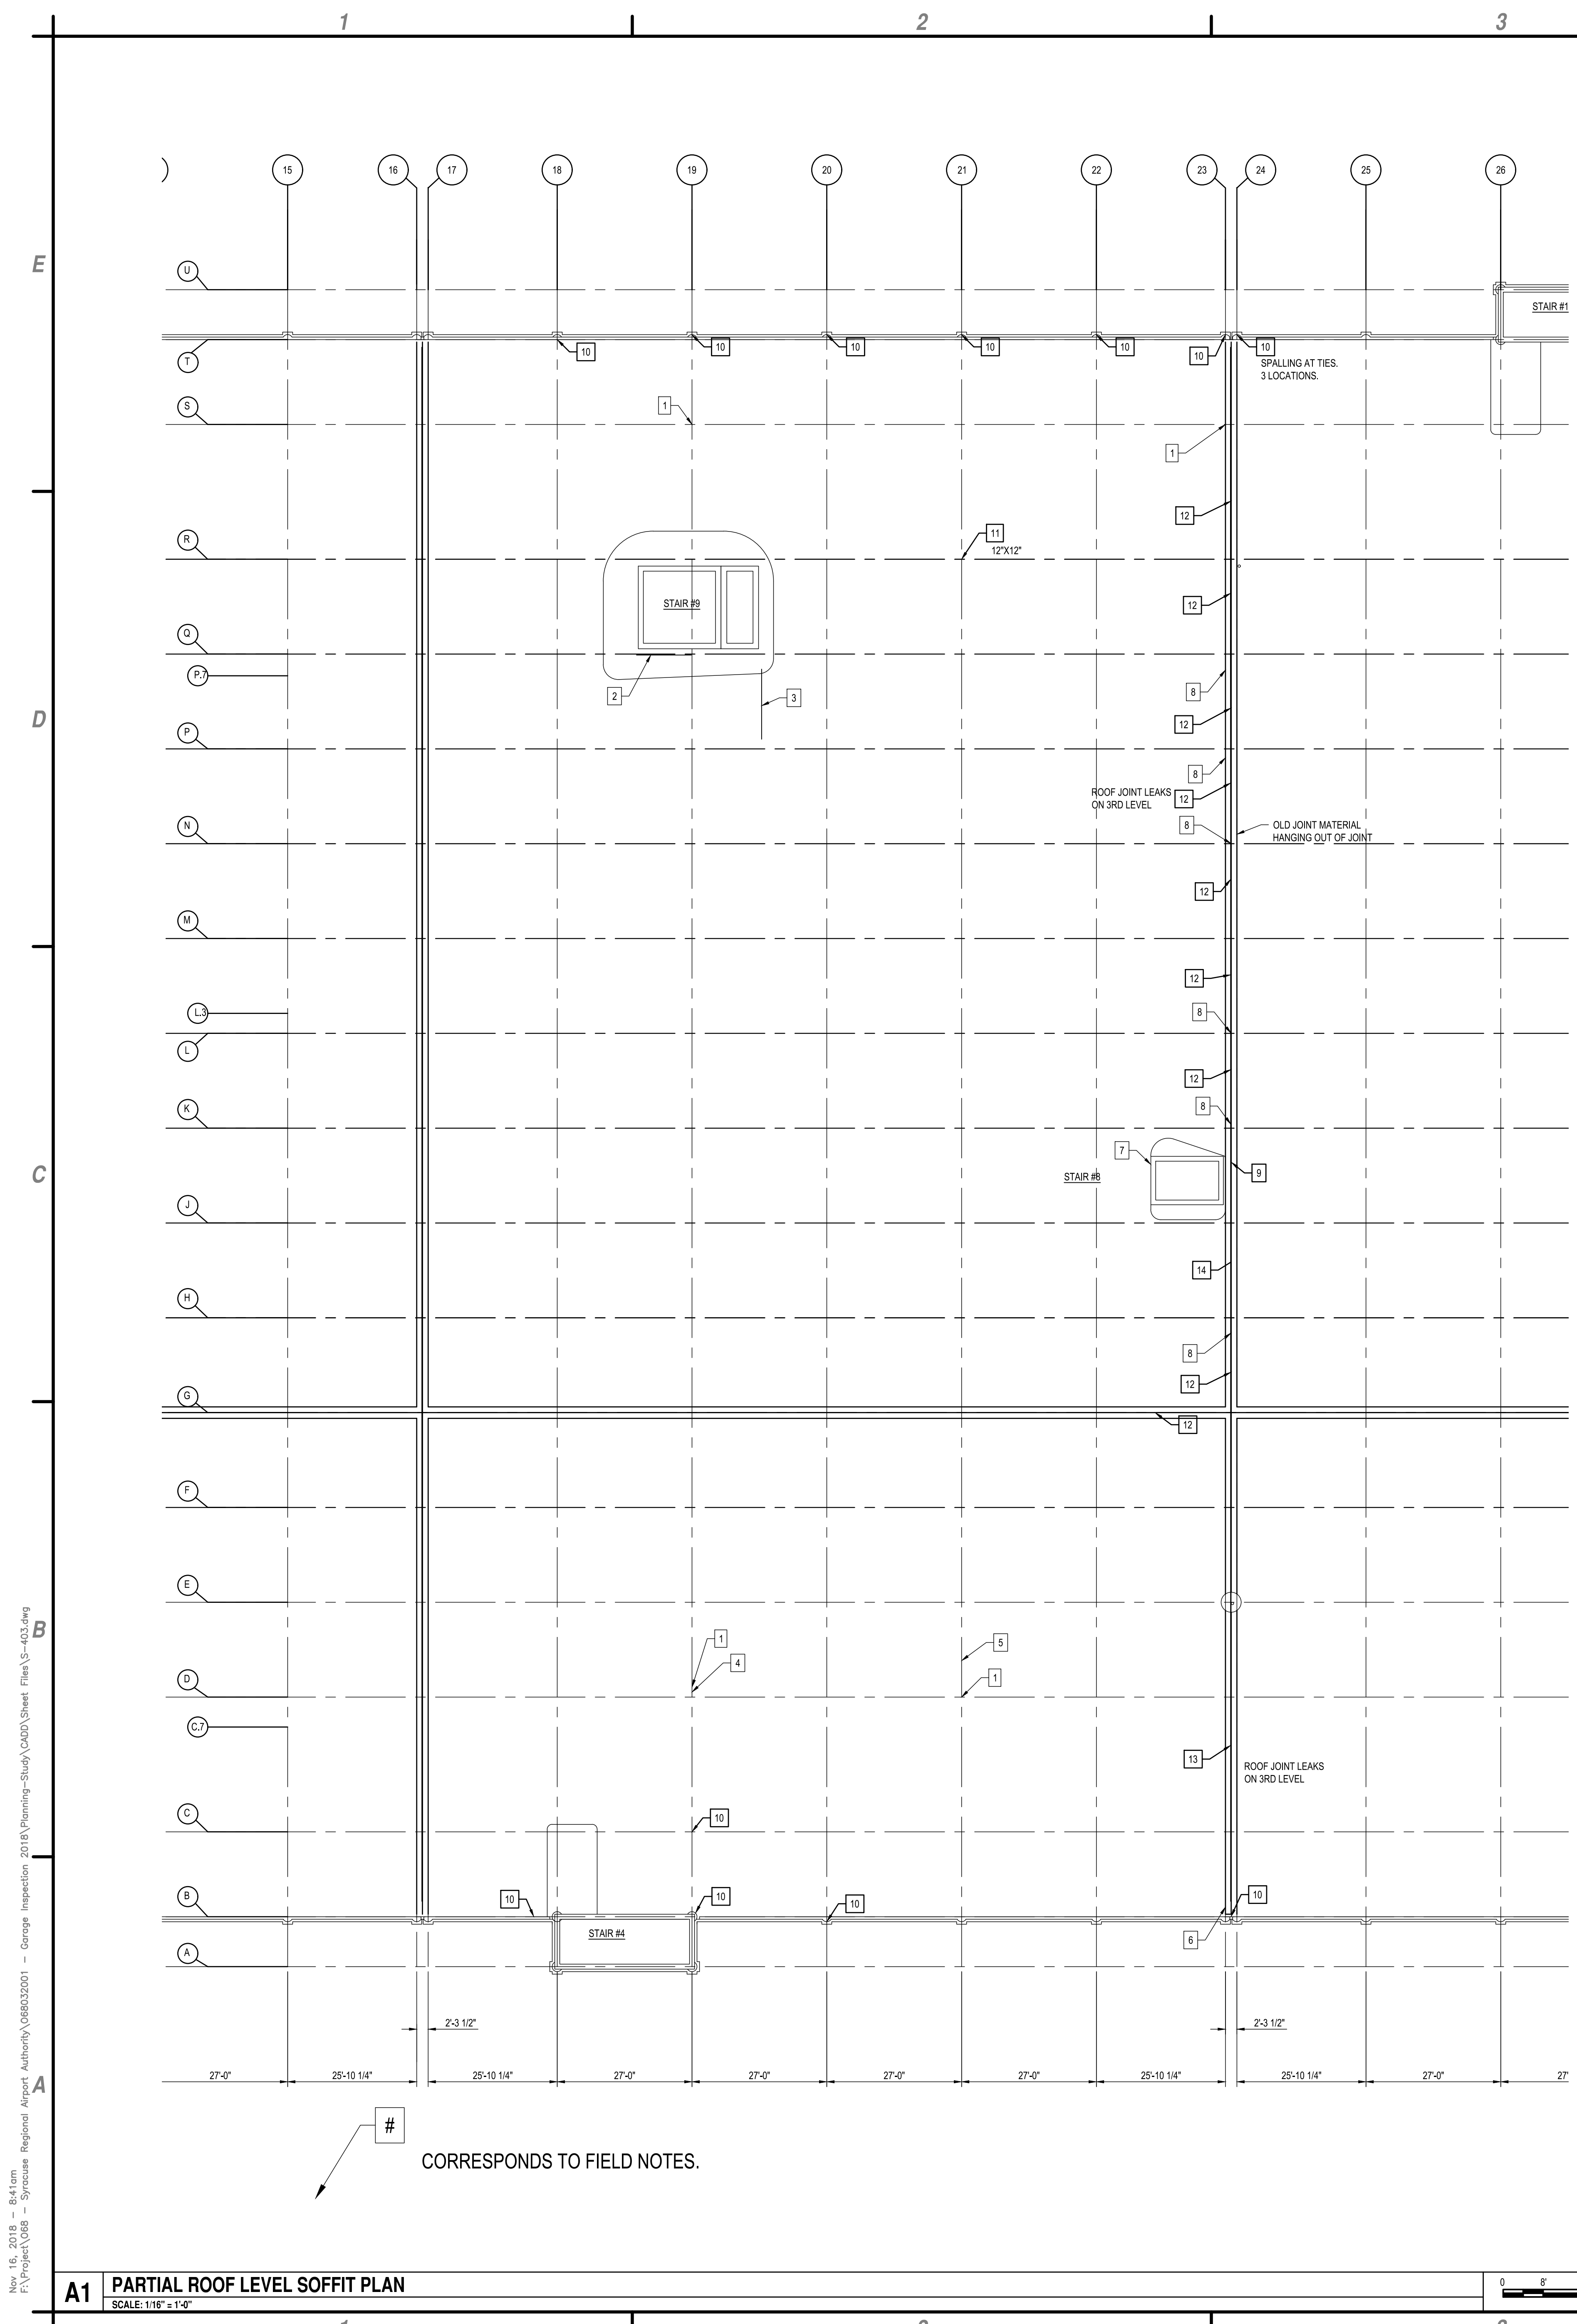
FIELD NOTES	
NOTE	DESCRIPTION
1	Missing 6" x 15" long fire board at base plate.
2	Missing 8' long fire board at bottom flange.
3	Missing 8" x 2' long fire board at bottom flange of small beam.
4	4' long hairline crack with efflorescence.
5	Missing fire board around base plate and water leak between precast slabs.
6	8" x 24" area of water damaged fire board at bottom of beam in east/west direction.
7	8" x 30" area of water damaged fire board at bottom of beam in east/west direction.
8	6" x 12" area of loose fire board.
9*	Replace entire joint next to stair. 100% damaged.
10	Random hairline cracks on column.
11*	Spall less than 1'x2' on column.
12*	Caulking failed at expansion joint.
13*	Failed caulking along expansion joint and 1'x6' delaminations along edge of joint. Up to 6' long damaged concrete.
14*	Damaged concrete along expansion joint. 6"x18" long.

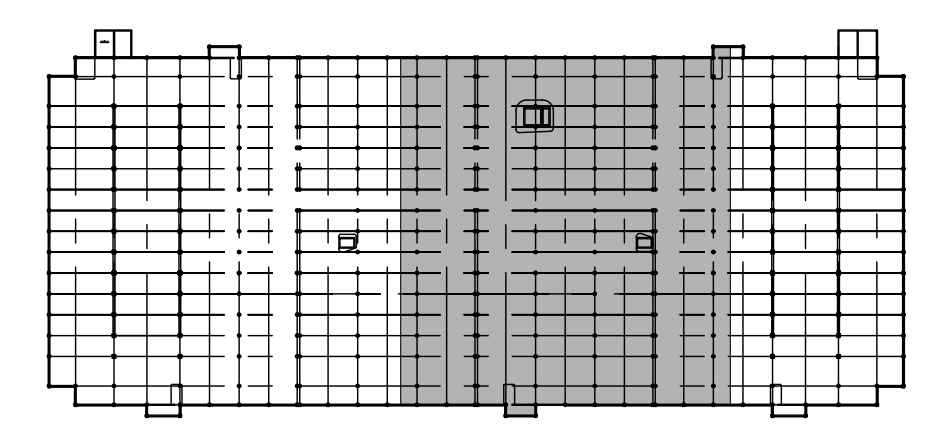
**SYRACUSE HANCOCK INTERNATIONAL AIRPORT
 PARKING GARAGE STRUCTURAL CONDITION SURVEY 2018**

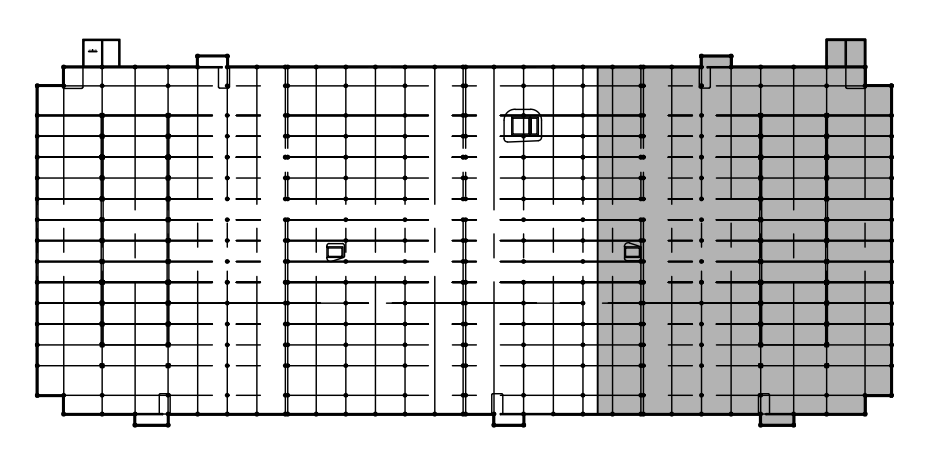
**SYRACUSE HANCOCK INTERNATIONAL AIRPORT
 PARKING GARAGE STRUCTURAL CONDITION SURVEY 2018**

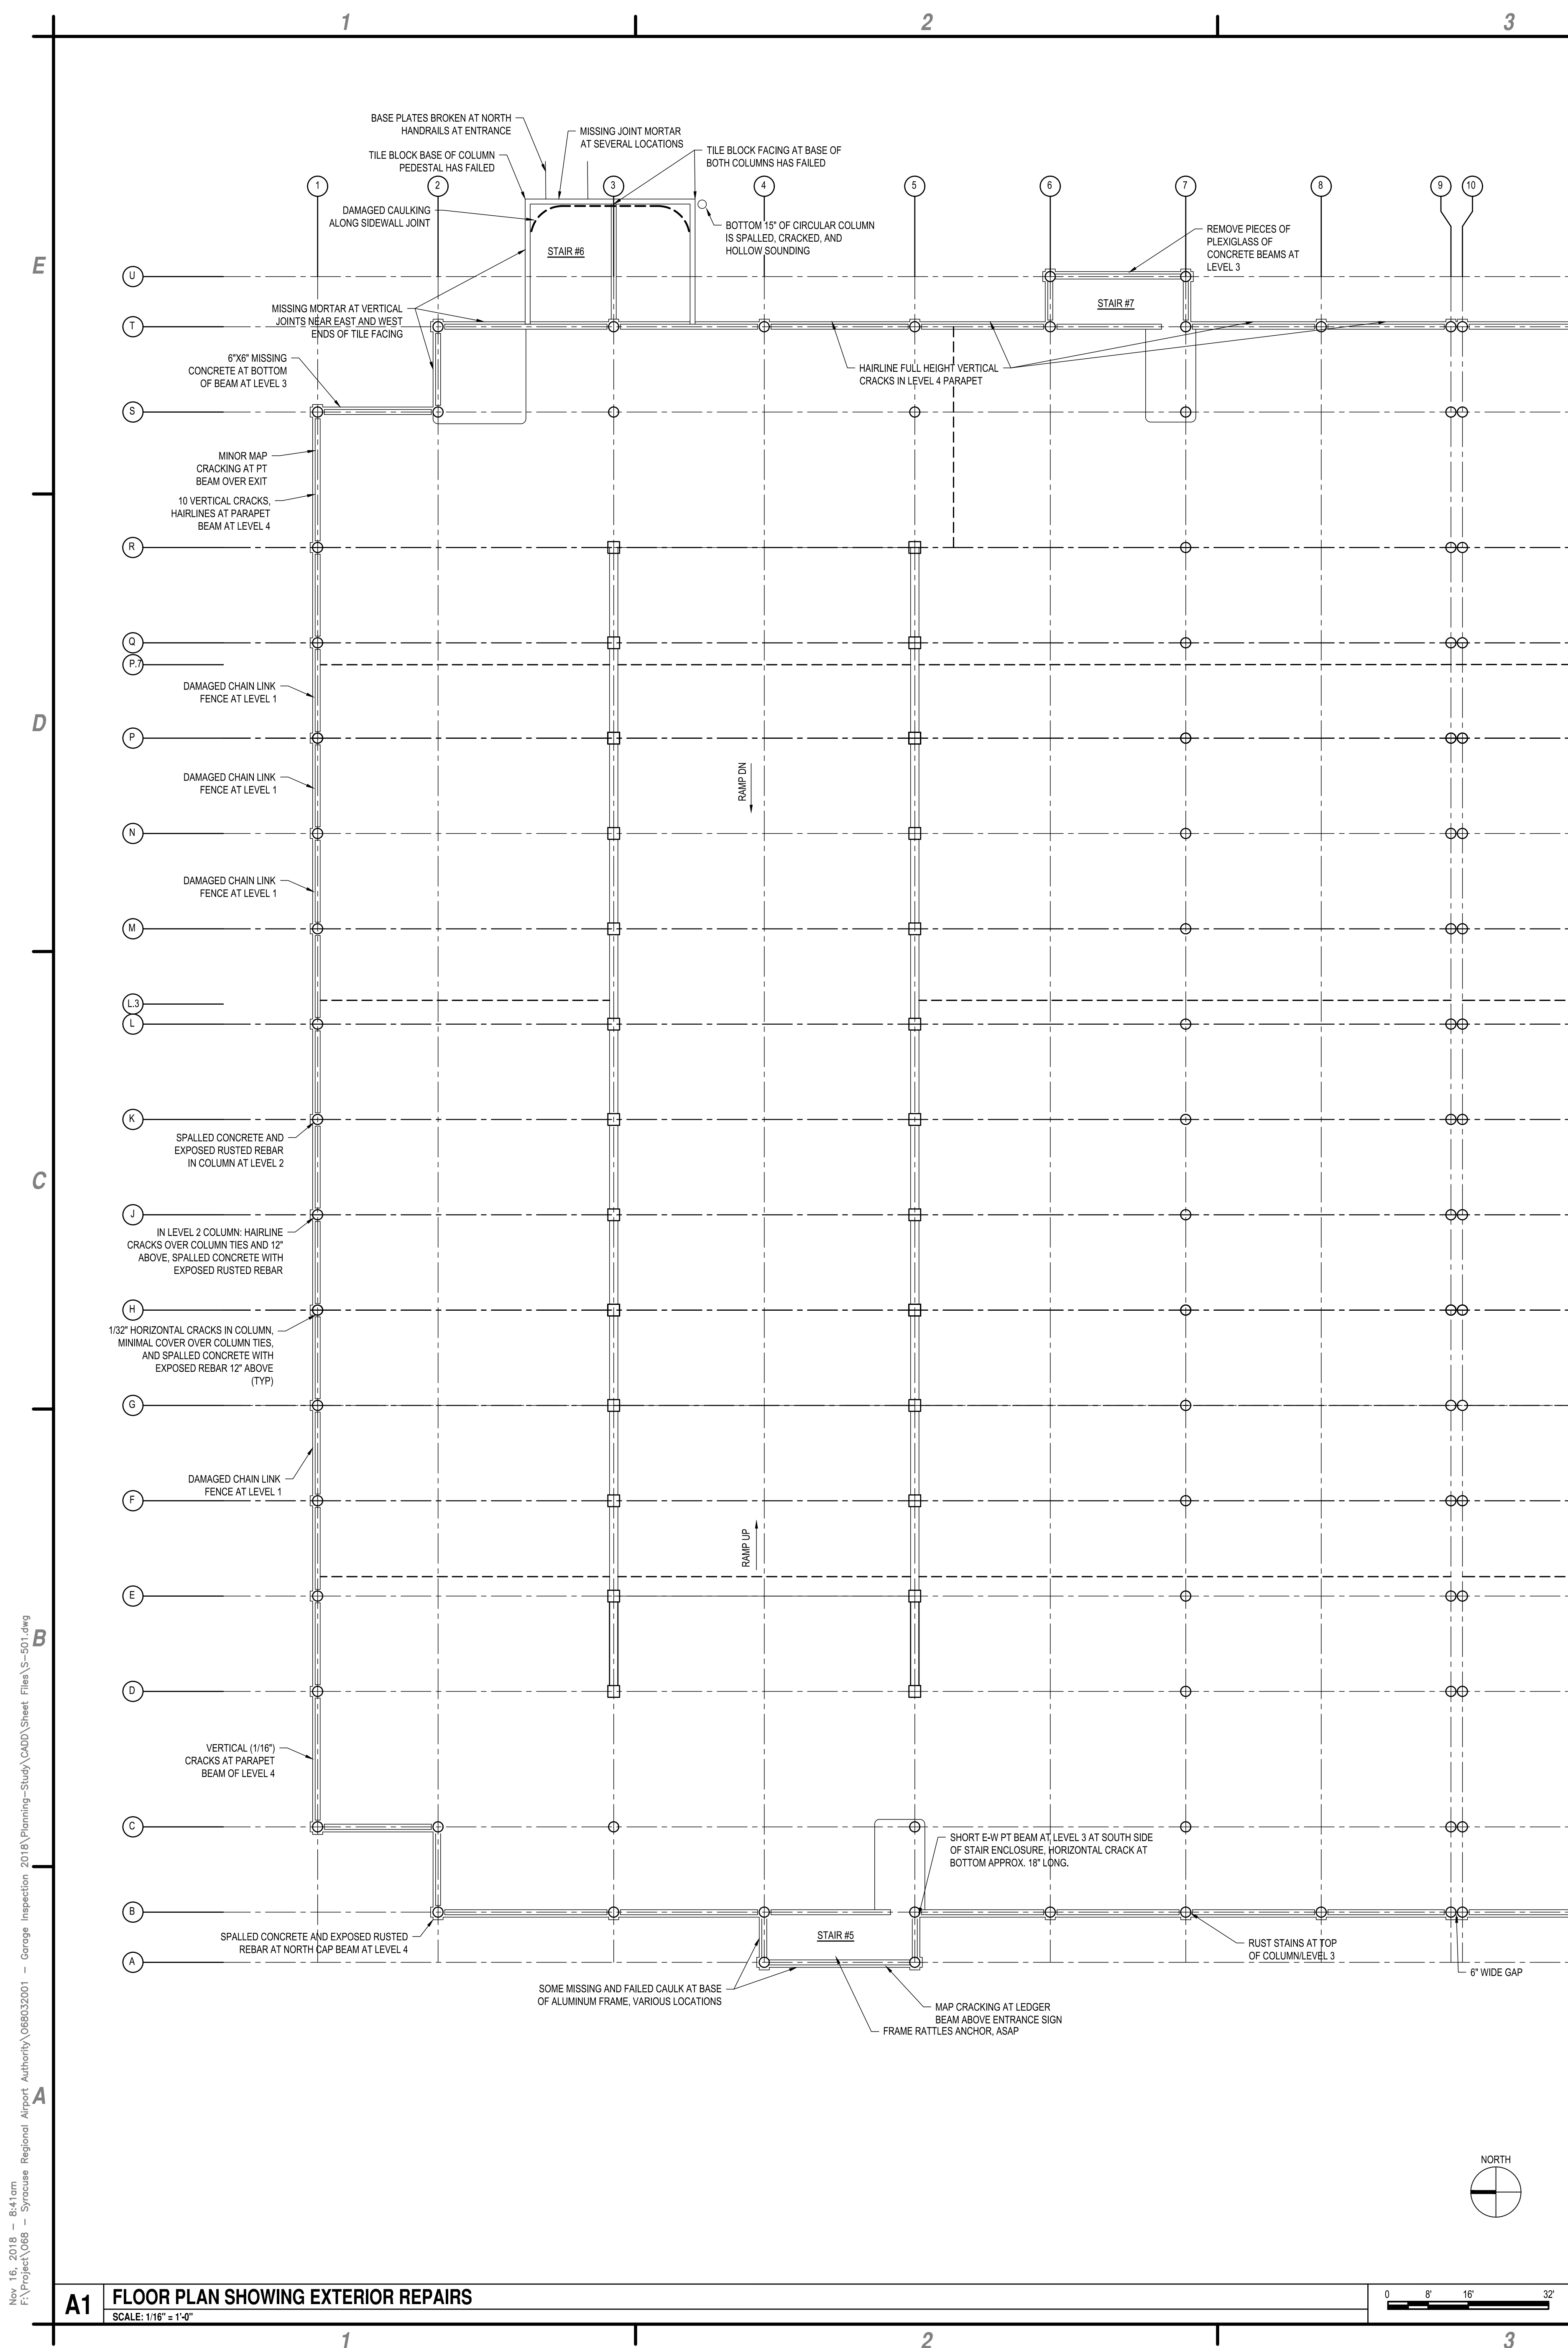
STAIR TOWER #5	
NOTE	DESCRIPTION
1	Heavy water infiltration and staining at first floor.
2	Corroded rail posts at first floor.
3	Heavy corrosion of the first floor stringers and anchors.
4	Heavy corrosion of the posts supporting the 1-2 intermediate landing.
5*	Damaged top flange of the west channel supporting 1-2 intermediate landing. Repair 2017
6	Up to 1/8" by 2' long cracks at the concrete beam at the second floor. Repair 2018
7	Several cracks up to 5' long along the concrete beam at the third floor. Repair 2018
8	Heavy paint damage, with heavy corrosion and section loss below the landing at the fourth level landing. Repair 2018
9*	Up to 1/2" gap between the nosing and concrete at fourth floor landing. Repair 2017

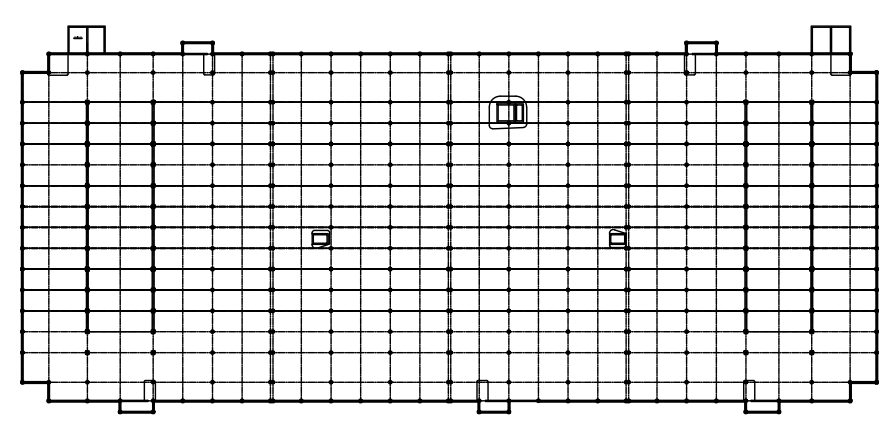
**SYRACUSE HANCOCK INTERNATIONAL AIRPORT
 PARKING GARAGE STRUCTURAL CONDITION SURVEY 2018**
