**PARKING GARAGE
STRUCTURAL CONDITION SURVEY REPORT-2018**

**HANCOCK AIRPORT PARKING GARAGE
1000 COL. EILEEN COLLINS BLVD
SYRACUSE, NY 13212**

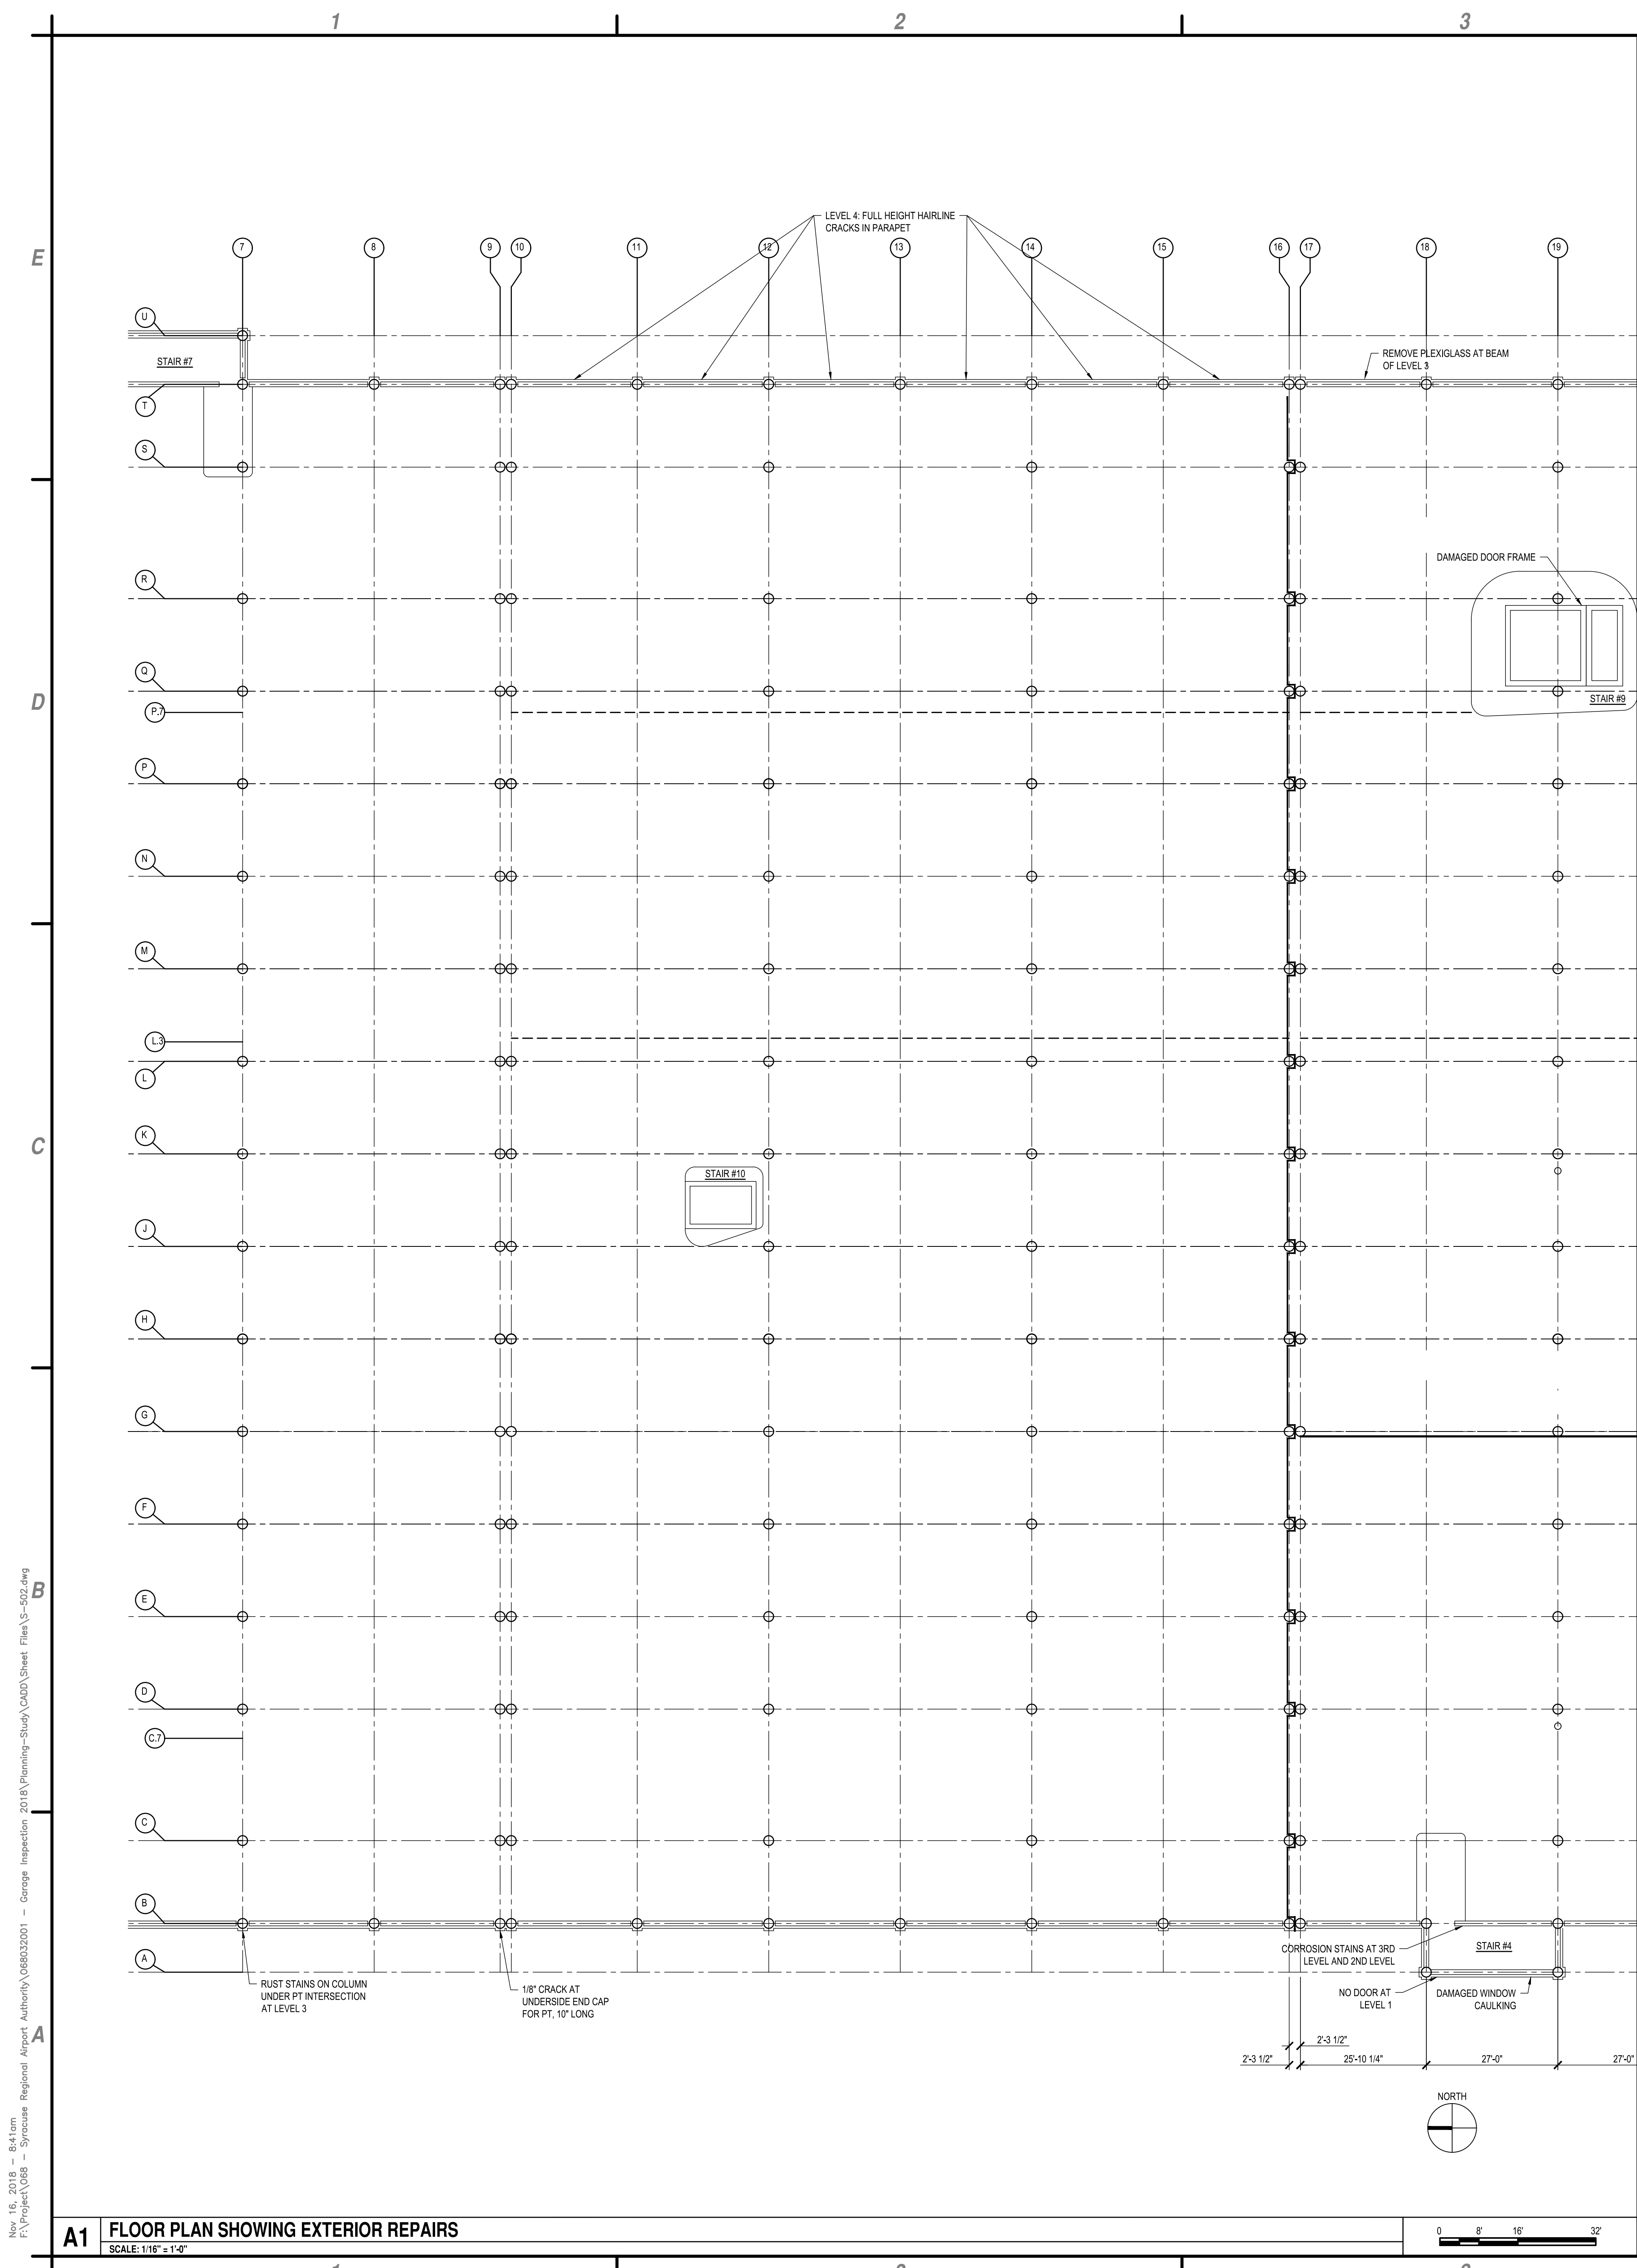
STAIR TOWER #4	
NOTE	DESCRIPTION
1	Damaged caulking around the aluminum frame enclosure.
2	Heavy corrosion at the railing posts at first floor.
3	Heavy corrosion of the stair stringers at the first floor.
4	Corrosion of the post baseplate supporting the 1-2 intermediate stair landing.
5	Heavy water stains.
6	Level 4- heavy damage to the steel pan of landing.
7	Level 4- 2' long crack in concrete landing. Repair 2017

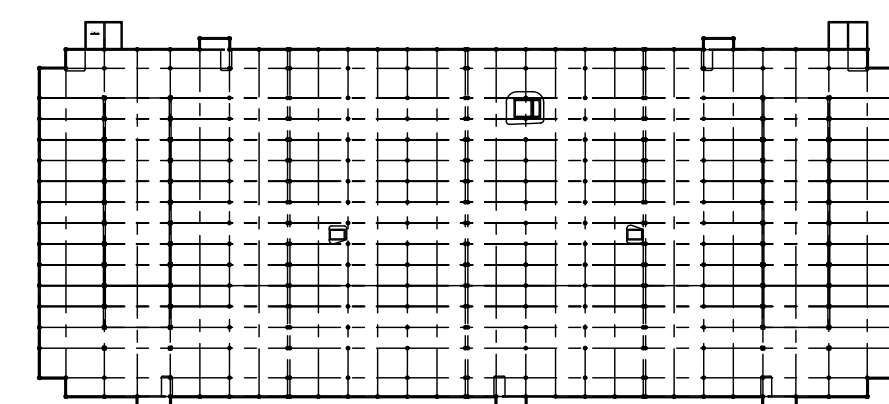
C&S COMPANIES
 C&S Engineers, Inc.
 499 Col. Eileen Collins Blvd.
 Syracuse, New York 13212
 Phone: 315-455-2000
 Fax: 315-455-9667
 www.cscos.com

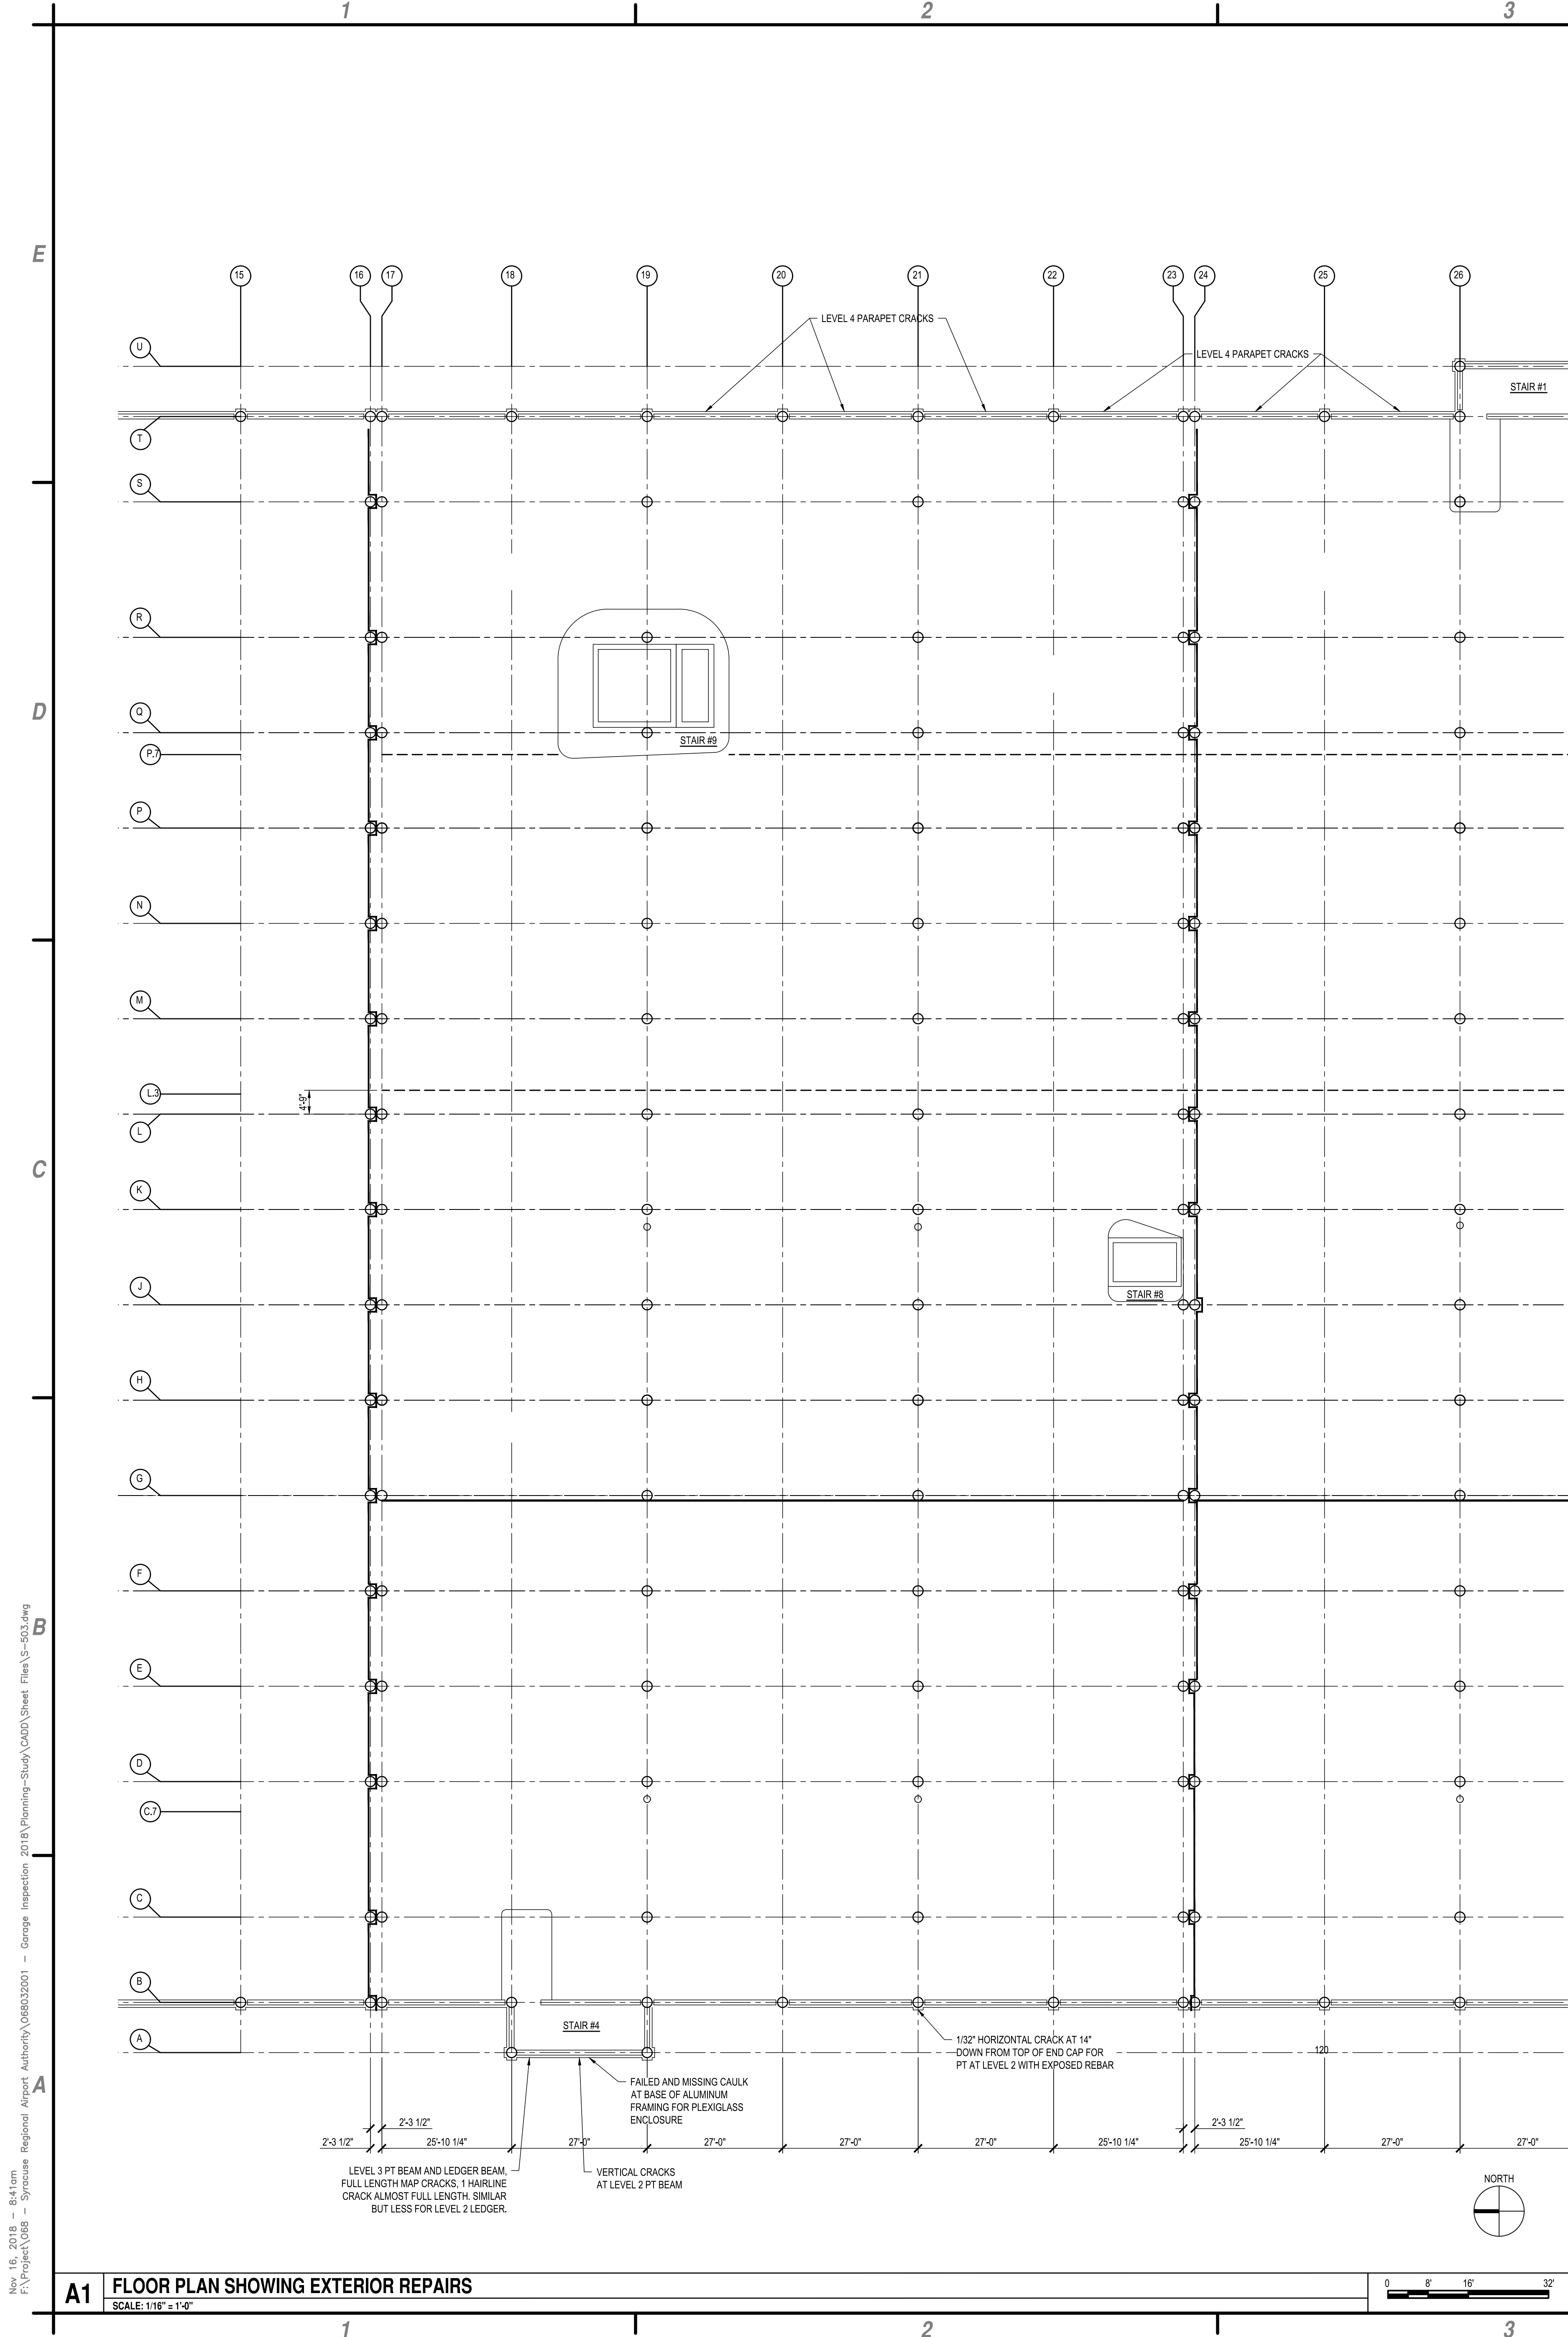
STAIR TOWER #8	
NOTE	DESCRIPTION
1	Not Used
2	Hole in south masonry wall at roof level.
3	Water damaged fireproofing board.
4	General paint damage.
5	Not Used
6	damaged door frame.

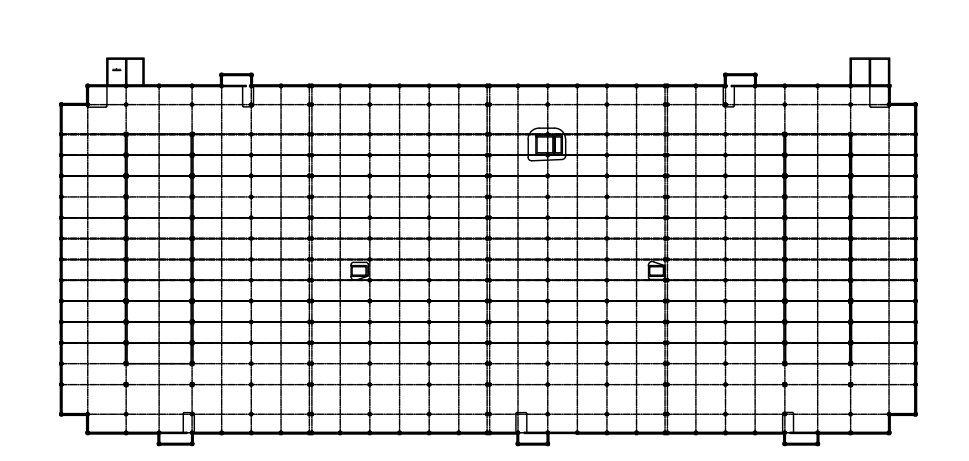
C&S COMPANIES
 C&S Engineers, Inc.
 499 Col. Eileen Collins Blvd.
 Syracuse, New York 13212
 Phone: 315-455-2000
 Fax: 315-455-9667
 www.cscos.com

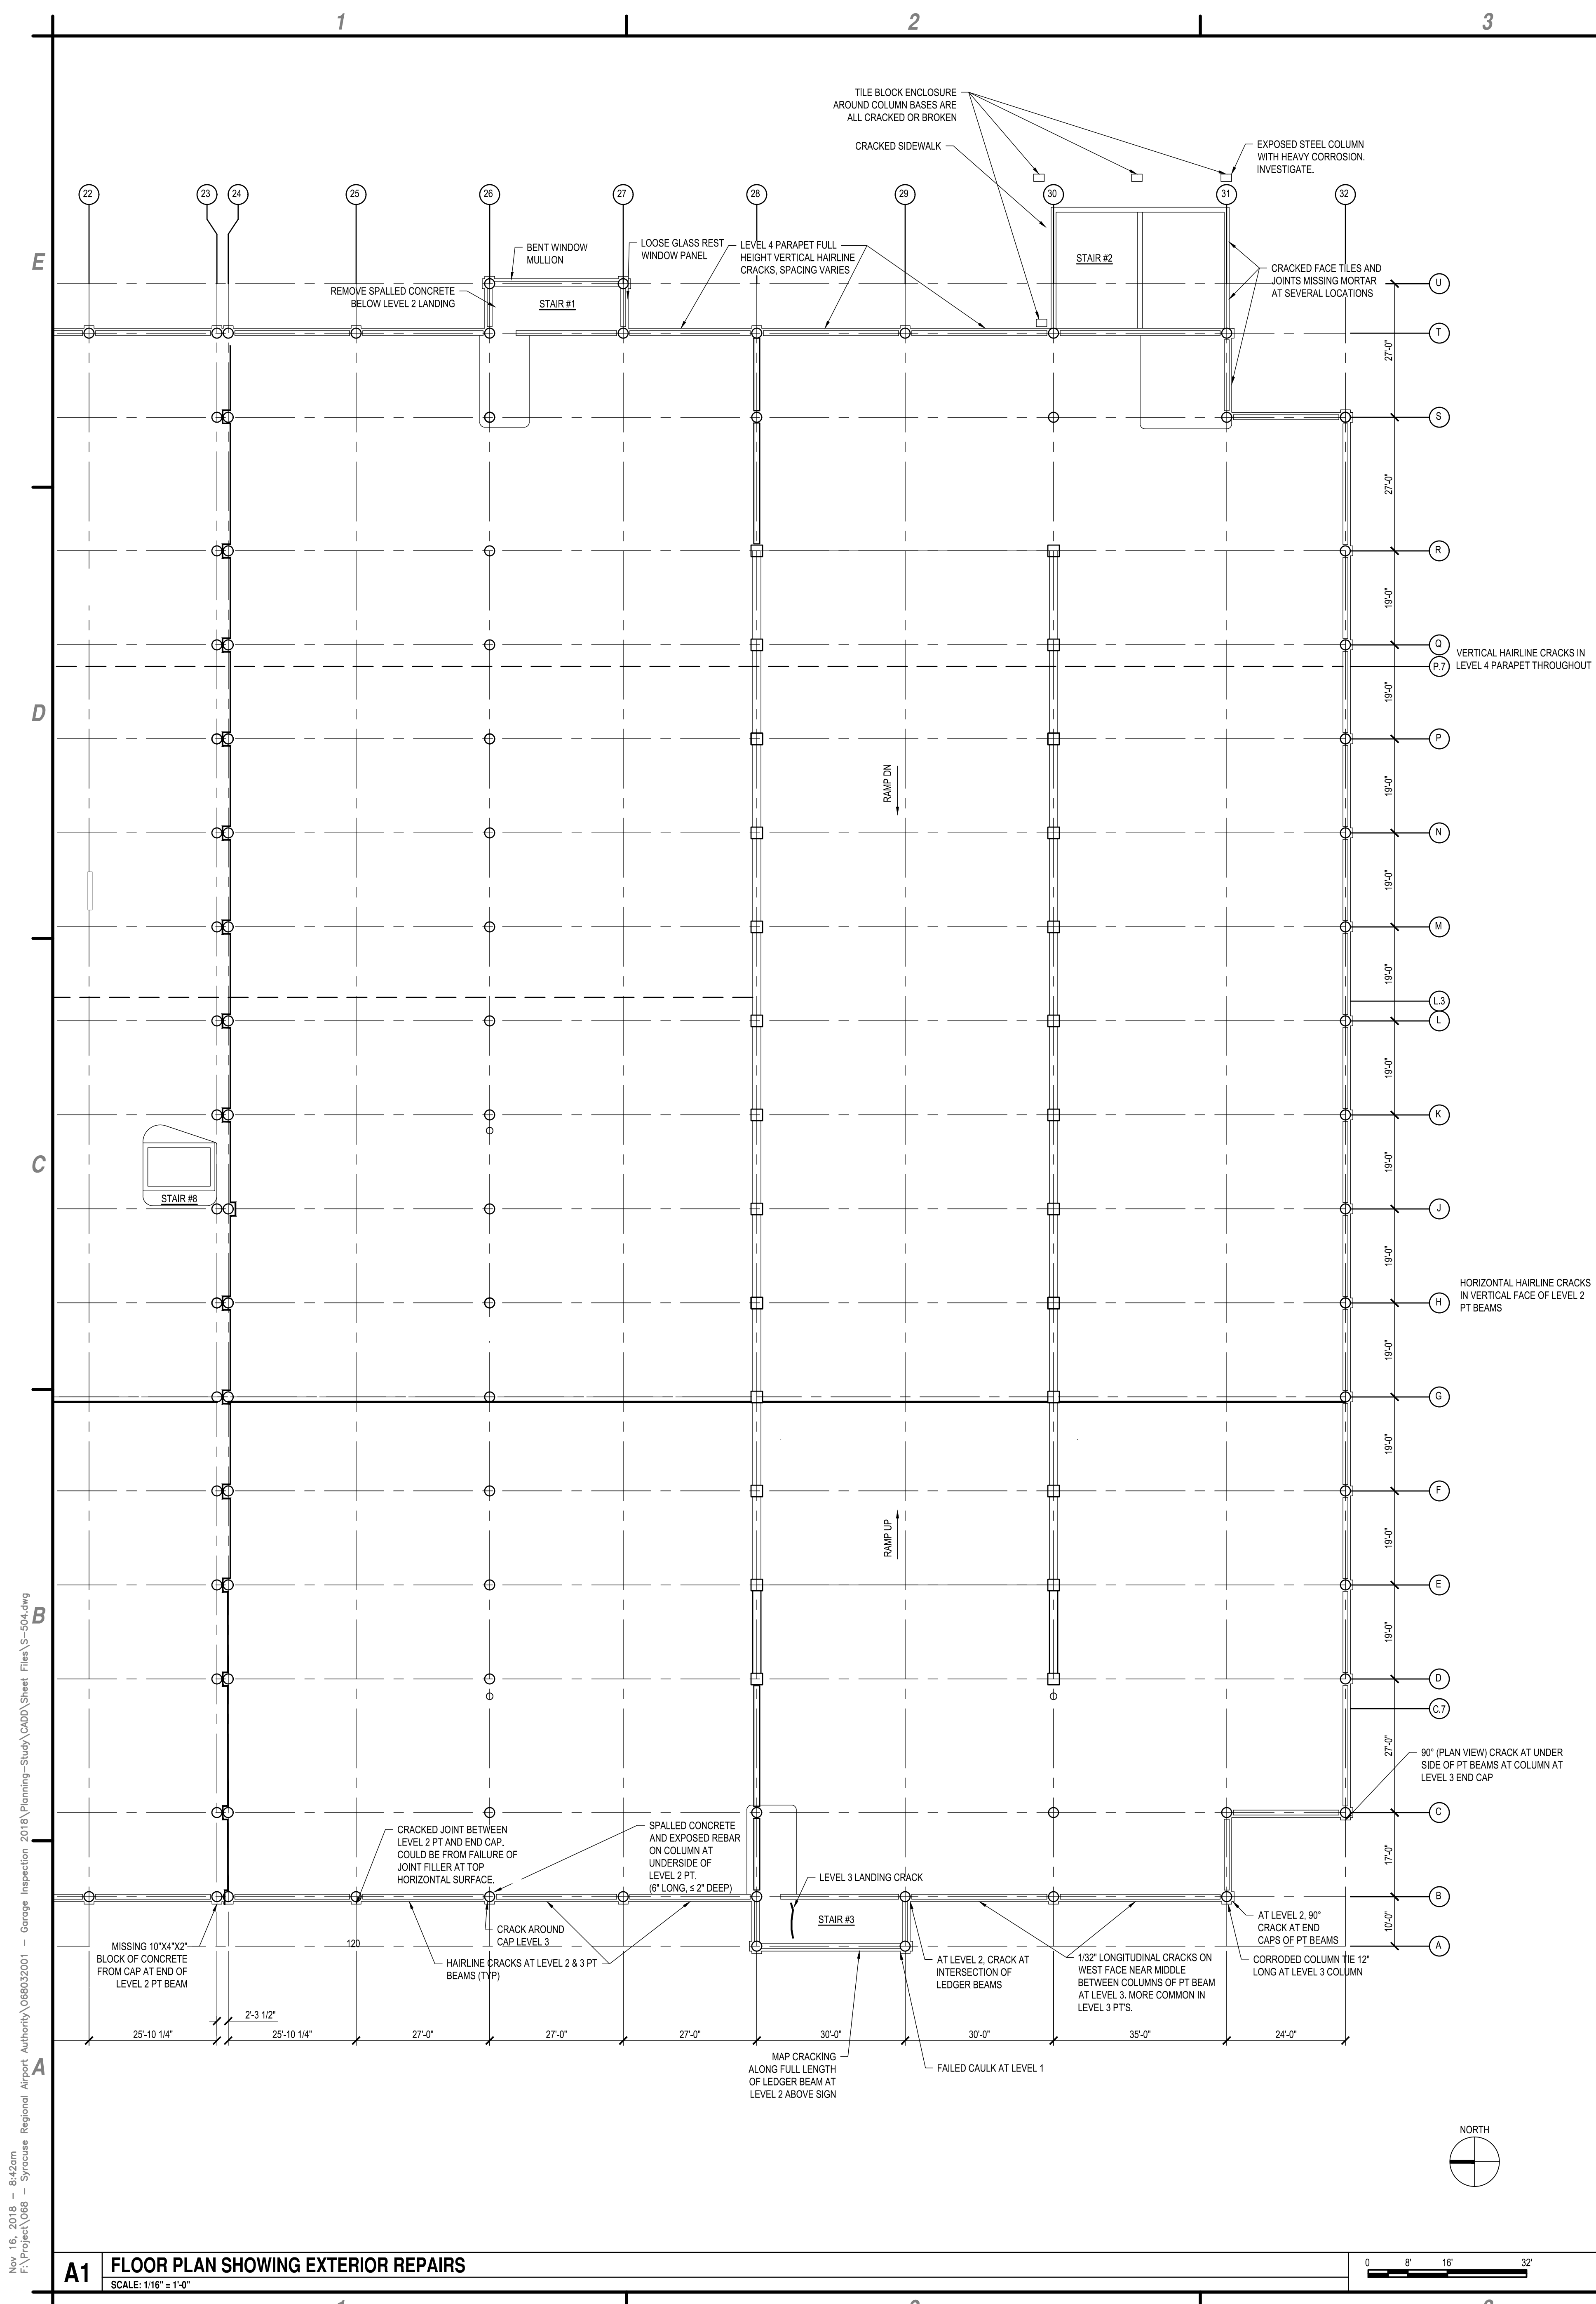
STAIR TOWER #1 (REPAIRS TO BE COMPLETED IN 2018)	
NOTE	DESCRIPTION
1	Spalled concrete and corrosion at the anchor bolts and base plates of the enclosure frame at roof level.
2	Damaged caulking at aluminum windowsills.
3	Cracked concrete beam supporting the landings at the second and third floor. Repair 2018
4	Heavy corrosion of all handrail posts. Repair 2018
5	Heavy corrosion of the stair stringers a ground level. Repair 2018
6	Corrosion of risers/nosing and treads at stair section from first to second floor. Repair 2018
7	Some deck cracking at second floor. Repair 2018
8	General corrosion and damaged paint. Repair 2018

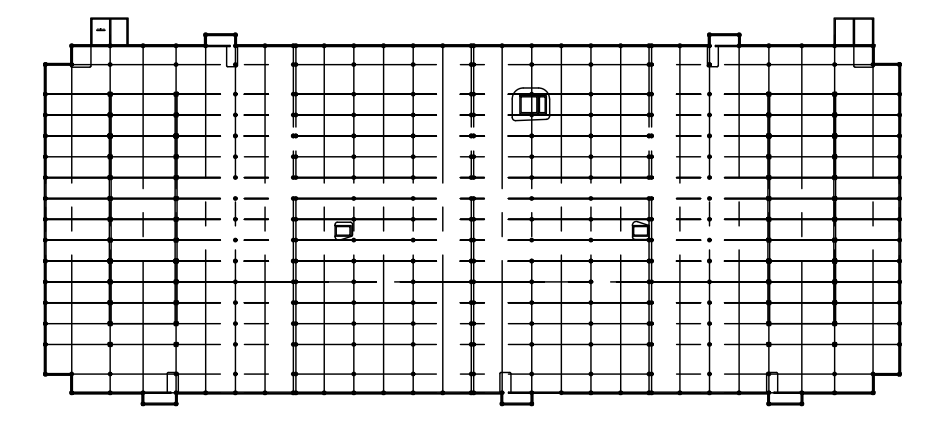
A1 FLOOR PLAN SHOWING EXTERIOR REPAIRS
SCALE: 1/16" = 1'-0"
