Wetland Delineation Report

Syracuse Hancock International Airport Land Release

Town of Salina Onondaga Co., New York

CHA Project Number: 077036

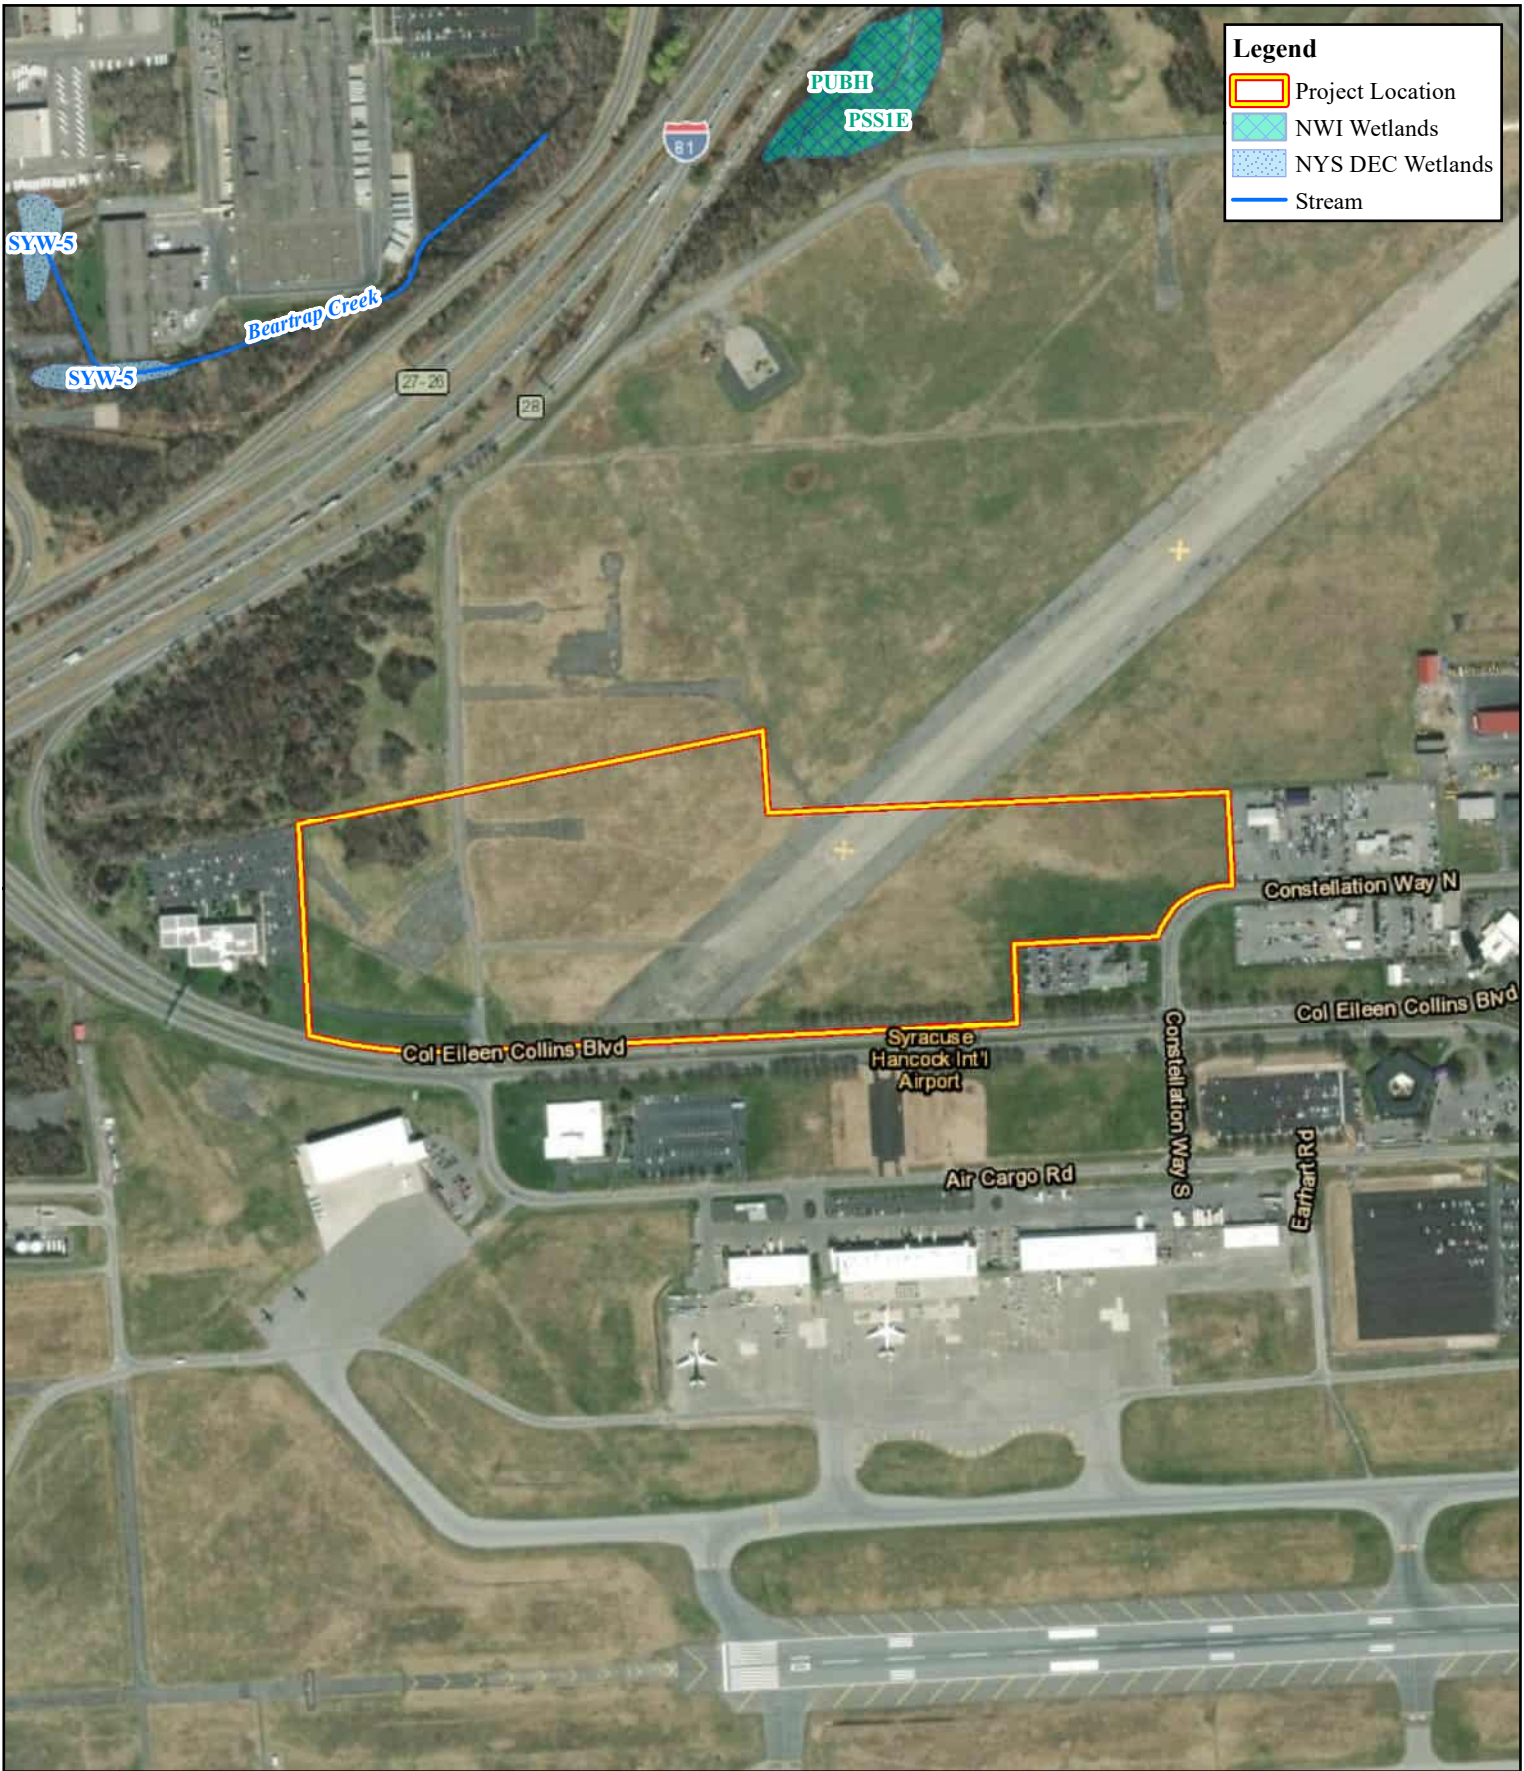
Wetlands Map

Review of the NYSDEC freshwater wetlands map did not identify any mapped state regulated wetlands or associated 100-foot Adjacent Areas within the project area.

Review of the NWI map did not identify any mapped wetlands within the project area.

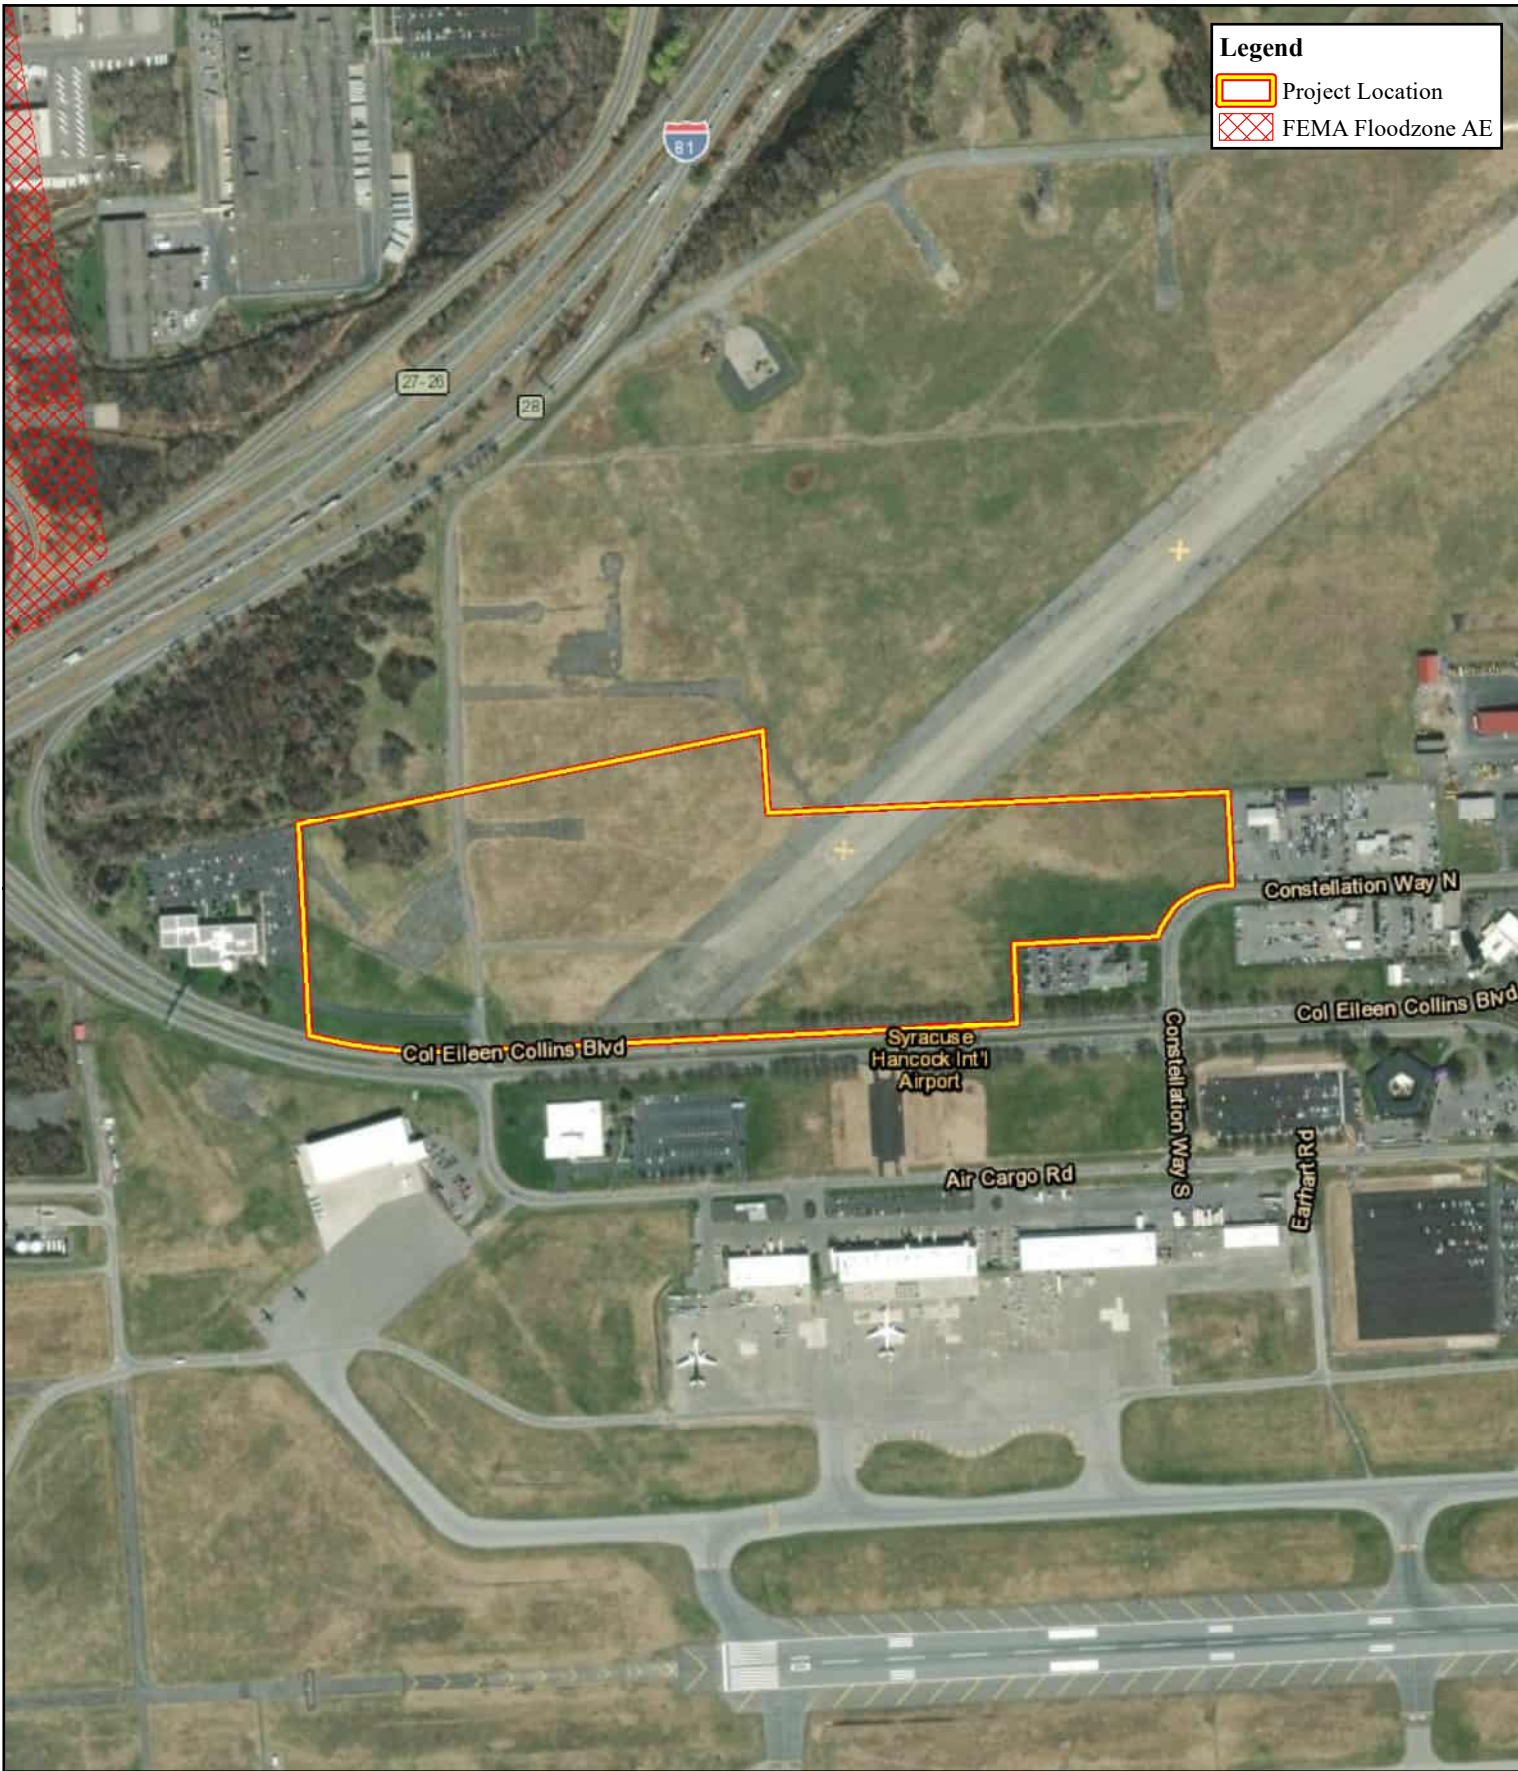
FEMA Floodzone Map

Based on review of the Federal Emergency Management Agency (FEMA) Flood Insurance Rate Map, no areas of 100-year floodplain are mapped within the project area.

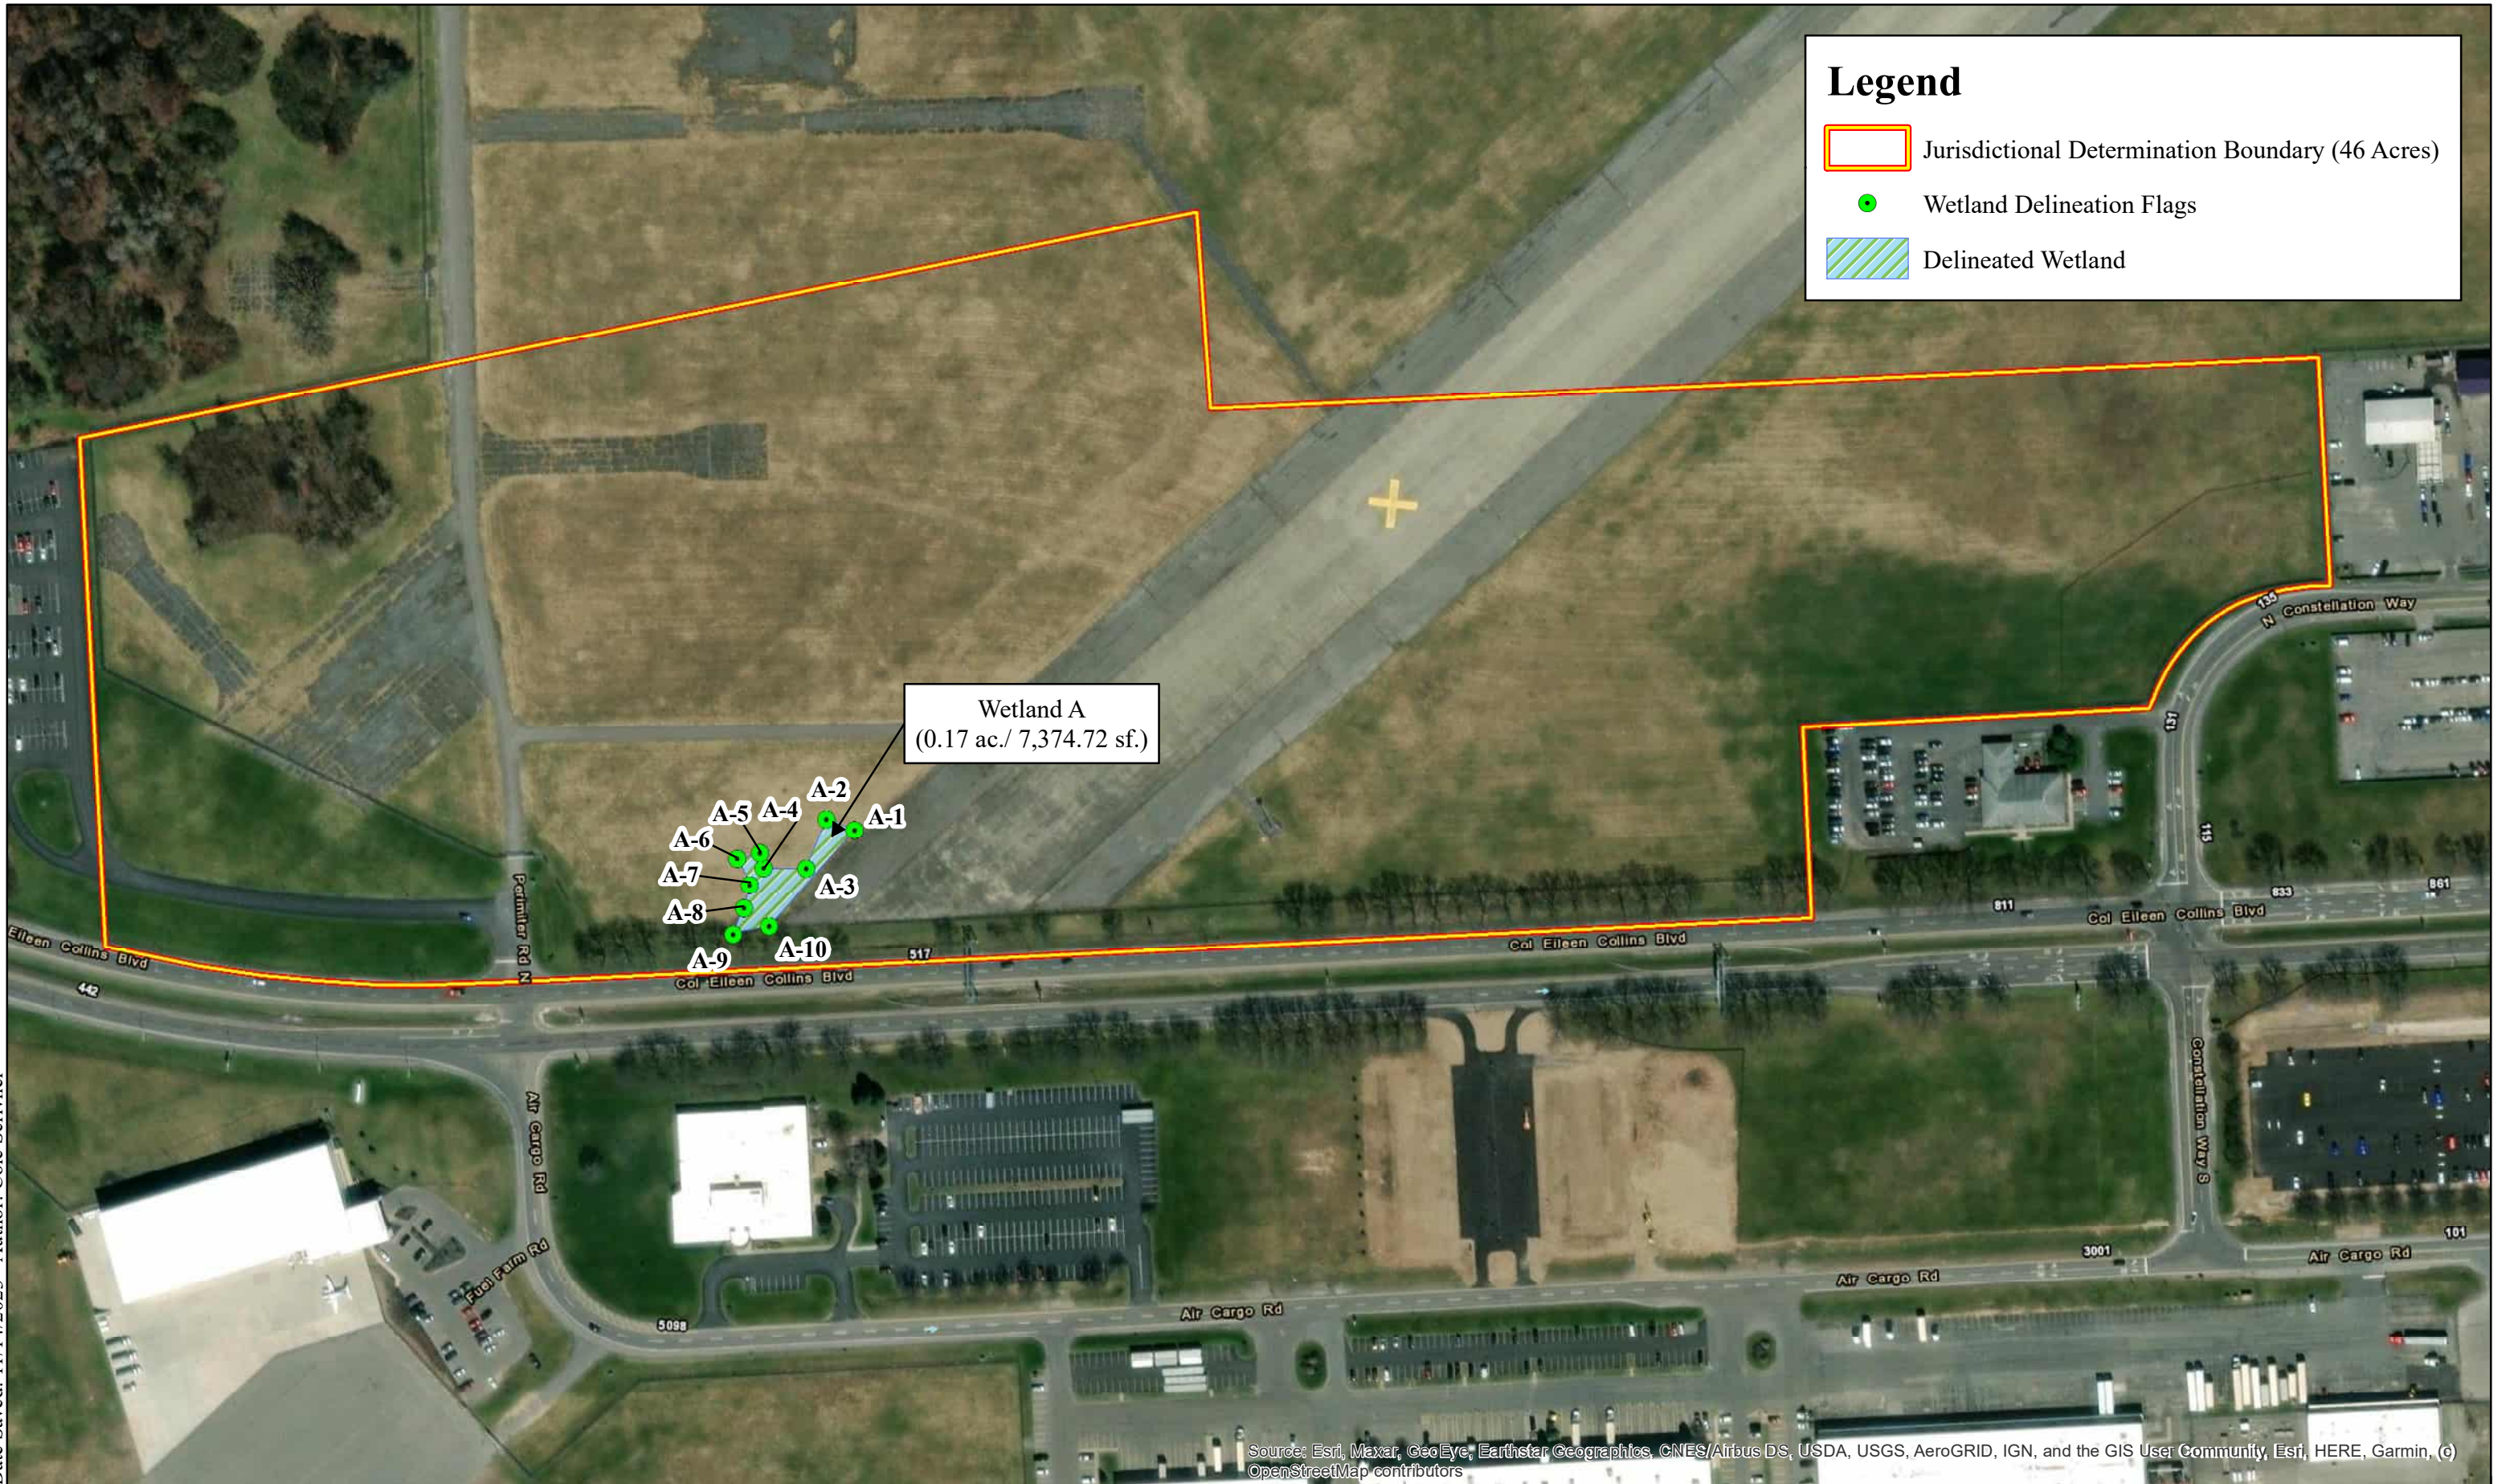
Wetland A – Wetland A is an isolated shallow emergent marsh (PEM) that is dominated by path rush (*Juncus tenuis*) with lesser occurrences of yellow nut sedge (*Cyperus esculentus*).

Observed hydrology indicators included Surface Water (A1), Oxidized Rhizospheres on Living Roots (C3) and Geomorphic Position (D2). The hydric soil indicator is Depleted Below Dark Surface (A11).

The total size of Wetland A is approximately 0.17 acres. This wetland is a small depression, has no inlet or outlet and no connection to tributaries or adjacent wetlands. Wetland A is not adjacent to a TNW, territorial sea, or interstate water. Wetland A is also not adjacent to a water defined as relatively permanent, standing or continuously flowing and does not have a continuous surface connection to those waters. Wetland A is presumed to be non-jurisdictional based on review of the current definition of Waters of the United States as described above.

Wetland A
(0.17 ac./ 7,374.72 sf.)

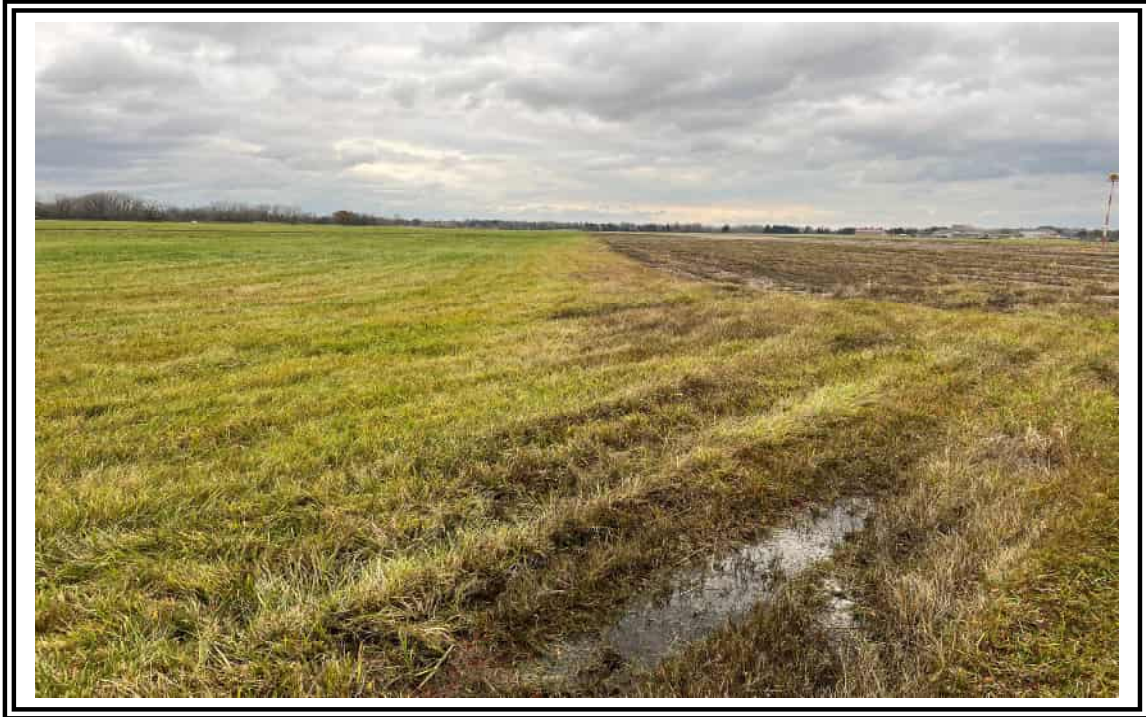
Photo 1-Wetland A facing northeast.

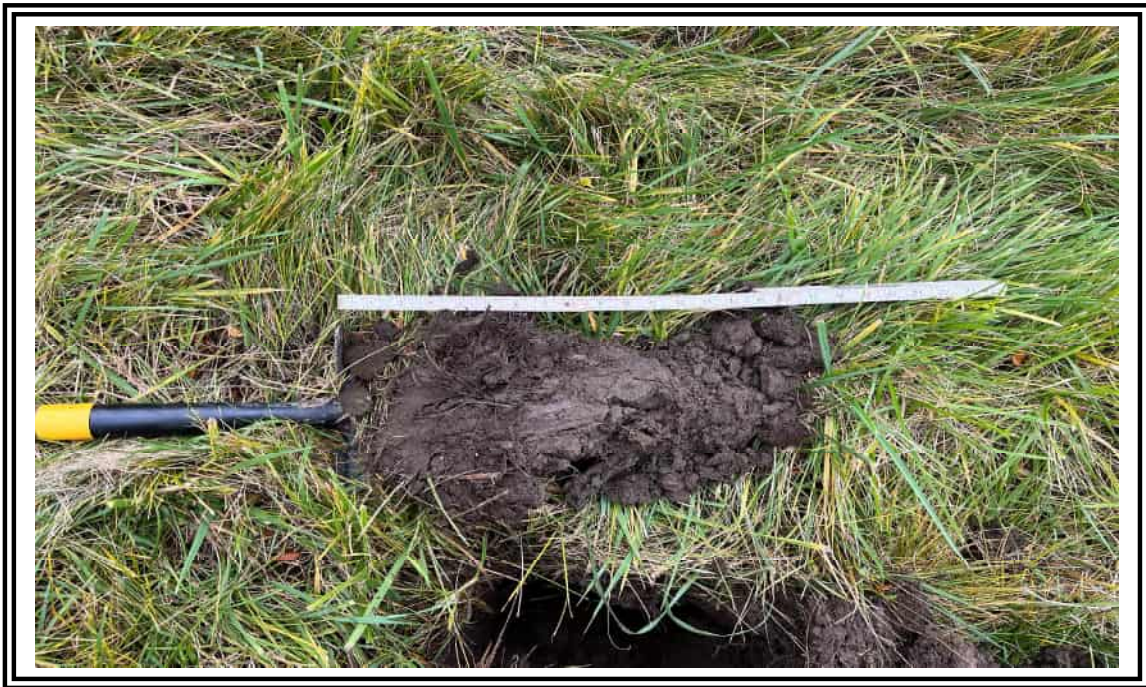
Depth (inches)	Matrix		Redox Features				Texture	Remarks
	Color (moist)	%	Color (moist)	%	Type ¹	Loc ²		
0-7	10YR 2/1	100					Loamy/Clayey	with organics
7-18	10YR 4/1	82	10YR 5/4	10	C	M	Sandy	Distinct redox concentrations
			2.5YR 3/6	8	C	PL/M		Prominent redox concentrations

Photo 2-Wetland A soils.

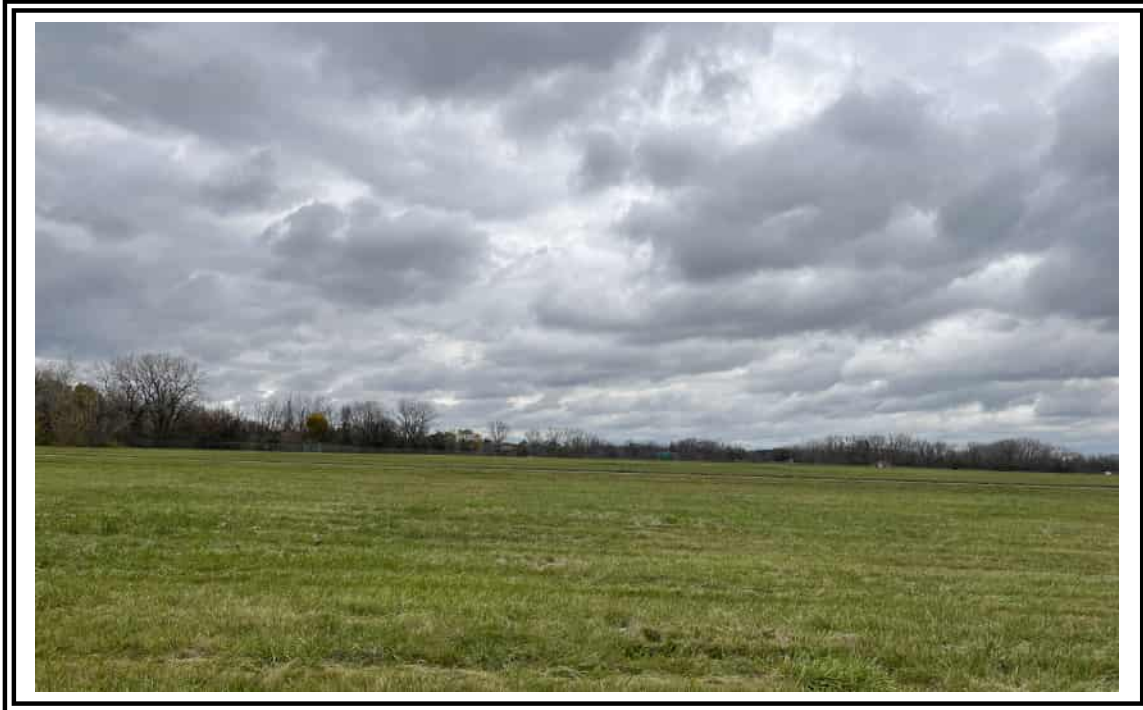
Photo 3-Upland A facing northwest.

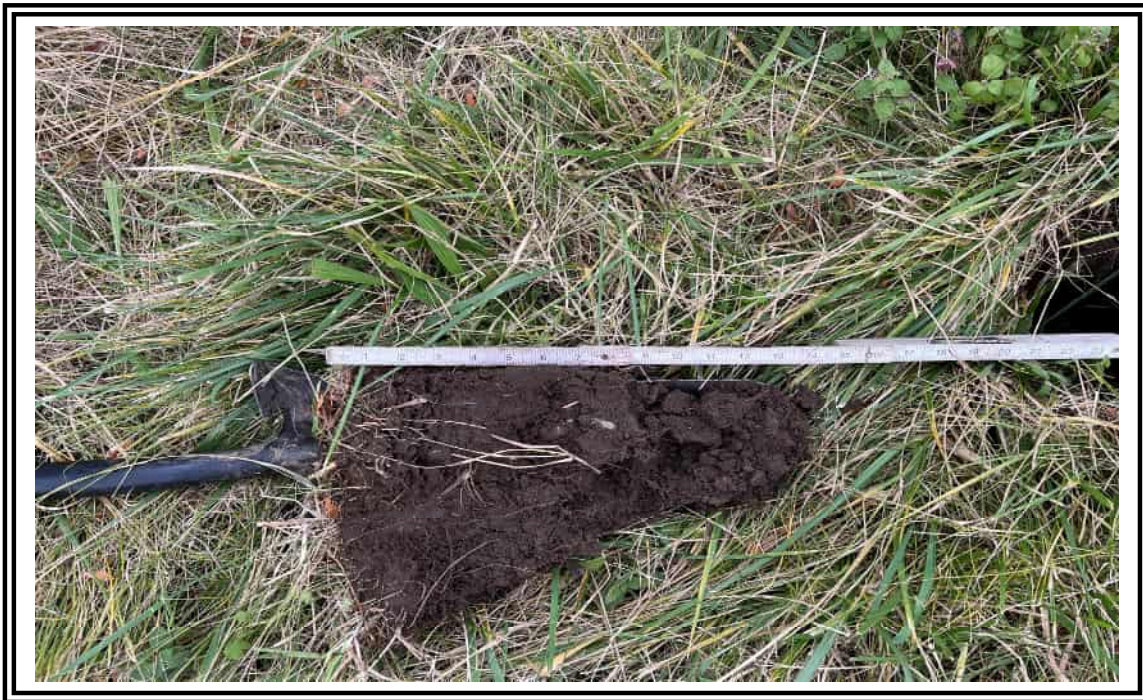
Photo 4-Upland A soils.

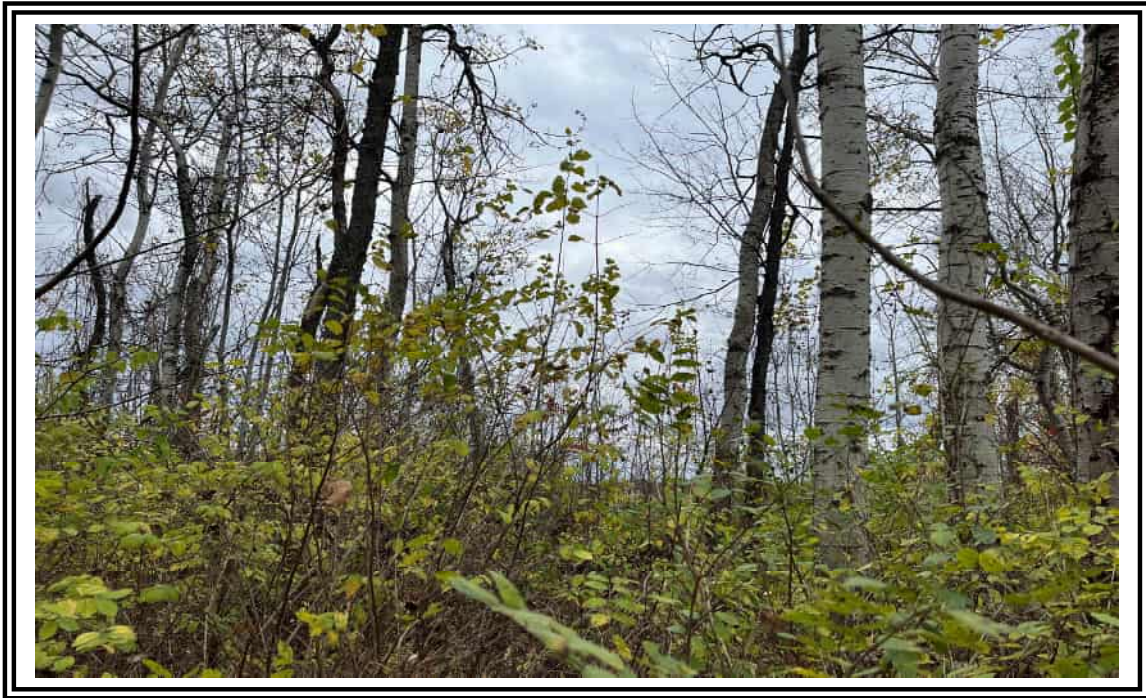
Successional northern hardwoods- This area is also located in the northwest corner of the project area. The dominant trees in this area are quaking aspen and black cherry (*Prunus serotina*). Sugar maple (*Acer saccharum*) is also present in lesser occurrences. The shrub layer is dominated by quaking aspen and morrow's honeysuckle. Other shrubs present include black cherry, red oak (*Quercus rubra*), buckthorn (*Rhamnus cathartica*), staghorn sumac and gray dogwood. The herbaceous layer contains species such as tall goldenrod, morrow's honeysuckle and pokeweed (*Phytolacca americana*). Vines present include poison ivy (*Toxicodendron radicans*), summer grape (*Vitis aestivalis*) and bittersweet (*Celastrus orbiculatus*).

Photo 5-Successional northern hardwoods facing east.

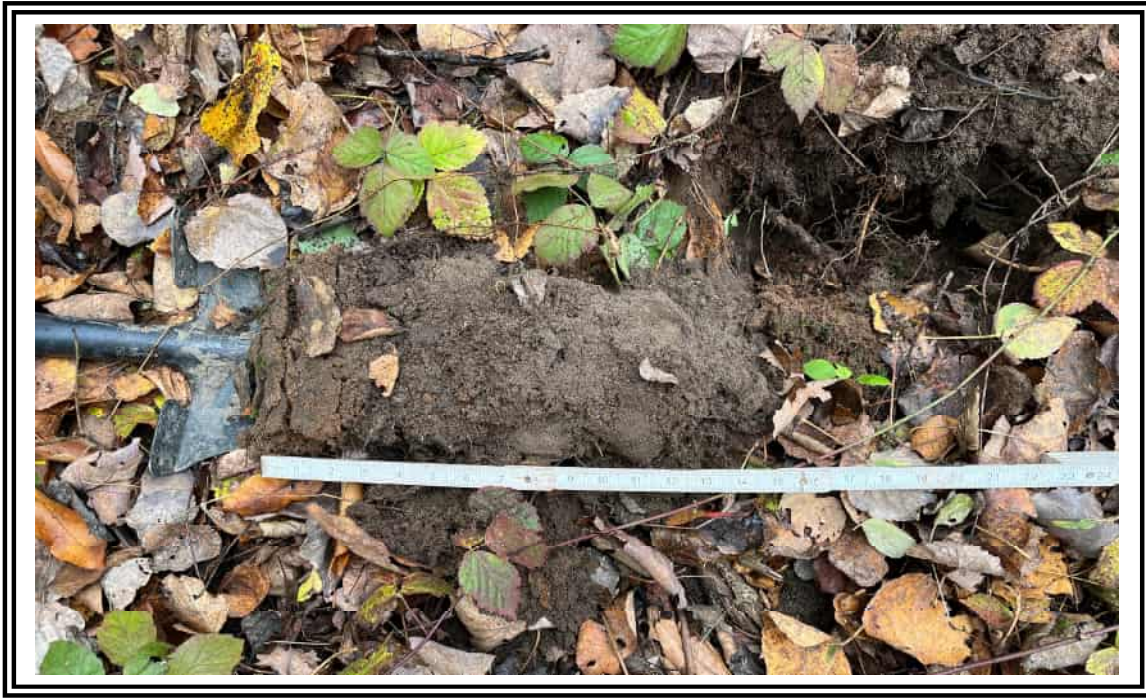
Photo 6- Successional northern hardwoods soils.

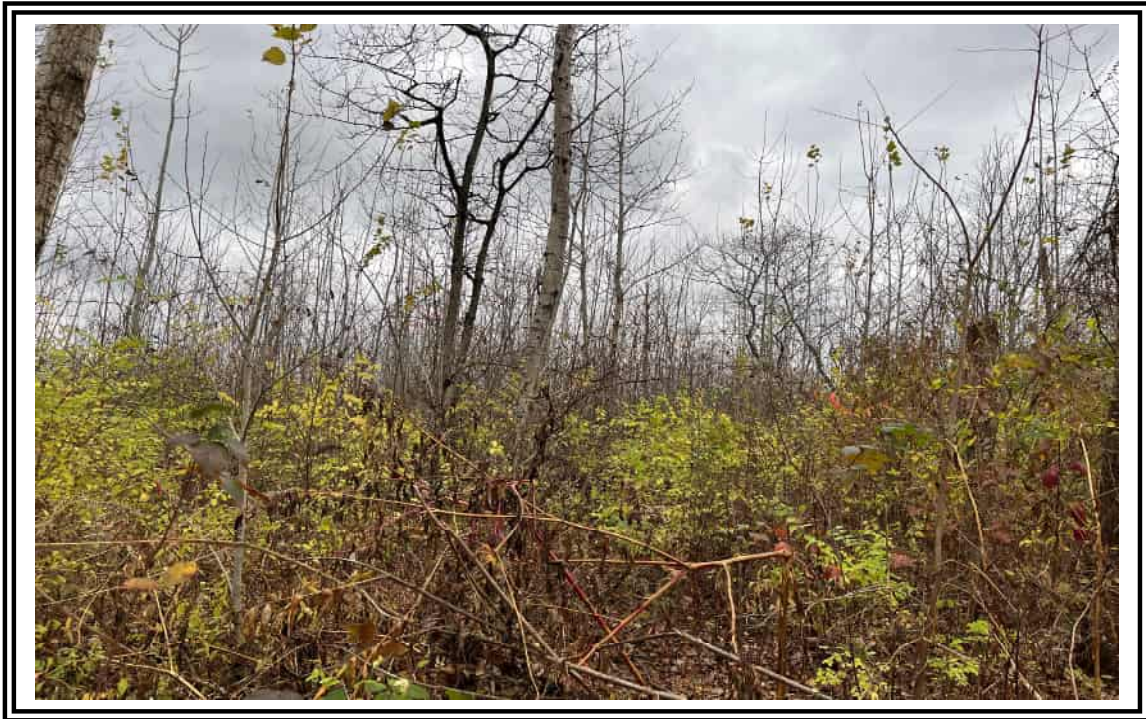
Successional shrubland-This area is located in the northwest corner of the project area. The dominant shrub in this area is quaking aspen (*Populus tremuloides*). Other shrub species present include gray dogwood (*Cornus racemosa*), morrow's honeysuckle (*Lonicera morrowii*), staghorn sumac (*Rhus typhina*), blackberry (*Rubus allegheniensis*) and black raspberry (*Rubus occidentalis*). The herbaceous layer contains species such as blackberry, morrow's honeysuckle and tall goldenrod (*Solidago altissima*).

Photo 7-Successional shrubland facing west.

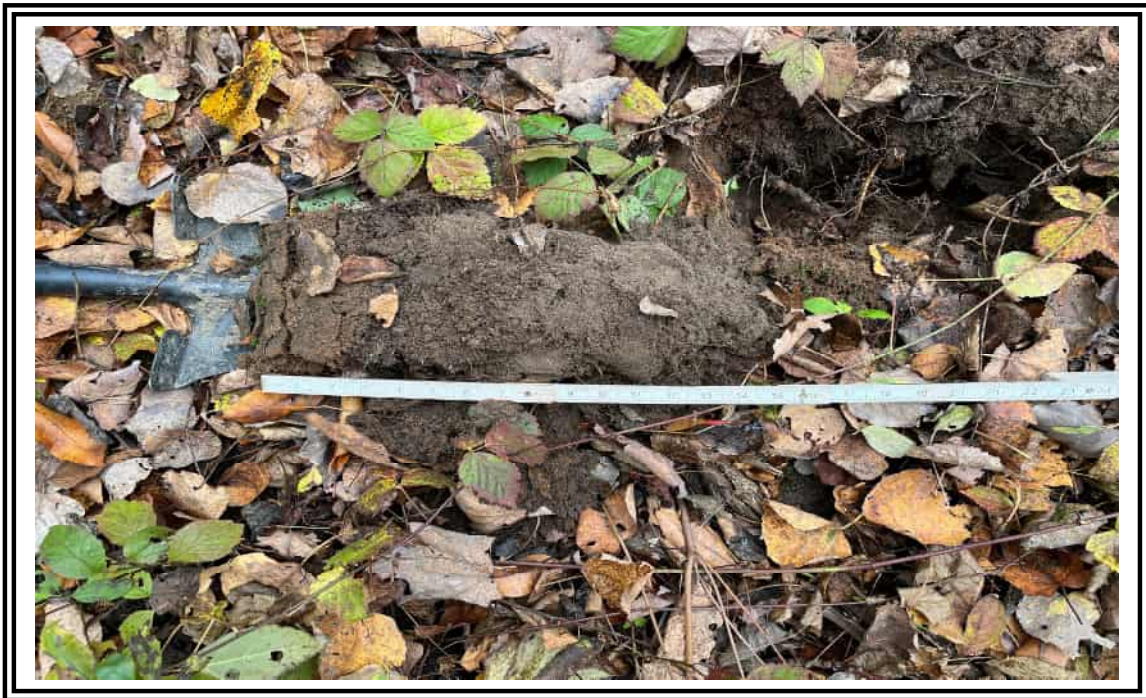
Photo 8- Successional shrubland soils.

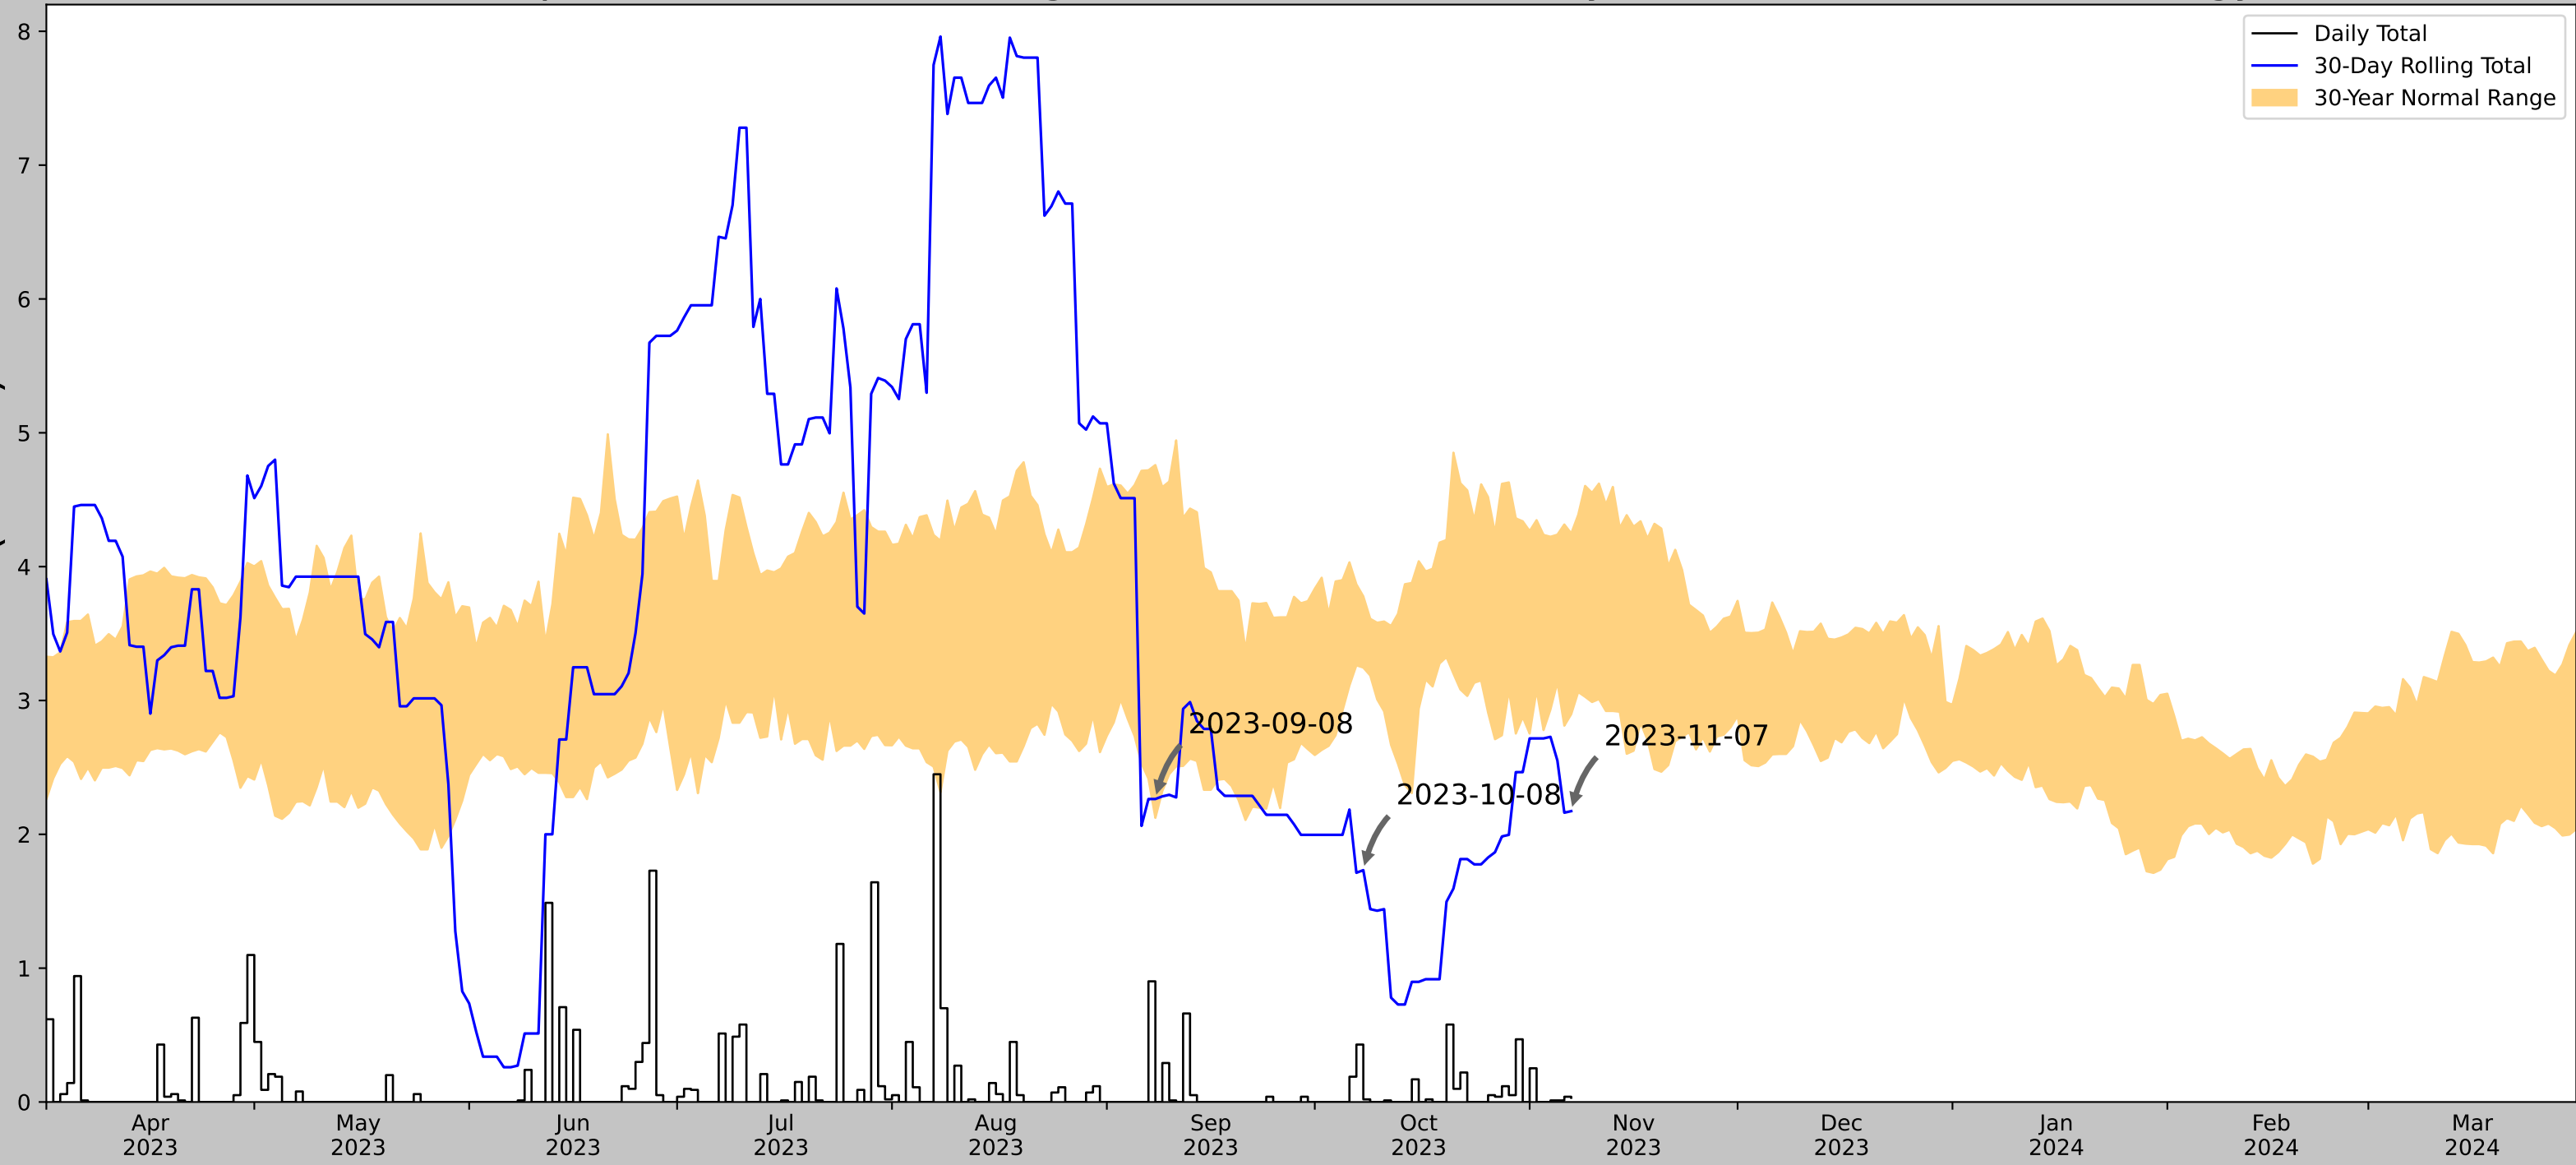
Antecedent Precipitation vs Normal Range based on NOAA's Daily Global Historical Climatology Network

The Antecedent Precipitation Tool identified that the drought index (PDSI) was mild wetness and that the delineation was performed under drier than normal conditions (index score of 7) (Attachment E).

Coordinates	43.113783, -76.127722
Observation Date	2023-11-07
Elevation (ft)	415.116
Drought Index (PDSI)	Mild wetness (2023-10)
WebWIMP H ₂ O Balance	Wet Season

30 Days Ending	30 th %ile (in)	70 th %ile (in)	Observed (in)	Wetness Condition	Condition Value	Month Weight	Product
2023-11-07	2.897638	4.248425	2.173228	Dry	1	3	3
2023-10-08	3.245669	3.778347	1.732284	Dry	1	2	2
2023-09-08	2.122441	4.759449	2.26378	Normal	2	1	2
Result							Drier than Normal - 7
